Recall Service Bulletin

APPLIES TO: This Recall service bulletin applies to motorhome chassis, model year 2017, K2 and K3 models built between March 24, 2016 and August 31, 2016.

NHTSA/TC Id: 16V-776

CONDITION: Certain wires in the throttle circuit were not twisted which could result in a throttle setting above or below the commanded throttle setting/input.

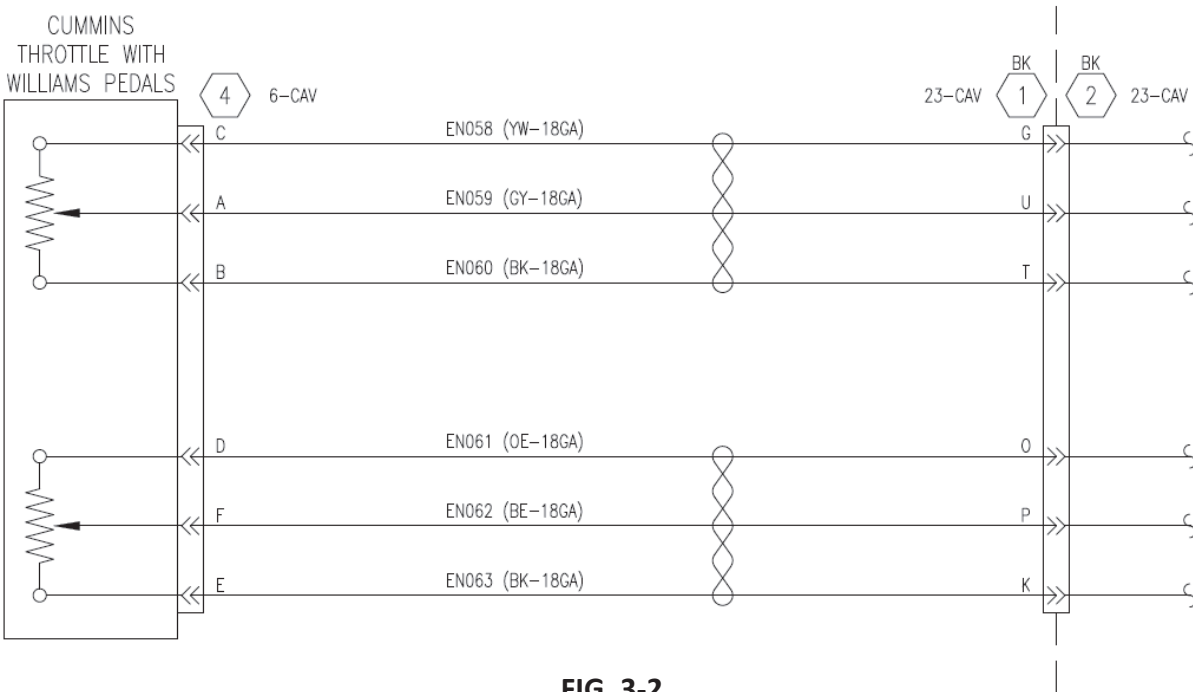
1. Identify and disconnect throttle pedal connector, Item ④ in FIG. 3-2, from throttle assembly. Pull back loom 12 inches over wiring terminated into throttle pedal connector. Verify wiring consists of 6 discreet wires (untwisted) then go to step 2. If wiring consists of 2 twisted triplets (refer to FIG. 3-2), replace loom over wiring and reconnect throttle pedal connector, Item ④. No further action is required.

2. Pull back existing throttle pedal connector and stow/tape it back onto existing harness.
3. Connect new throttle pedal connector, Item ④, of new 3995-GG5-001 overlay harness into throttle assembly. Refer to FIG. 3-2.

5. Locate and disconnect main chassis harness interconnect, Item ①, from forward electrical compartment disconnect. Refer to FIG. 3-2
6. Using Deutsch contact removal tool, remove circuits from disconnected Item ①, cavities O, P, K, G, U, and T. Refer to FIG. 3-1.

- Cut off contacts from removed circuits, individually heat shrink, and pull/tape back onto existing harness.
- Insert new circuits from new overlay harness into existing main chassis harness interconnect connector Item 1. Refer to FIG. 3-1. Each wire is tagged with a label depicting which cavity it belongs in. Refer to FIG. 3-2. Note that the wiring/pin out does not change.

, to firewall disconnect. Refer to FIG. 3-2.
10. Assure new overlay harness is secured to existing harness as required throughout its entire run. Tape back any extra length as required.
11. Using Cummins® INSITE™, verify that no fault codes are generated at key-up. Also verify that appropriate values are seen in regards to throttle pedal position.
