RECALL CAMPAIGN 16V-832: REPLACE SENSOR CLUSTER UNIT

This Service Information bulletin supersedes SI B65 28 16 **dated March 2017**.

F10 (5 Series Sedan)	
----------------------	--

Removing and installing/replacing central sensor

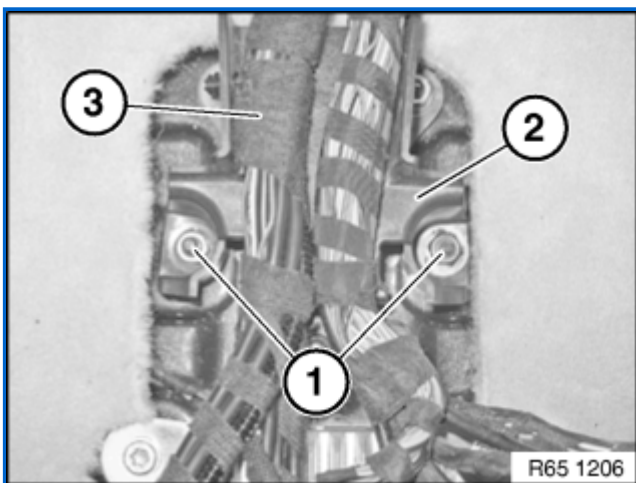
Unscrew nuts (1).

Remove holder (2) from centre console wiring harness (3).

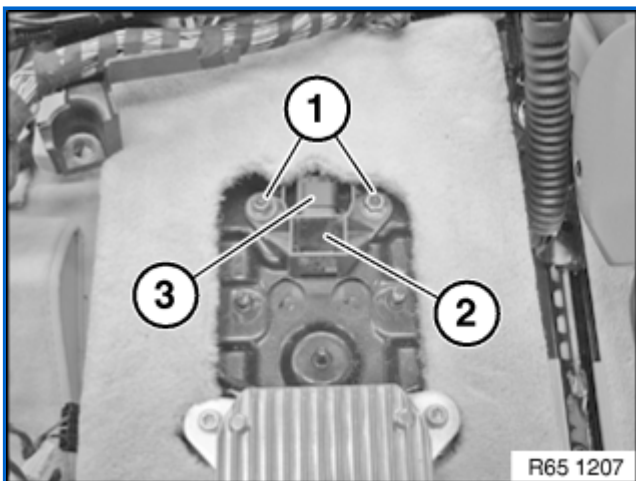
Unscrew nuts (1).

Remove sensor (2).

Unlock plug connection (3) and disconnect.

Tightening torque [65 77 5AZ](#).

Make sure sensor is mounted without play.
