Maserati Technical Bulletin

Date: November 29th, 2016
Bulletin No. MAS001052 – Rear Differential
Inspection_US
Recall Campaign - 328
Supersedes: N/A

Model: Quattroporte (M156) and Ghibli (M157)

Subject: Vehicle Safety Recall Campaign 328 – Rear Differential Inspection

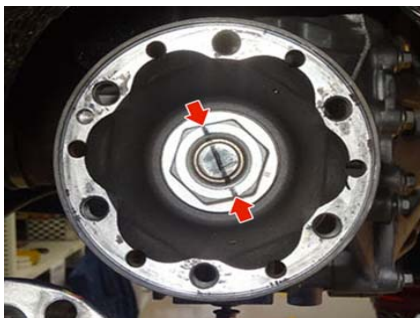
Fig.13

12. Perform a visual inspection of the nut to **make sure it has not moved** (Fig.13). Compare it with the picture taken in step 10. If there was any movement of the nut, the differential must be replaced. Refer to section 3.21.001 – 00 of the Workshop Manual and attachment “A” in this bulletin.

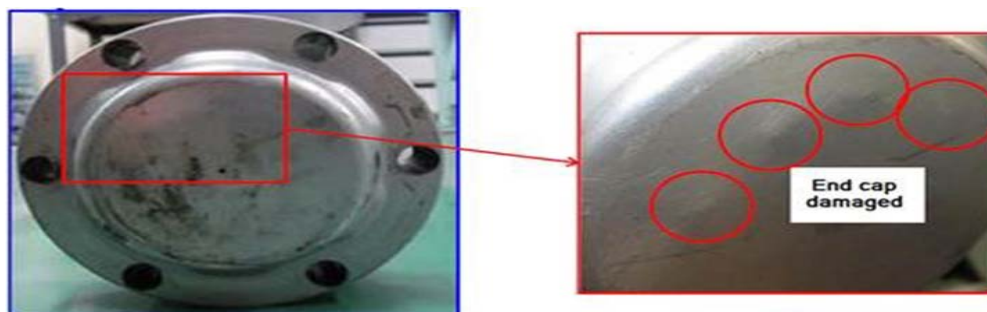
Fig.14

13. Perform a visual inspection of the drive shaft cover to make sure there are no bumps or protrusions that may alter the smoothness of the cover (Fig.14). If any bumps or protrusions are found, the drive shaft must be replaced. If replacing the drive shaft, refer to section 3.30.001 of the Workshop Manual.
