Correct Orientation of OnGuard Collision Mitigation System on specific Jayco Motorized - Entegra - Cornerstone Class A Motorhomes

2017 Cornerstone Class A Motorhomes

**Instructions for Spartan Service Centers to correct orientation of OnGuard system**

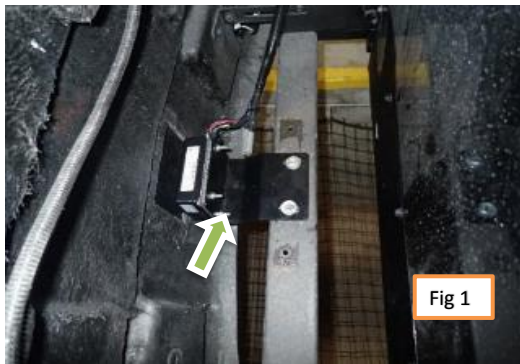
- Fig 1:** Open generator compartment.  
Locate the OnGuard Radar System computer.

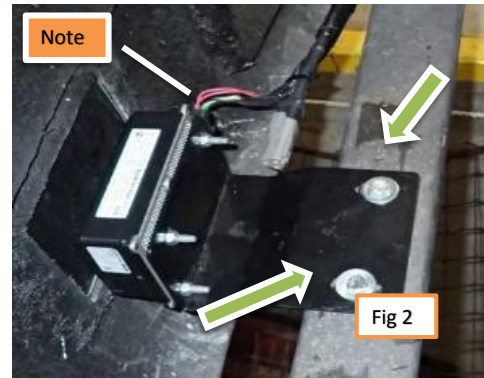
- Fig 2:** Remove bolts connecting the computer system to the compartment door (save bolts for reinstall).  
**Note:** Wiring harness is on the passenger side of the system. Confirms incorrect orientation.

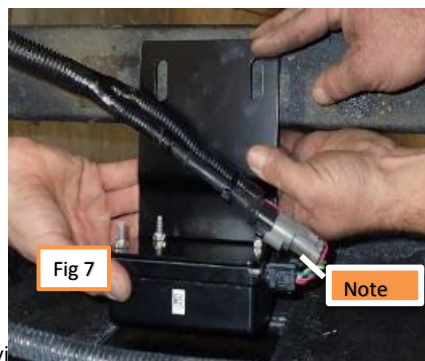
Fig 7: **Note** Wiring harness now on the drivers side of system. Confirms correct orientation.
