POLARIS®

TECHNICAL SERVICE BULLETIN

Bulletin Number: L-16-01

2016-2017 GEM Drive-Mode Switch Replacement

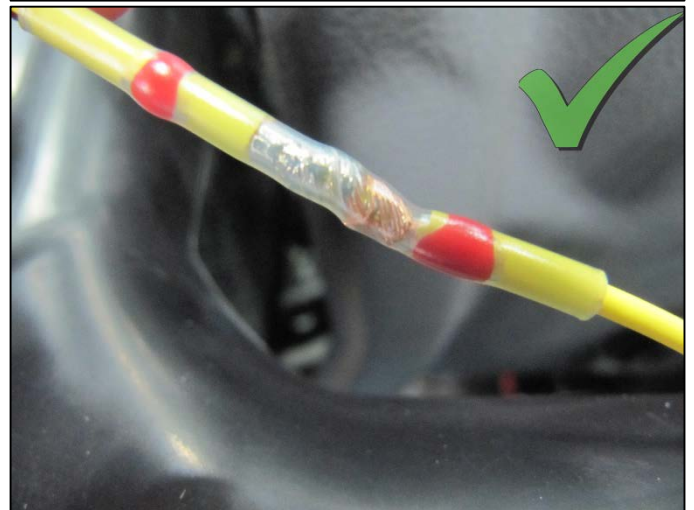
Acceptable – Solder is fully melted and sleeve has contracted.

21. Evenly apply heat to the solder sleeve until the sleeve has contracted and the solder ring has evenly melted into the wires.

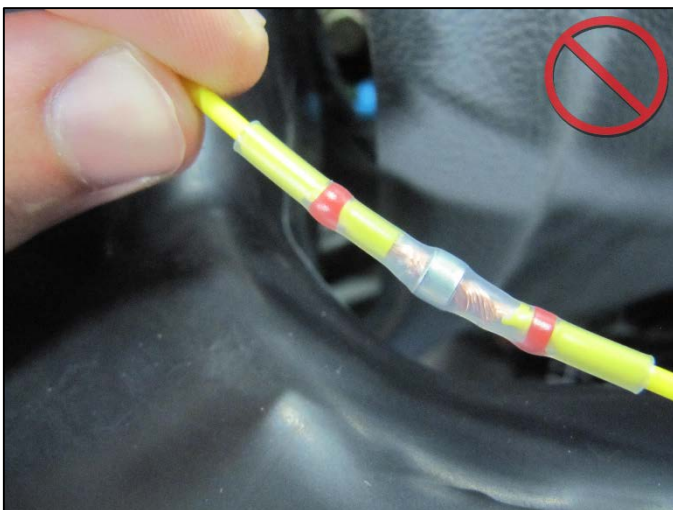
Unacceptable – Inadequate heat. Contour of the solder ring is clearly visible.

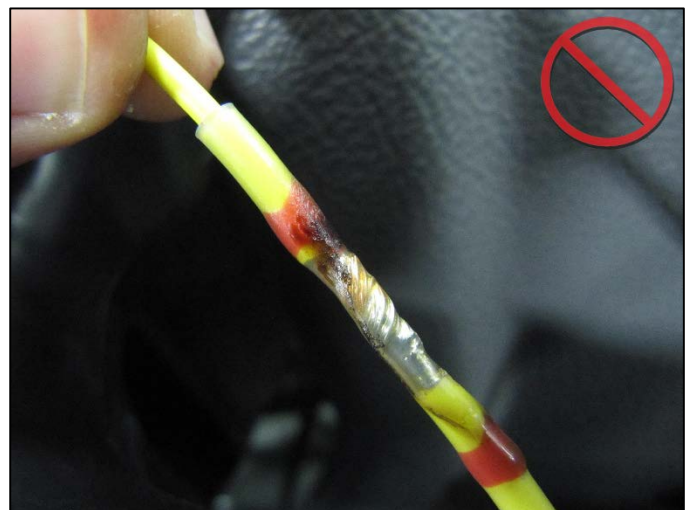
Unacceptable – Excessive heat. Sleeve is burnt and has left the wires exposed.
