Safety Recall: Rear Wire Harness/Rear Subframe Harness

| Year | Model | Trim | VIN Range |
|---|---|---|---|
| 2017 | Ridgeline | AWD | Check the iN VIN status for eligibility |

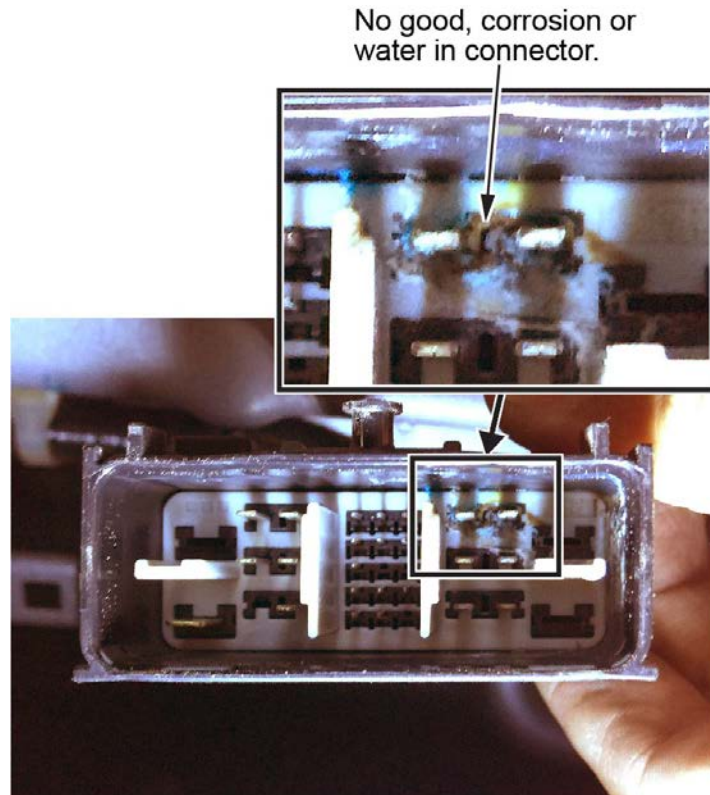
3. Disconnect connector C601 (rear wire harness/rear subframe harness), and inspect the interior of the connector and terminals on both the male and the female side for signs of water intrusion and/or corrosion.

Is there water and/or corrosion inside the connector?

Yes – Go to REPAIR PROCEDURE B.

No – Go to REPAIR PROCEDURE A.
