**January 10, 2017**

05592 Version 4

**Safety Recall: Rear Wire Harness/Rear Subframe Harness**

Year	Model	Trim	VIN Range
2017	Ridgeline	AWD	Check the iN VIN status for eligibility

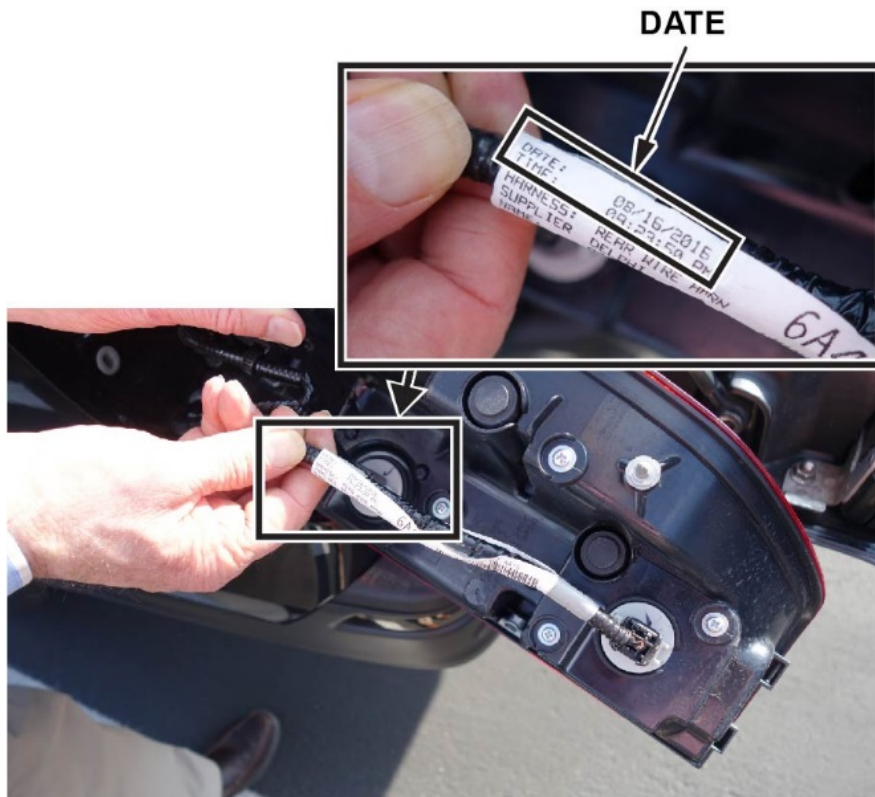
1. Remove the left taillight. Refer to the service information.
2. Check the date on the label on the rear wire harness.
  - If the harness date is **before** August 9, 2016 (08/09/2016), go to step 3.
  - If the harness date is **on or after** August 9, 2016 (08/09/2016), go to REPAIR PROCEDURE C.

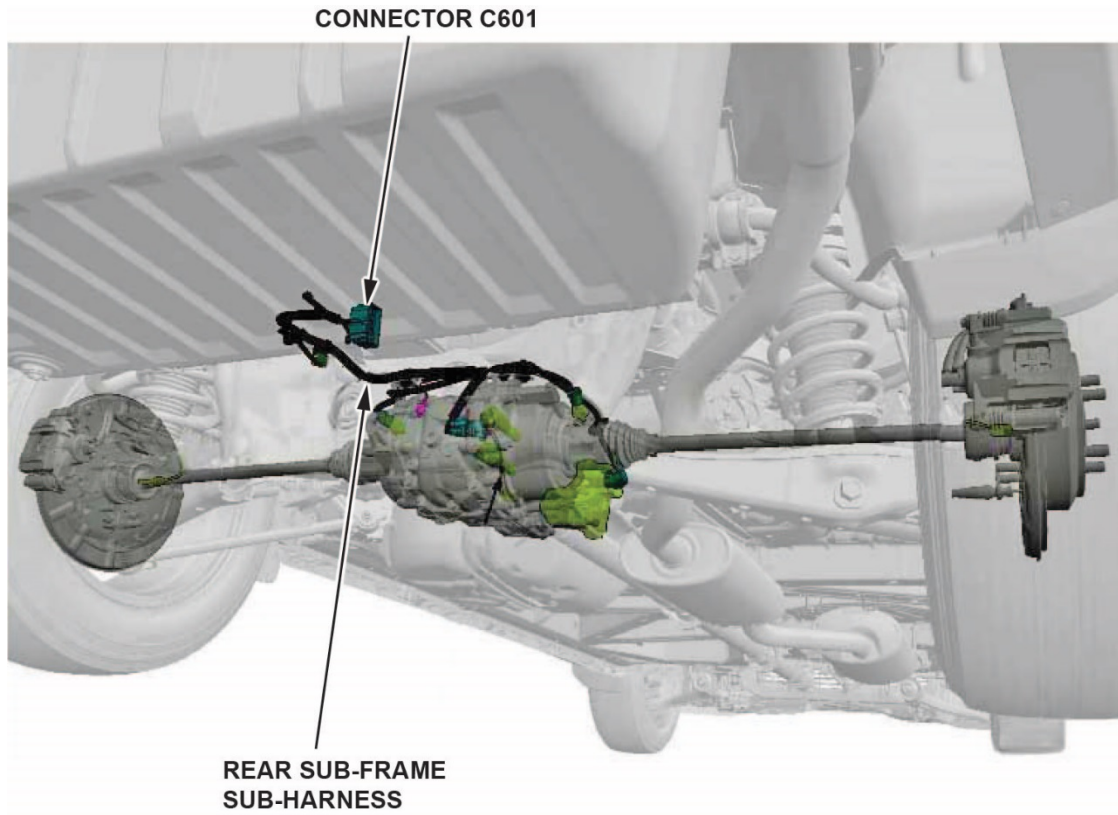
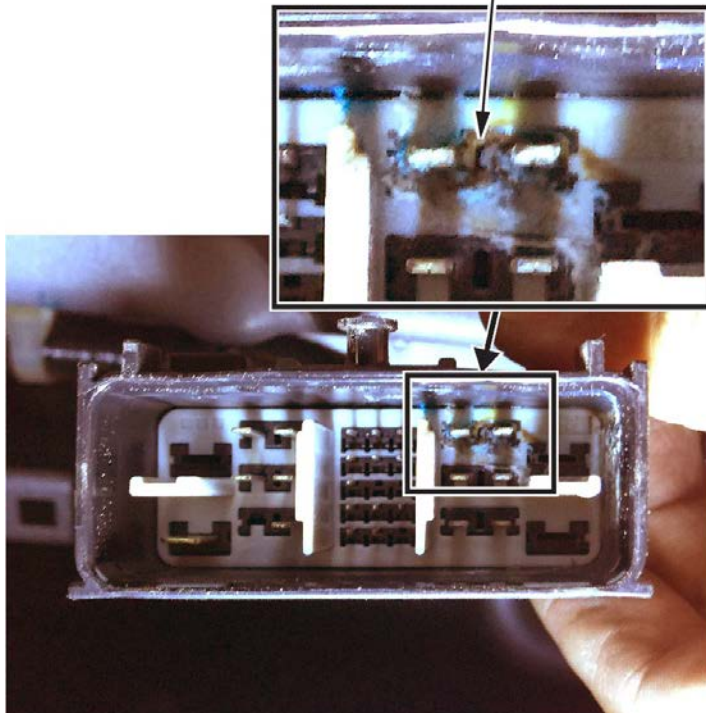
3. Disconnect connector C601 (rear wire harness/rear subframe harness), and inspect the interior of the connector and terminals on both the male and the female side for signs of water intrusion and/or corrosion.

No good, corrosion or  
water in connector.

Yes – Go to REPAIR PROCEDURE B.

No – Go to REPAIR PROCEDURE A.

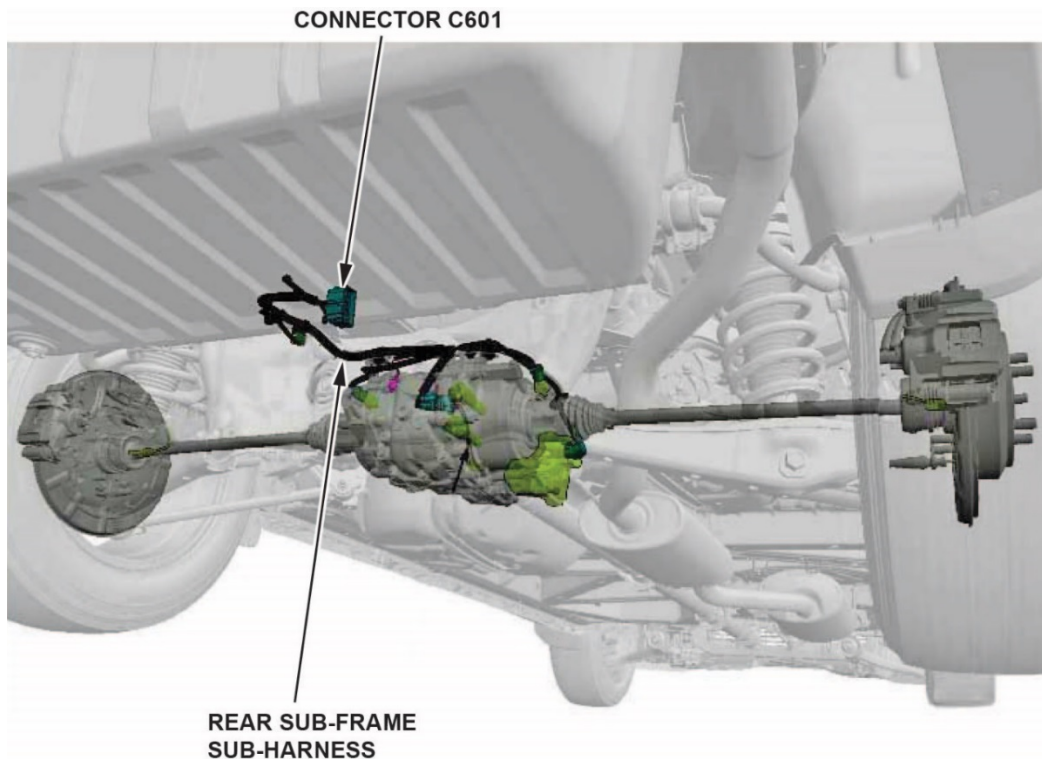
1. Disconnect connector C601 (rear wire harness/rear subframe harness), and inspect the interior of the connector and terminals on both the male and the female side for signs of water intrusion and/or corrosion.

No good, corrosion or water in connector.

Yes – Go to REPAIR PROCEDURE B.

No – Go to step 2.
