March 10, 2017

05943 Version 5

Safety Recall: Rear Wire Harness/Rear Subframe HarnessSupersedes 16-093, dated January 10, 2017, to revise the section highlighted in **yellow****AFFECTED VEHICLES**

Year	Model	Trim	VIN Range
2017	Ridgeline	AWD	Check the iN VIN status for eligibility

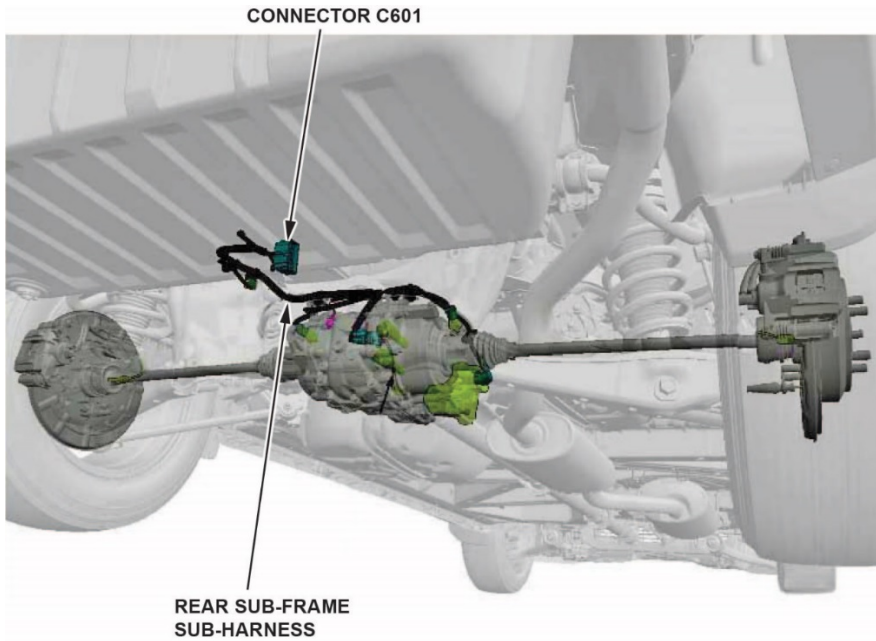
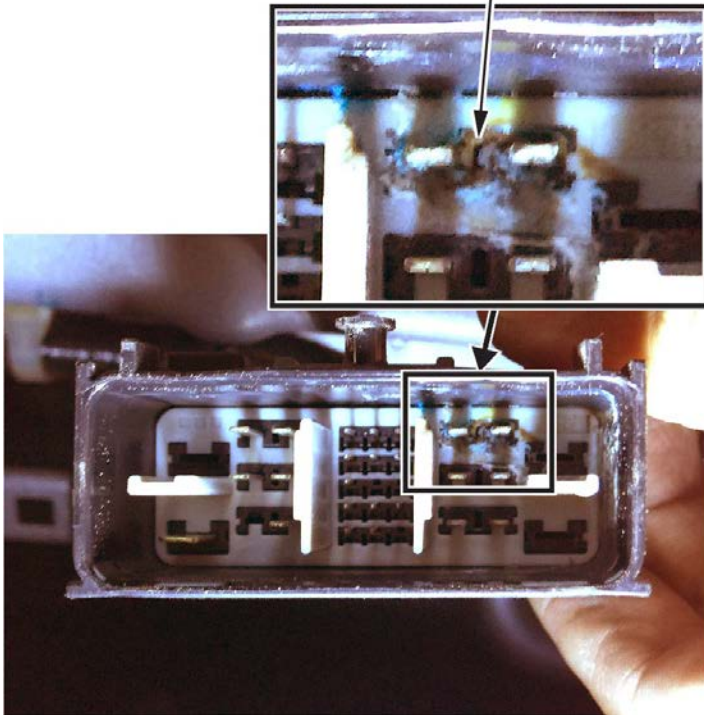
3. Disconnect connector C601 (rear wire harness/rear subframe harness), and inspect the interior of the connector and terminals on both the male and the female side for signs of water intrusion and/or corrosion.

No good, corrosion or water in connector.

Yes – Go to REPAIR PROCEDURE B.

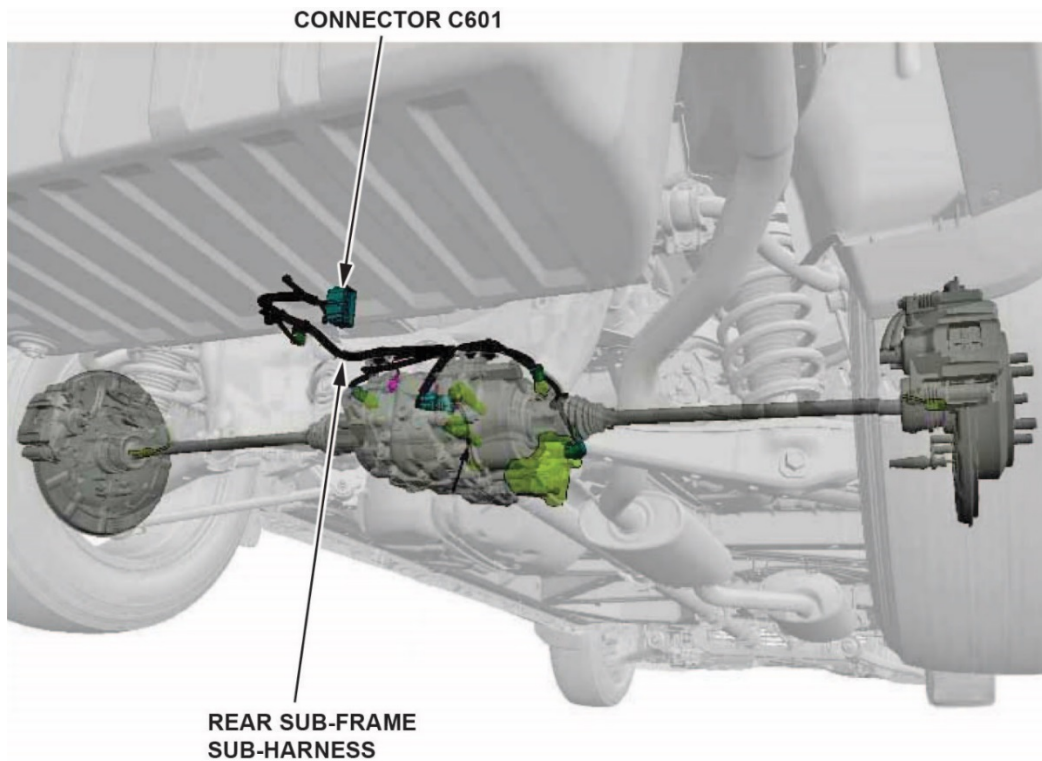
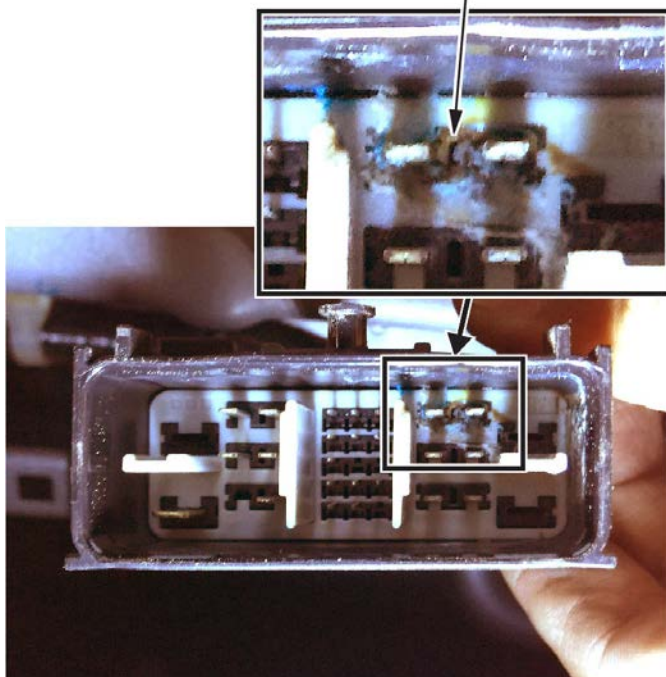
1. Disconnect connector C601 (rear wire harness/rear subframe harness), and inspect the interior of the connector and terminals on both the male and the female side for signs of water intrusion and/or corrosion.

No good, corrosion or water in connector.

Yes – Go to REPAIR PROCEDURE B.
