Thor Motor Coach Recall Repair Instructions

Recall # **16V-893**

Description/Title: **Mor-Ryde Ramp Door Hinge Assembly Weld Failure**

Affected Product Line(s): **Certain 2016 and 2017 Outlaw Motor Homes**

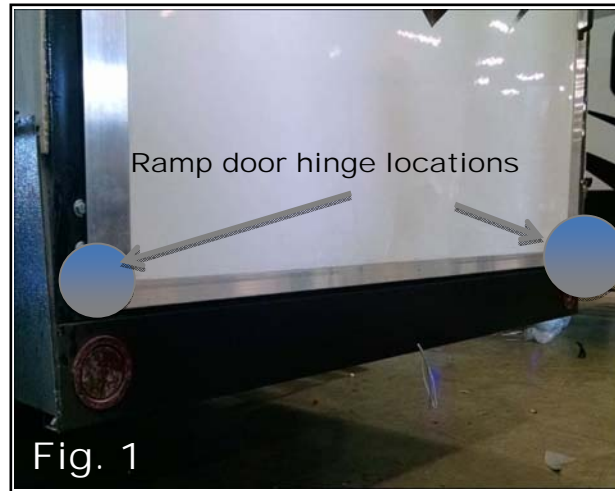
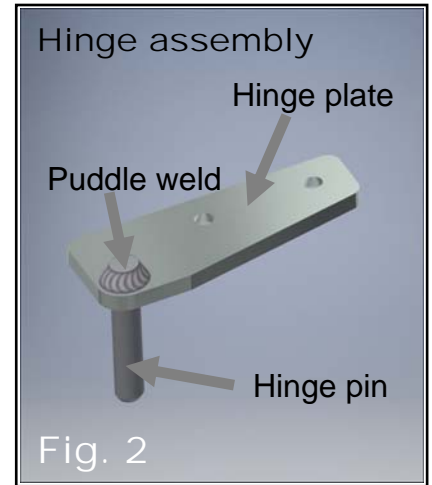
Hinge Inspection - The hinges on the Mor-ryde ramp door need to be inspected for adequate puddle weld on the back of the hinge. The hinges in question are located at the bottom corners of the door, Figure 1. With the door closed, the puddle weld is not visible, Figure 2.

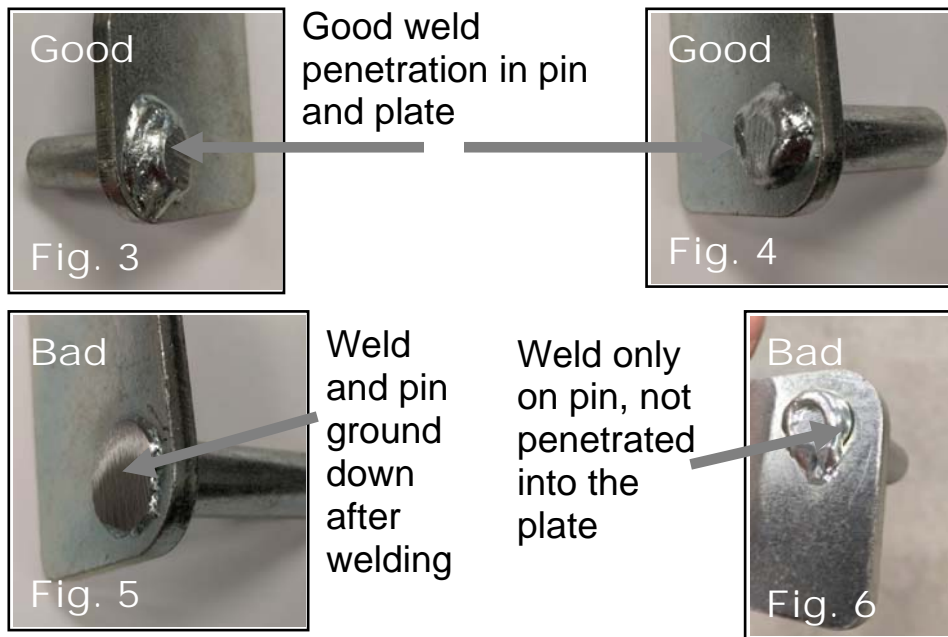
Open door and clear any black caulk or foam from the bottom of the hinge to allow access to the back side of the hinge, exposing the weld. Using a light, inspect the welds using the following figures 3, 4, 5, and 6 as examples. Take a picture of each hinge weld. **IMPORTANT!** Your visual inspection is to ensure the weld is adequate, but most importantly that the weld and pin have not been ground down as in figure 5.

Pass: The weld is complete, has penetrated the plate and the pin.

Fail: The weld does not penetrate both the plate and the pin, or it has been ground down after it was welded.

If the hinges pass inspection, there replacement is not required. **Be sure to include picture of the hinges on the Pre-Authorization.** If hinge weld does not pass inspection, continue to step 4 for kit installation instructions.
