RECALL CAMPAIGN BULLETIN

NTB17-005

VOLUNTARY RECALL CAMPAIGN 2015-2016 ROGUE OCCUPANT CLASSIFICATION SYSTEM CONTROL UNIT REPLACEMENT

APPLIED VEHICLE: 2015-2016 Rogue (T32)

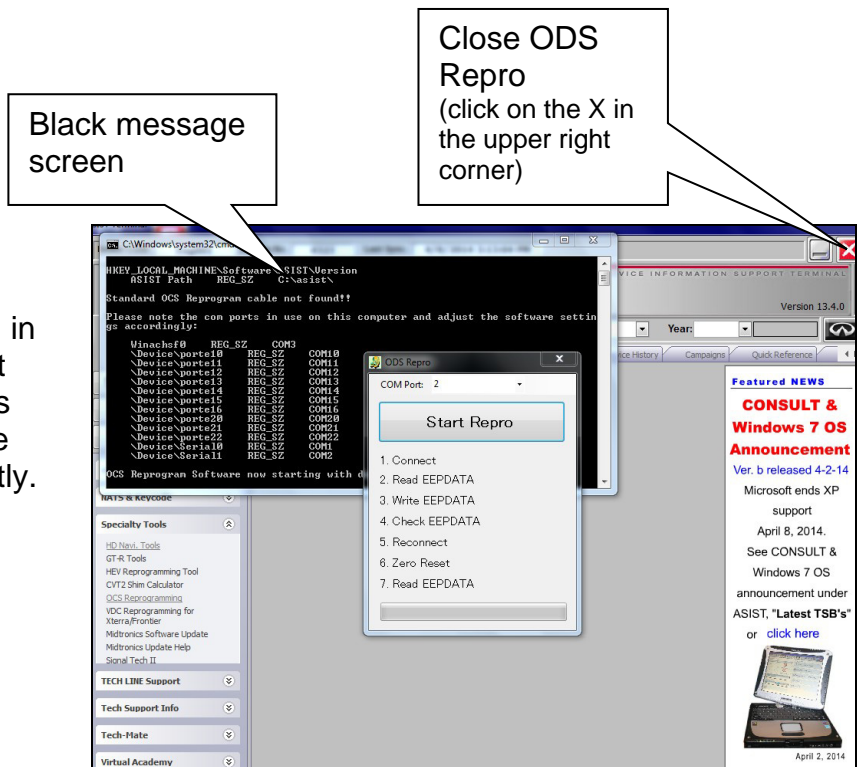
Figure 4

NOTE: If you get a black message screen as shown in Figure 4, this indicates that the reprogramming cable is not connected, or the cable driver did not install correctly.

- a. Close ODS Repro.
- b. Close ASIST.
- c. Start over from step 1 on page 6.

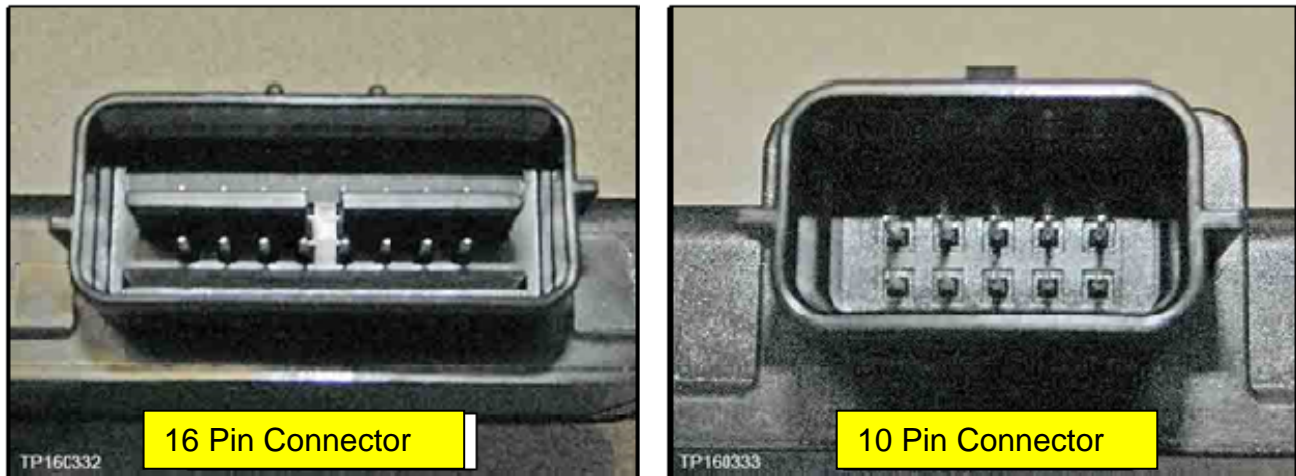
- (1) Refer to the electronic parts catalog (FAST) and look up the OCS ECU assembly part number by VIN.
- (2) Confirm that the number of pins of the new part are the same as the original OCS Control Unit (See Figure 19).

11. Select the correct OCS Control Unit from Parts Information and confirm that the pin count is the same as the OCS Control Unit being replaced. See Figure 19 on page 16.
12. Install the new OCS Control Unit in reverse order.
13. Connect the Negative battery terminal cable.
14. Reset/reinitialize systems as needed.
 - Refer to the ESM section, **PG – Power, Supply & Ground Elements** for a listing of systems that require reset/initialization after reconnecting the 12V battery.
 - Look in the PG section index for **ADDITIONAL SERVICE WHEN REMOVING BATTERY NEGATIVE TERMINAL**.
 - This list often includes items such as radio, power windows, clock, sunroof, etc.
