RECALL CAMPAIGN 16V-919: ELECTRICAL GROUND CABLE FOR THE DME CONTROL UNIT

F15 (X5)	
With the N20 engine

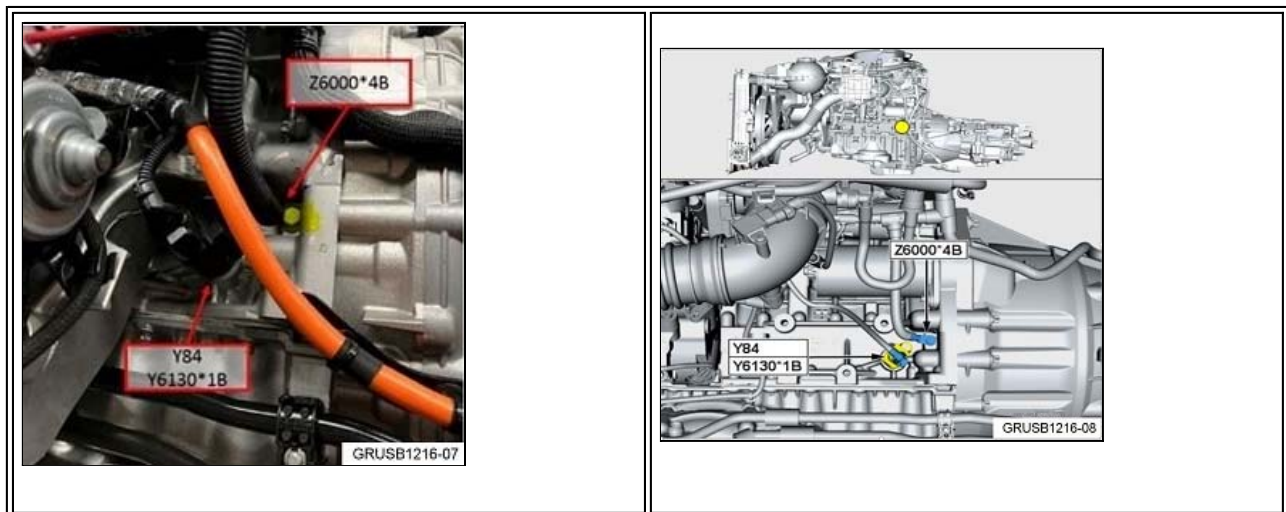
There is a possibility the ground cable from the engine wiring harness between the DME (Digital Engine Electronics) and the engine block is not fastened to the correct torque specification.

A faulty ground connection between the DME and the engine block could cause sporadic reset of the DME while driving. This could lead to the engine stalling or depending on the driving speed after the reset of the DME, difficulty in restarting the engine.

6. Check that the M6 bolt (DME ground connection “**Z6000*4B**”) is torqued to **8 Nm** as shown below and described in the repair instruction:

Ensure that the ground cable is indeed tight by trying to move it back and forth by hand. It is possible the specified torque of **8 Nm** is reached, but the ground cable is not secured tightly.
