P095NAS3

TECHNICAL BULLETIN

23 FEB 2017

SAFETY RECALL: Autoliv Seatbelt Operation

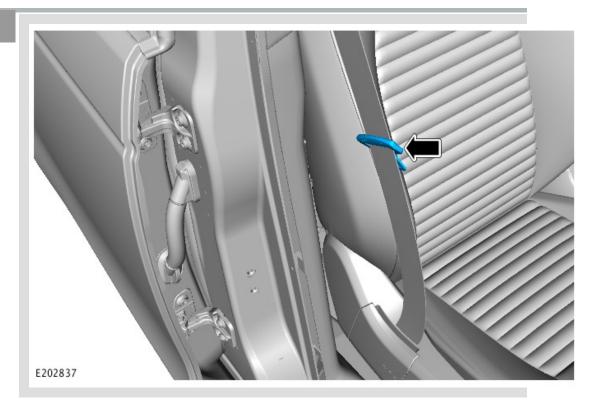
2

Locate the date embossed into the front seatbelt anchor.

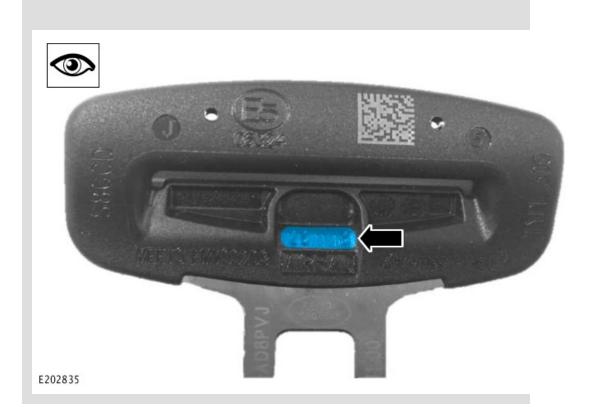
Record the left seatbelt production date **AND** production part number on the repair order.

- Repeat steps 1-3 on front row seating left seatbelt anchor.
- Check the left and right seatbelt production date **AND** corresponding production part numbers against the table above:

If both seatbelts do not have one of the listed seatbelt production dates **AND** corresponding production part number, release the vehicle.

If either seatbelt has any of listed date codes

AND corresponding production part number,

HOLD the vehicle.

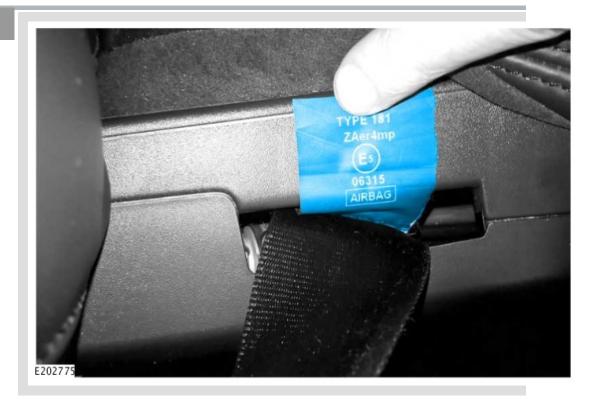
2

Locate the label on the front row seating right seatbelt.

The label may need to be folded back away from the seatbelt to read the printed information.

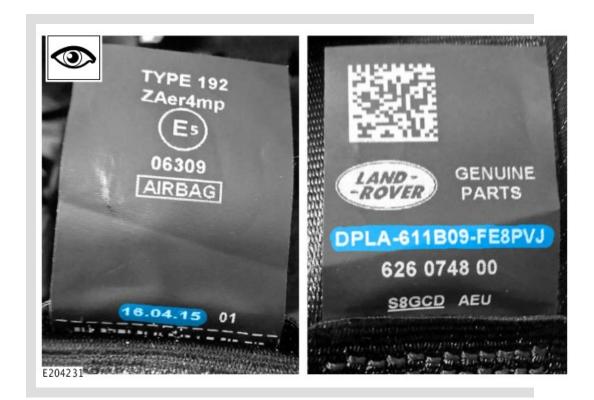
Record the left seatbelt production date **AND** production part number on the repair order.

- Repeat steps 1-3 on the front row seating left seatbelt.
- Check the left and right seatbelt production date **AND** corresponding production part numbers against the table above:

If both seatbelts do not have one of the listed seatbelt production dates **AND** corresponding production part number, release the vehicle.

If either seatbelt has any of listed date codes **AND** corresponding production part number, **HOLD** the vehicle.
