MORryde Safety Recall RD153-001 Ramp Door Hinge Assembly Weld Failure

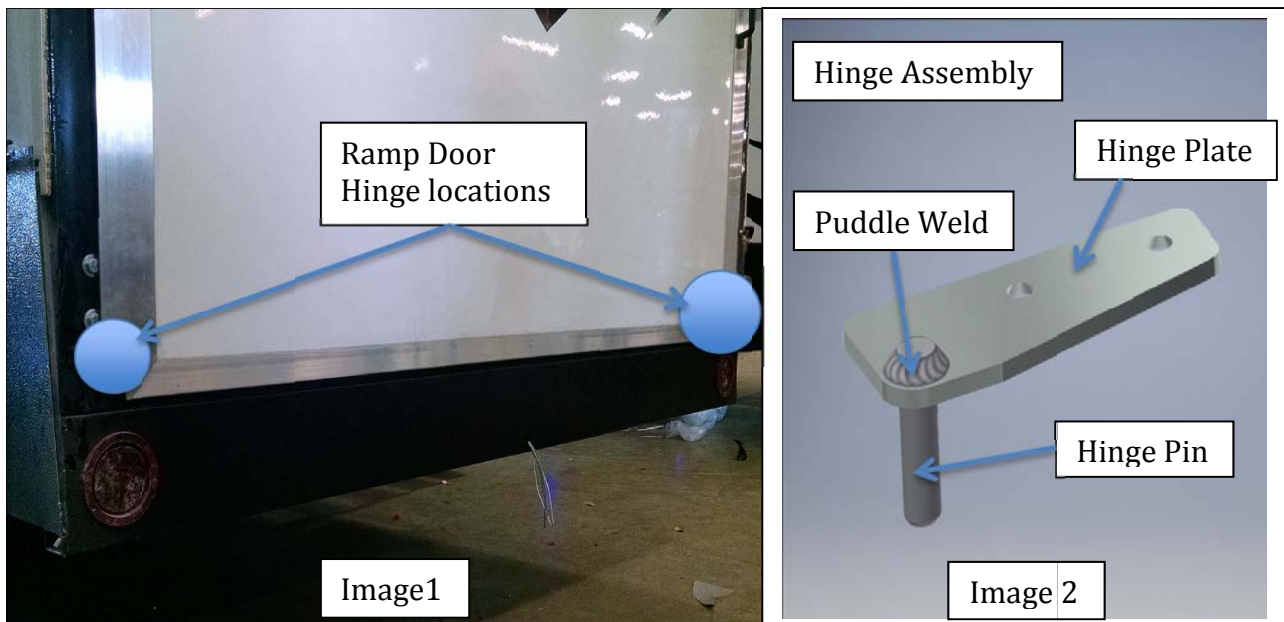
Background: The MORryde ramp door design includes a Hinge Assembly at each outside bottom corner of the ramp door (images 1 and 2). We have had several instances of a problem with the Hinge Assembly on the ramp door frame. It was determined the root cause was inadequate puddle weld securing the Hinge Pin to the Hinge Plate (image 2). Upon further investigation it was determined that we have produced approximately 2500 ramp doors and 5000 Hinge Assemblies. To date we have found 3 Hinges Assemblies to have inadequate puddle weld securing the Hinge Pin to the Hinge Plate (image 2).

Risk: If the puddle weld is inadequate the pin can separate from the plate. This can allow that side of the door to shift. The internal springs to the door will help keep the door from falling if this happens. If the door were to be completely opened with a failed hinge, the springs will lift the hinged end of the door causing the top of the door to swing down with more force than normal.

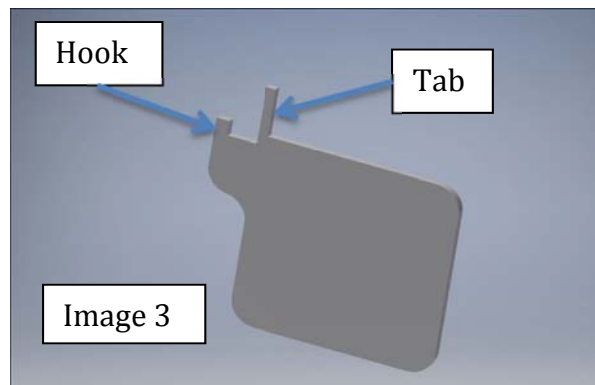
MORryde inspection tool, part number RD134-001 (image 3). This inspection tool RD134-001 is cut out of 0.075" thick steel. Use caution not to bend the tabs during the inspection process.

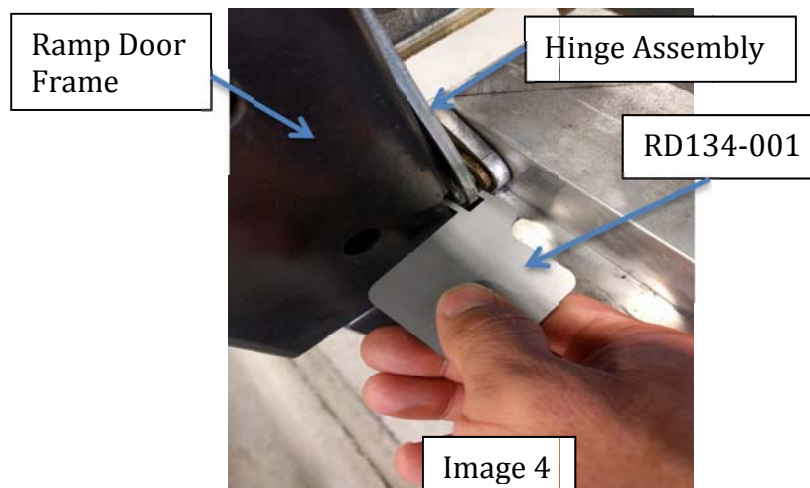
Inspection Procedure: Use inspection tool, RD134-001 (Image 4). If the weld is found to be inadequate, the hinge assemblies will need to be replaced. This process should take no more than 15 minutes to inspect.

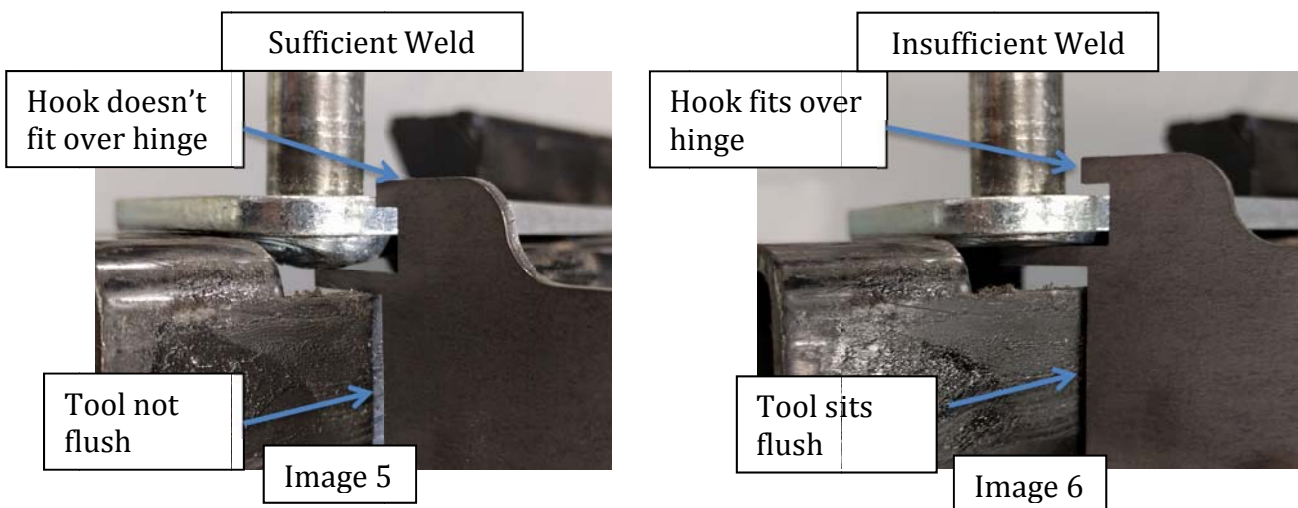
Test 1: Check the space between the cutout in the ramp door frame and the back side of the weld. The tab is inserted in that gap and pushed straight in to see if the tool will sit flush with the face of the frame (Image 5). Take care not try to twist the tool, the tab that gets inserted will bend.

Fail: If the inspection tool sits flush then the weld is insufficient and the test is failed. Please perform test 2.

Test 2: The second way the tool checks the weld is if the tab goes in completely between the hinge and the frame. The hook checks to see if there is enough protrusion of the weld on the backside of the hinge assembly. (Image 5 and 6). The second test is only applicable if the hinge assembly fails the first test.

Fail: If the inspection tool hook fits over the hinge and the tool is flush then the weld is insufficient and failed this test. **Please contact the MORryde customer service department immediately for repair.**
