IMPORTANT SAFETY RECALL – 16V-177

September 16, 2016

SN621

SUBJECT: *TLM Boom Tip Leveling & Master Cylinder Clearance*

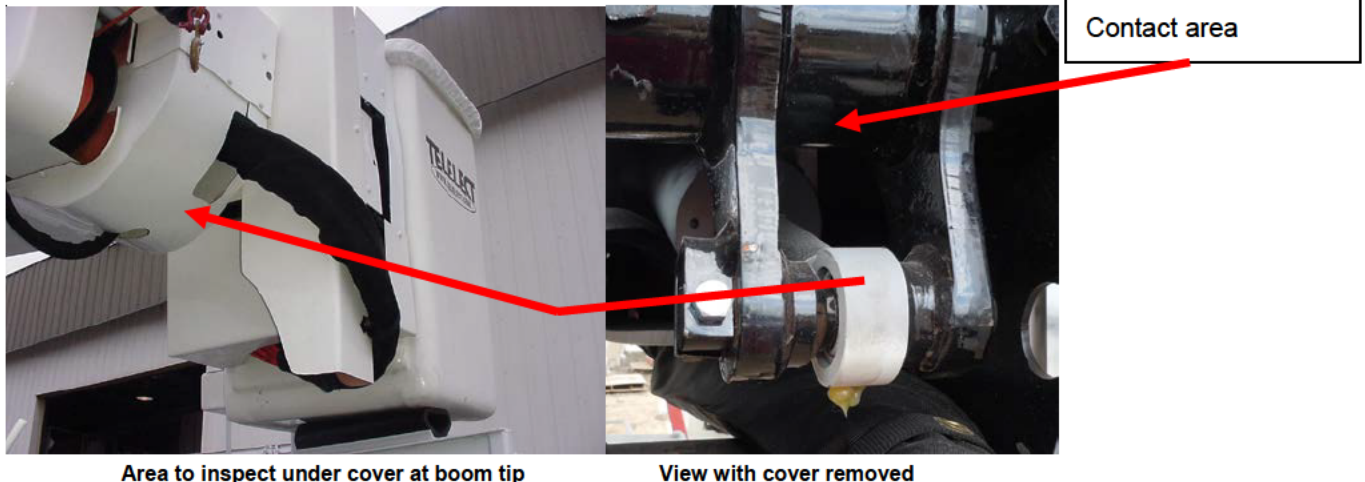
Terex Utilities became aware that it is possible that both the boom tip leveling cylinder and the master cylinder at the elbow can make contact with structural components. This contact can cause damage to the boom tip leveling cylinder rod eye and the master cylinder rod eye. Continued contact can cause cracks in the rod eye.

1. Perform a visual inspection of the boom tip rod eye for cracks. Look especially around the area where the rod eye is welded to the rod. Also inspect the contact area for signs of contact in the painted surface. Also inspect the cylinder rod for chrome damage to determine if contact is evident.

4. **If any cracks are detected in the cylinder rod eye do not operate the unit, take it out of service immediately.** Contact your local Terex dealer or TEREX Utilities at 605-882-4000 or email machine information to utilities.warranty@terex.com to arrange repair before further use.

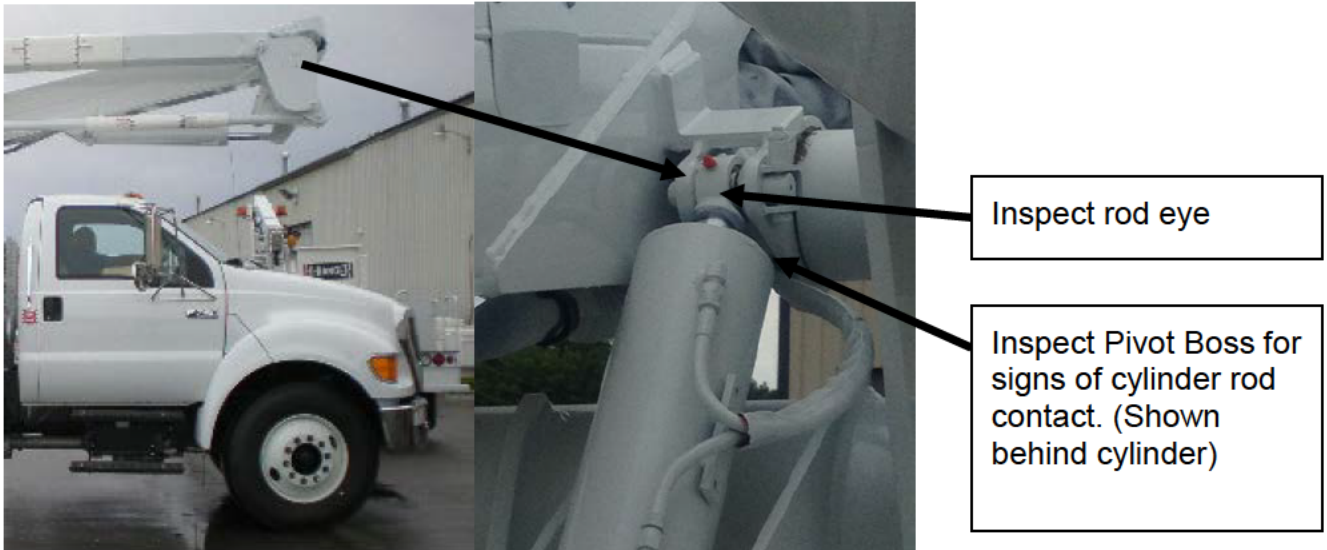
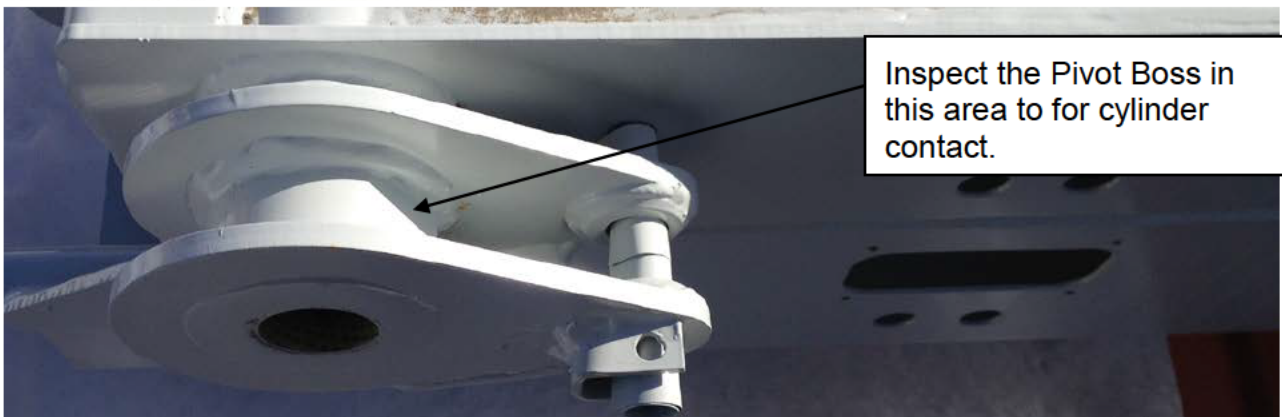
2. Perform a visual inspection for cracks in the rod eye areas shown below. Look especially around the area where the rod eye is welded to the rod.
3. Inspect the Pivot Boss for signs of the Master Leveling Cylinder rod contact when the upper boom is raised fully. Also inspect the cylinder rod for chrome damage to determine if contact is evident.

Note: Master cylinder rod eye contact can occur if the upper boom is raised to the end of stroke at full speed. Wear of the upper boom bushing can cause excessive movement past the intended position.
