IMPORTANT SAFETY RECALL
NHTSA Recall# 16V-659

Wabash National Corporation (WNC) has decided that a defect which relates to motor vehicle safety, exists in certain converter dollies manufactured by WNC.

Subject: Converter Dollies

Re.: Version 2A: Welded Repair

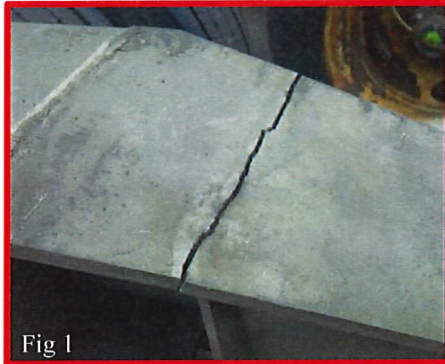
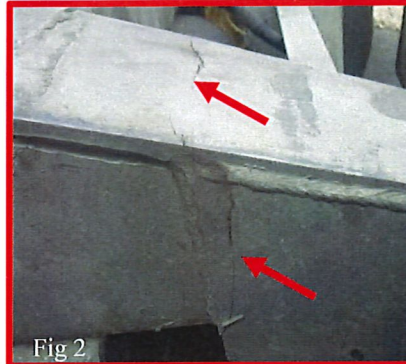
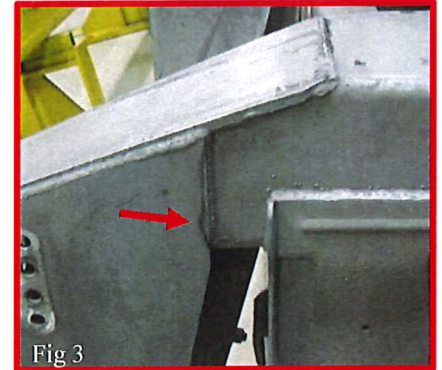
Issue Overview: Cracked dolly counterbalances (Fig 1-3). The failure of this connection is progressive in nature and inspection is required until units can be repaired.

Cracked counterbalance

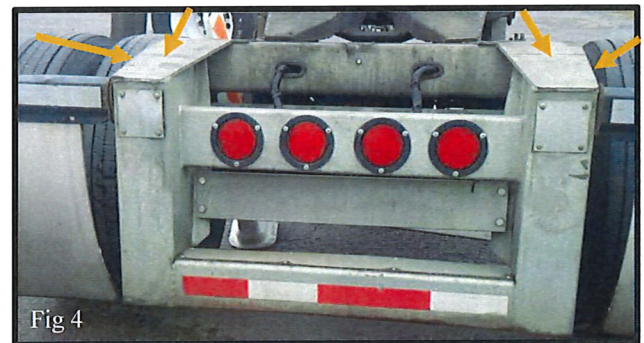
- Inspect counterbalance connections for cracks (Fig 4). Dollies with cracks across top plate are to be taken out of service immediately until repairs can be made (Fig 1). These units need to be transported on flatbed to repair location.
- Outboard vertical side welds can be temporarily repaired to get units to a repair location, coordinated with WNC Warranty.
- Temporary repairs still require a final repair as soon as possible.

Arrows indicate areas of inspection

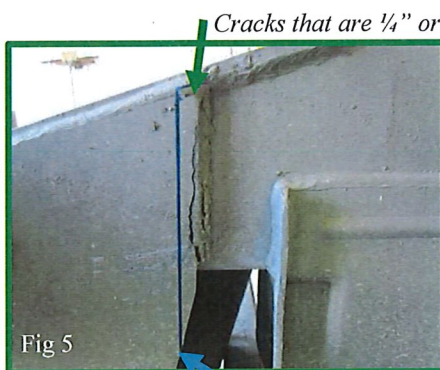
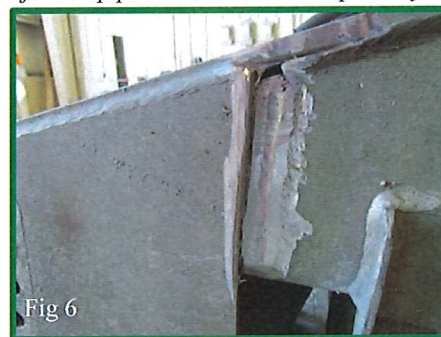
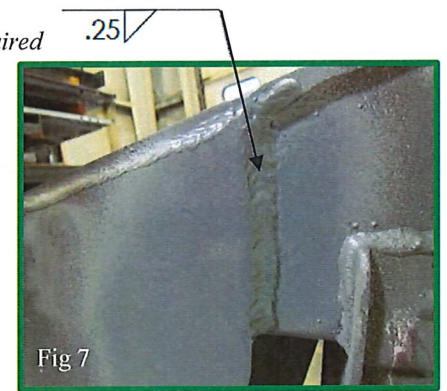
Cracks that are 1/4" or more from top plate weld can be temporarily repaired

- If crack is present only on outboard vertical weld, unit can be temporarily repaired by grinding out the entire crack. Care must be taken not to grind into top cap. Any notch to top plate must be welded and ground smooth. Grind vertical line down through entire leg (Fig 5 & 6). Re-weld with a vertical up joint (Fig7).
- Then coat the repair with cold galvanization.

Regardless of crack length, grind to new material behind crack and through entire vertical leg. See cut line

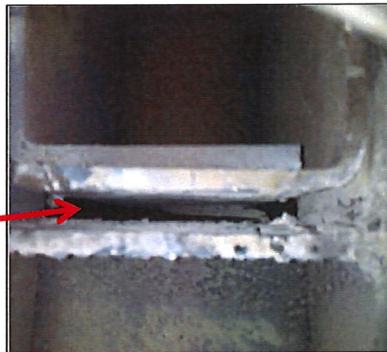
Figure 7A

Head on view of gap before shimming

- If a gap larger than 1/8" exists between frame and Z-plate (Fig. 7A), a shim is required. To shim, prep an approximately 2" x 4" shim (Fig. 7B) in the thickness necessary to reduce the gap between frame and Z-plate. The shim thickness required, shall allow no more than a 1/8" gap to be welded.

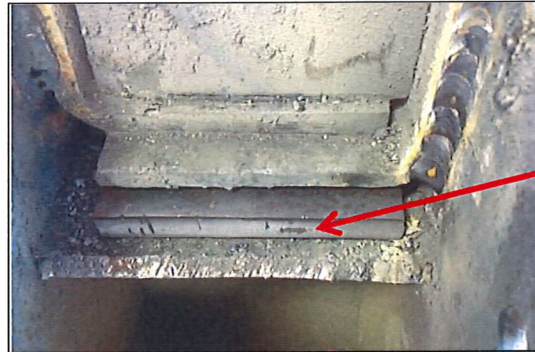
Figure 7B

Example of shim installed in gap
