15041 Driver Air Bag Replacement

Reference Number: N162028810 Release Date: August 2017

Revision: 00

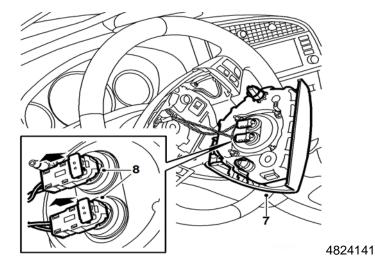
Important: Exercise the greatest caution when the air bag is removed. There is a significant risk that the connector in the steering shaft control module will be broken.

7. Carefully pull the air bag away from the steering wheel (7).

8. Pull up the connector catches using a small screwdriver. Remove the connector (8).
