Product Safety Recall

15041 Driver Air Bag Replacement

Reference Number: N162028810

Release Date: January 2018

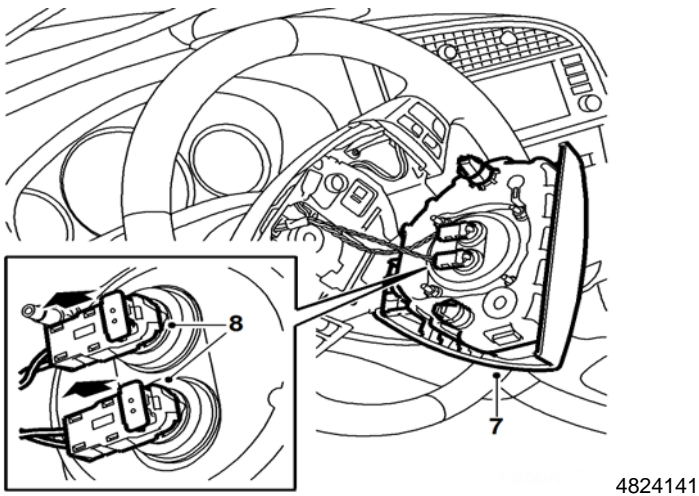
Important: Be extremely careful when removing the air bag. There is a considerable risk of breaking the connector in the contact roller.

7. Carefully pull the air bag away from the steering wheel (7).

8. Pull up the connector's locking catches using a small screwdriver. Unplug the connectors (8).
