# Product Safety Recall

## 15041 Driver Air Bag Replacement

**Reference Number:** N162028810

**Release Date:** February 2018

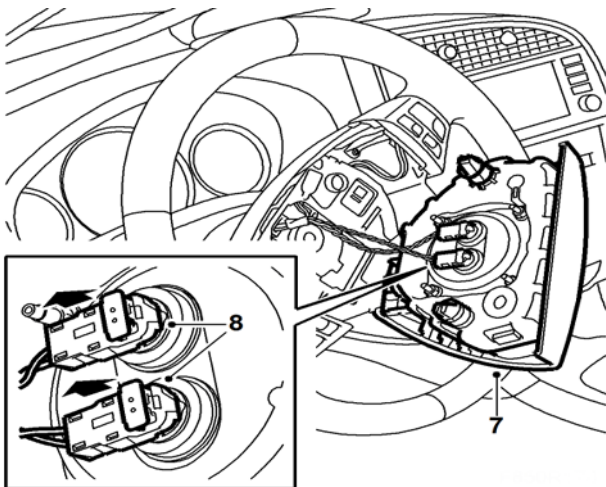
4824141

**Important:** Exercise the greatest caution when the air bag is removed. There is a significant risk that the connector in the steering shaft control module will be broken.

7. Carefully pull the air bag away from the steering wheel (7).

8. Pull up the connector catches using a small screwdriver. Remove the connector (8).

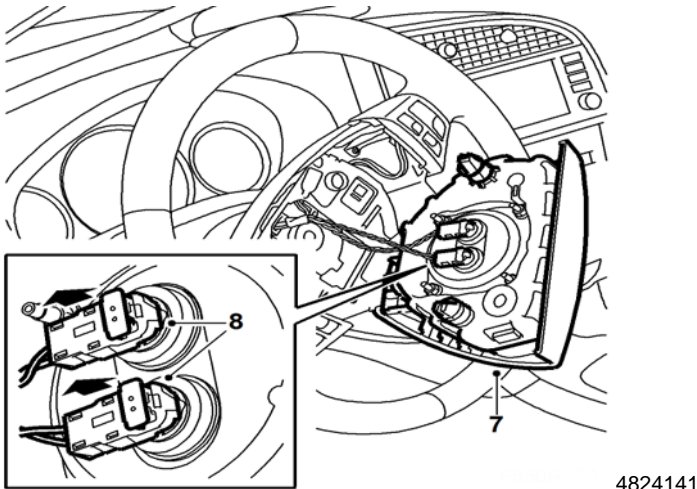
**Important:** Be extremely careful when removing the air bag. There is a considerable risk of breaking the connector in the contact roller.

7. Carefully pull the air bag away from the steering wheel (7).

8. Pull up the connector's locking catches using a small screwdriver. Unplug the connectors (8).
