Product Safety Recall

15041 Driver Air Bag Replacement

Reference Number: N162028810

Release Date: December 2018

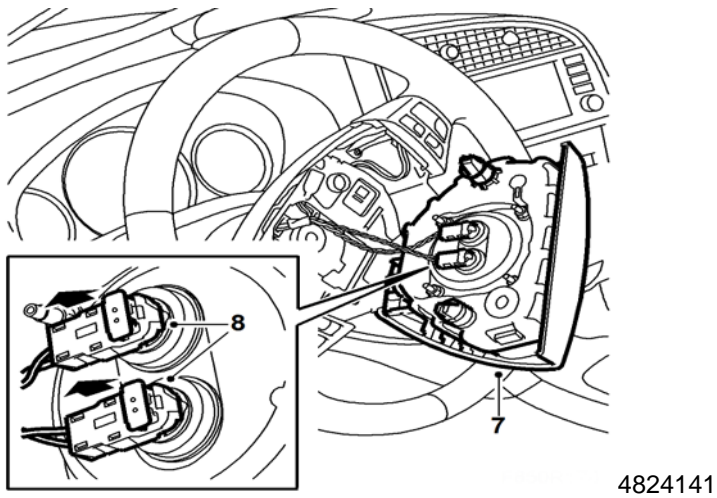
Important: Exercise the greatest caution when the air bag is removed. There is a significant risk that the connector in the steering shaft control module will be broken.

7. Carefully pull the air bag away from the steering wheel (7).

8. Pull up the connector catches using a small screwdriver. Remove the connector (8).

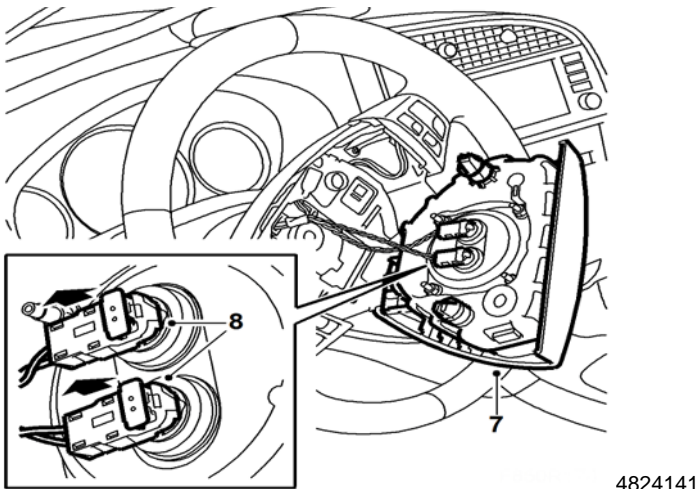
Important: Be extremely careful when removing the air bag. There is a considerable risk of breaking the connector in the contact roller.

7. Carefully pull the air bag away from the steering wheel (7).

8. Pull up the connector's locking catches using a small screwdriver. Unplug the connectors (8).
