Product Safety Recall

15043 Driver Air Bag Replacement

Reference Number: N162028811

Release Date: December 2018

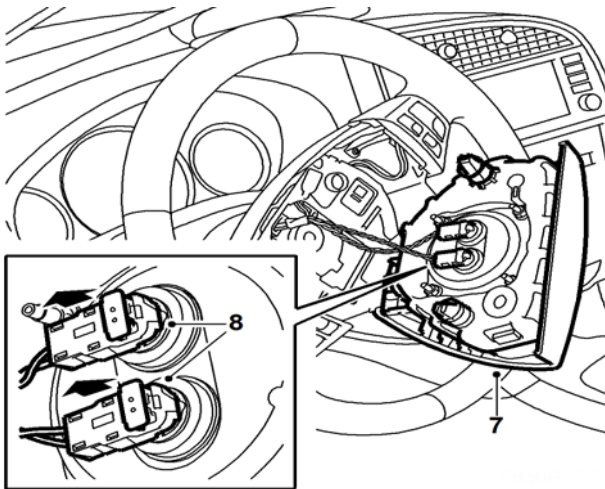
4824141

Important: Exercise the greatest caution when the air bag is removed. There is a significant risk that the connector in the steering shaft control module will be broken.

7. Carefully pull the air bag away from the steering wheel (7).

8. Pull up the connector catches using a small screwdriver. Remove the connector (8).

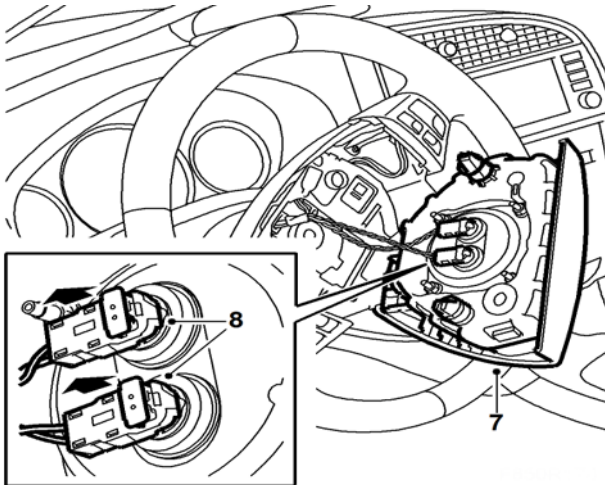
4824141

Important: Be extremely careful when removing the air bag. There is a considerable risk of breaking the connector in the contact roller.

7. Carefully pull the air bag away from the steering wheel (7).

8. Pull up the connector's locking catches using a small screwdriver. Unplug the connectors (8).
