# Recall Bulletin

**SUBJECT:** Brake Pedal Pivot Nut/Bolt Loose

**MODELS:** 2015 - 2016 Chevrolet Silverado LD, HD  
2015 - 2016 Chevrolet Tahoe PPV (RPO 9C1)  
2015 - 2016 Chevrolet Tahoe Special Services (RPO 5W4)  
2015 - 2016 GMC Sierra HD

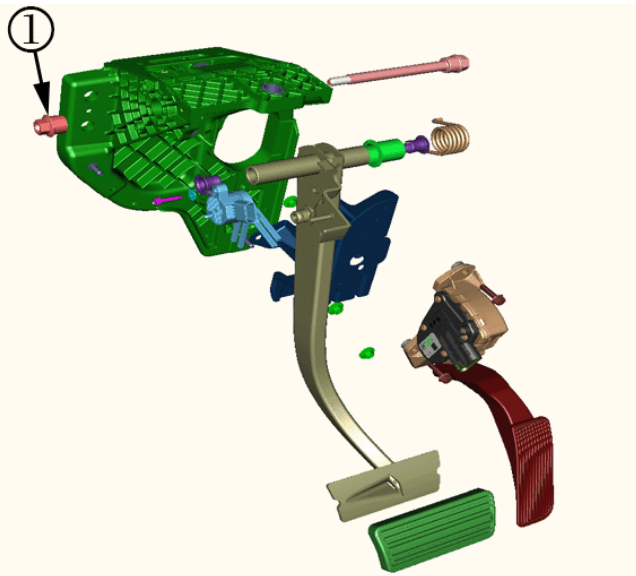
4404307

- Using an inspection mirror, determine if the brake pedal pivot nut is on the outboard side of the vehicle.

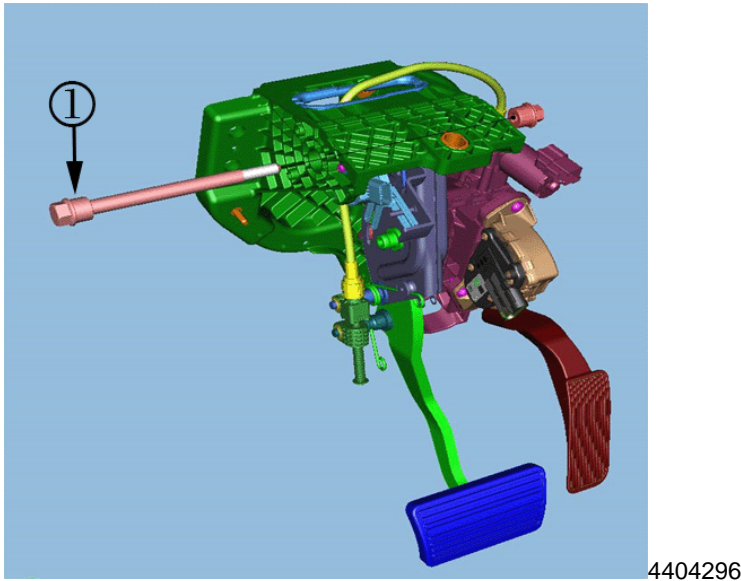
- If the brake pedal pivot nut (1) is on the outboard side of the vehicle, proceed to step 2.

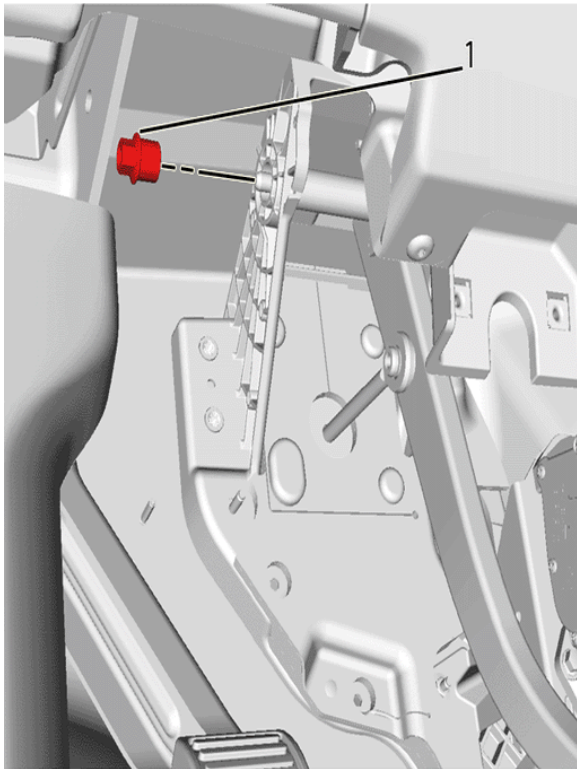
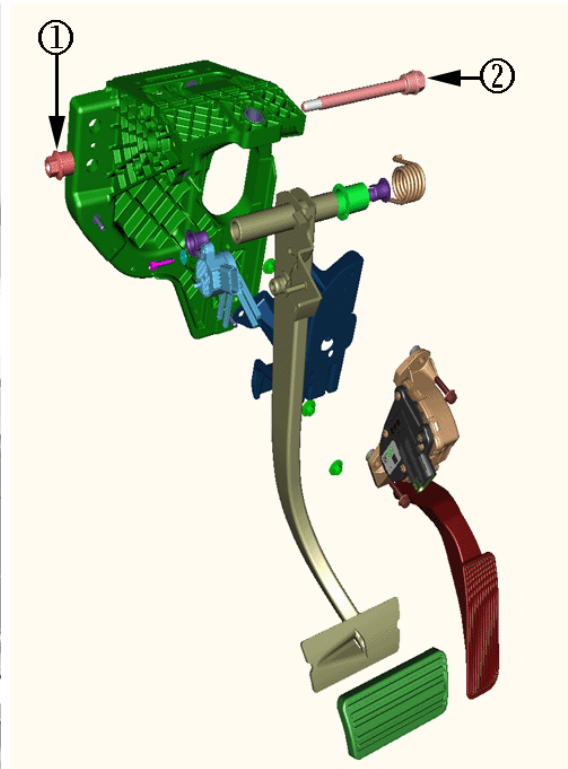
4404322

- If the brake pedal pivot bolt (1) is on the outboard side of the vehicle (nut on the inboard side), no further action is required.
2. Determine if the vehicle is equipped with a manual or automatic transmission.
    - If the vehicle is equipped with a manual transmission remove the clutch pedal. Refer to *Clutch Pedal Replacement* in SI. After the clutch pedal has been removed, proceed to step 5.
    - If the vehicle is equipped with an automatic transmission, proceed to step 3.
  3. Remove the Instrument Panel Knee Bolster. Refer to *Instrument Panel Knee Bolster Replacement* in SI.
  4. Remove the Floor Front Air Outlet Duct - Left Side. Refer to *Floor Front Air Outlet Duct Replacement - Left Side* in SI.
