Bulletin No.: 20760E
Date: September 2018

PRODUCT SAFETY RECALL

SUBJECT: Brake Pedal Pivot Nut/Bolt Loose

MODELS: 2015 - 2016 Chevrolet Silverado Crew Cab LD with Special Services (RPO 5W4)
2015 - 2016 Chevrolet Silverado HD
2015 - 2016 Chevrolet Tahoe PPV (RPO 9C1)
2015 - 2016 Chevrolet Tahoe with Special Services (RPO 5W4)
2015 - 2016 GMC Sierra HD

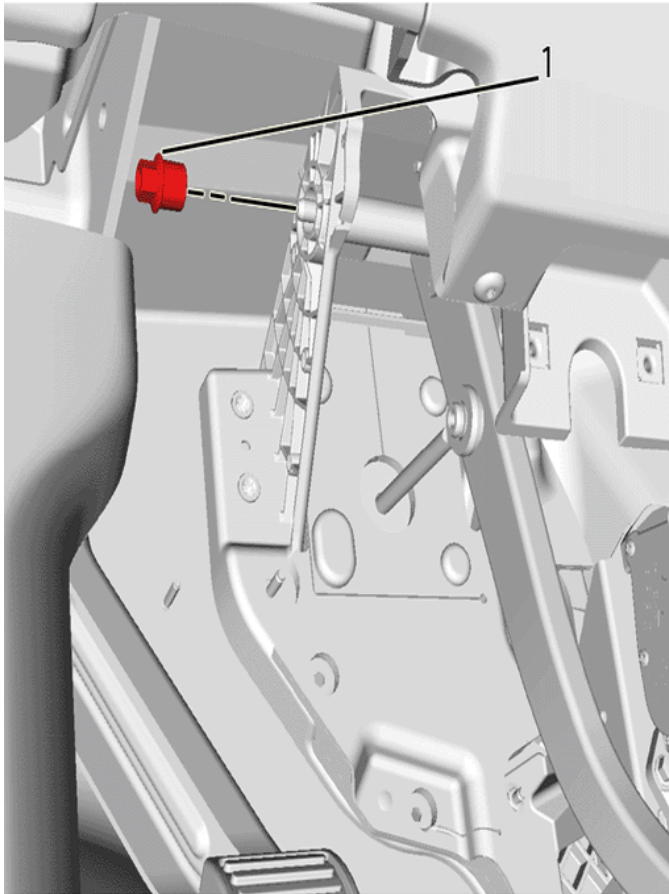
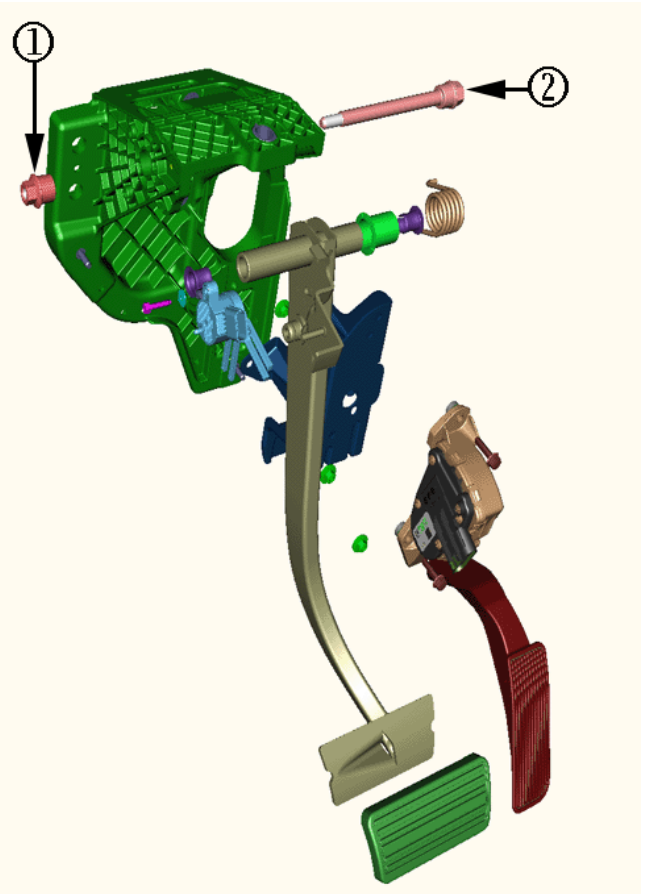
4404322

Note: The bolt may be facing either direction, not necessarily the direction shown above. Do NOT attempt to reorient the bolt and nut if they are not facing the direction shown in the photo – only apply Loctite to the nut and torque to specification as described below.

4. Holding the brake pedal pivot bolt (2) with a box end wrench, remove the brake pedal pivot nut (1).

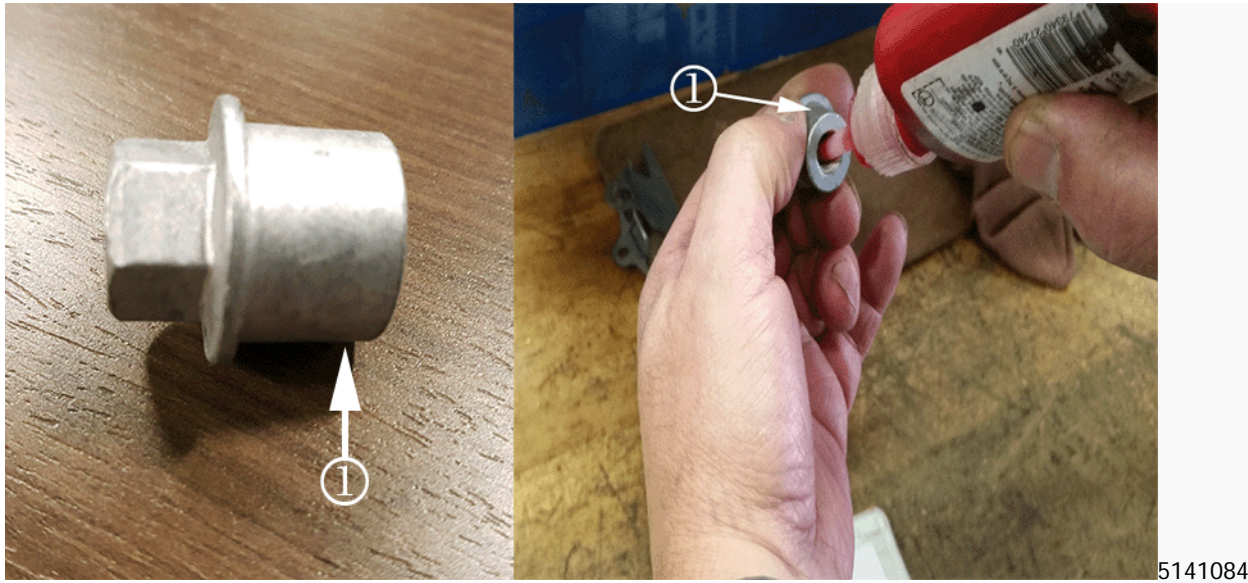
Note: Do NOT get threadlocker on the exterior of the brake pedal pivot nut. The exterior of the brake pedal pivot nut must be kept clean of threadlocker.

- 5. Holding the nut horizontally, apply two drops of red threadlocker to the threads in the collar portion (1, opposite the hex end) of the nut.
