Bulletin No.: 20760C
Date: March 2016

PRODUCT SAFETY RECALL

SUBJECT: Brake Pedal Pivot Nut/Bolt Loose

MODELS: 2015 - 2016 Chevrolet Silverado Crew Cab LD with Special Services (RPO 5W4)
2015 - 2016 Chevrolet Silverado HD
2015 - 2016 Chevrolet Tahoe PPV (RPO 9C1)
2015 - 2016 Chevrolet Tahoe with Special Services (RPO 5W4)
2015 - 2016 GMC Sierra HD

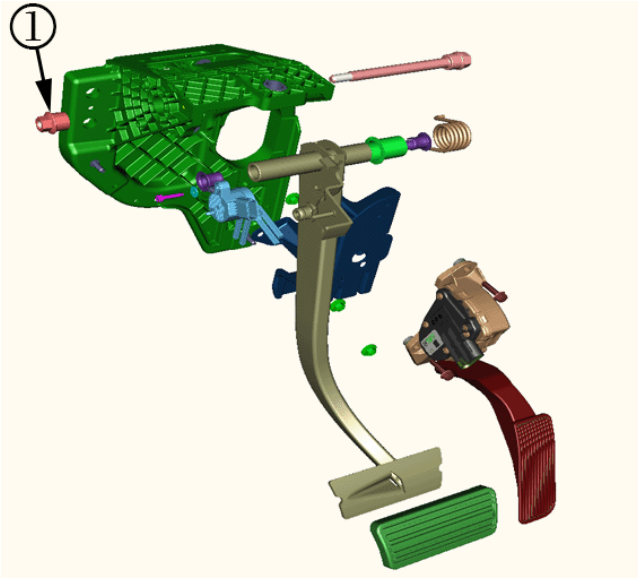
4404307

1. Using an inspection mirror, determine if the brake pedal pivot nut is on the outboard side of the vehicle.

- If the brake pedal pivot nut (1) is on the outboard side of the vehicle, proceed to step 2.

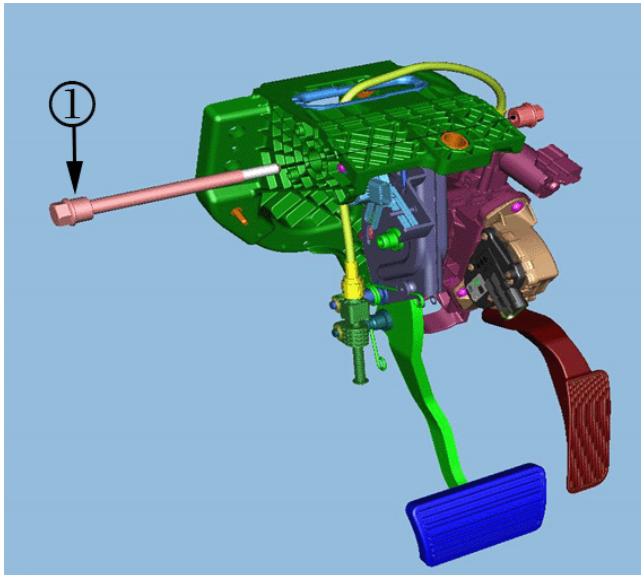
4404296

- If the brake pedal pivot bolt (1) is on the outboard side of the vehicle (nut on the inboard side), no further action is required.
2. Determine if the vehicle is equipped with a manual or automatic transmission.
 - If the vehicle is equipped with a manual transmission remove the clutch pedal. Refer to *Clutch Pedal Replacement* in SI. After the clutch pedal has been removed, proceed to step 5.
 - If the vehicle is equipped with an automatic transmission, proceed to step 3.
 3. Remove the Instrument Panel Knee Bolster. Refer to *Instrument Panel Knee Bolster Replacement* in SI.

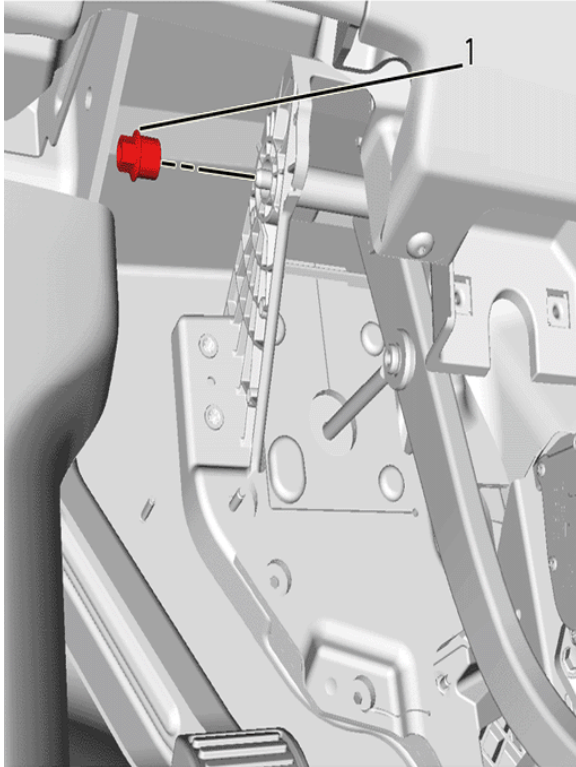
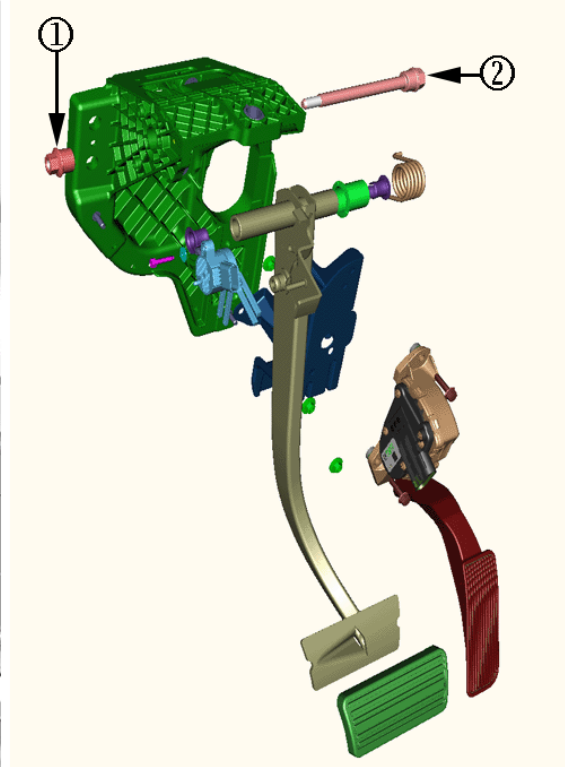
4404322

Caution: Apply pressure to the brake pedal pivot bolt while removing the nut to ensure the bolt does not back out of the housing. Part damage could occur if the bolt backs out of the housing.

5. Holding the brake pedal pivot bolt (2) with a box end wrench, remove the brake pedal pivot nut (1).

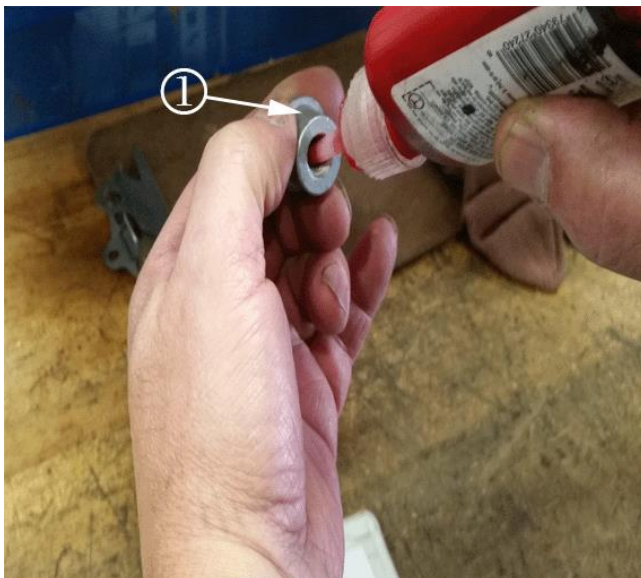
4404331

Note: Do NOT get threadlocker on the exterior of the brake pedal pivot nut. The exterior of the brake pedal pivot nut must be kept clean of threadlocker.

6. Holding the nut horizontally, apply two drops of red threadlocker to the threads in the collar portion (1) of the nut.

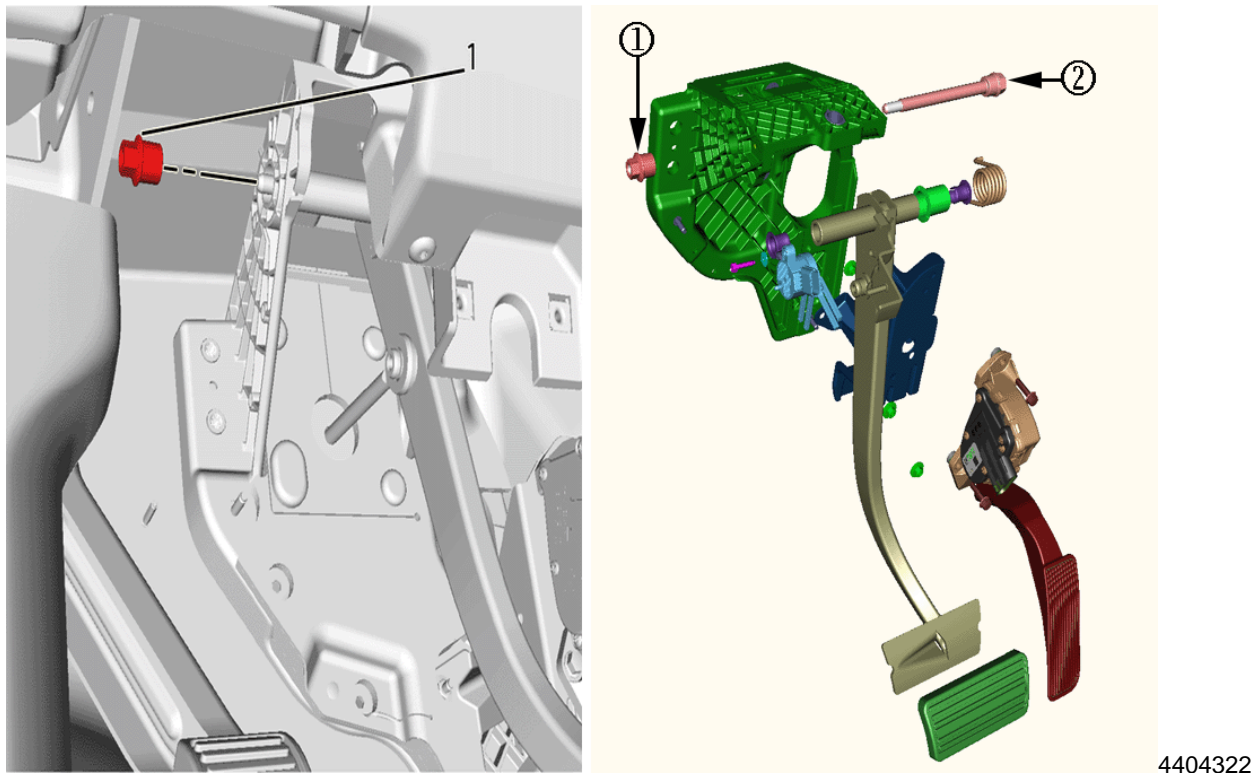
Caution: Apply pressure to the brake pedal pivot bolt while installing the nut to ensure the bolt does not back out of the housing. Part damage could occur if the bolt backs out of the housing.

7. Holding the brake pedal pivot bolt (2) with a box end wrench, install the brake pedal pivot nut (1).
8. Holding the brake pedal pivot bolt with a box end wrench, torque the brake pedal pivot nut to 26 Nm (19 lb ft).
9. On vehicles equipped with a manual transmission, install the clutch pedal. Refer to *Clutch Pedal Replacement* in SI.
10. Install the Floor Front Air Outlet Duct - Left Side. Refer to *Floor Front Air Outlet Duct Replacement - Left Side* in SI.
11. Install the Instrument Panel Knee Bolster. Refer to *Instrument Panel Knee Bolster Replacement* in SI.
