Bulletin No.: 20760B
Date: March 2016

PRODUCT SAFETY RECALL

SUBJECT: Brake Pedal Pivot Nut/Bolt Loose

MODELS: 2015 - 2016 Chevrolet Silverado Crew Cab LD with Special Services (RPO 5W4)
2015 - 2016 Chevrolet Silverado HD
2015 - 2016 Chevrolet Tahoe PPV (RPO 9C1)
2015 - 2016 Chevrolet Tahoe with Special Services (RPO 5W4)
2015 - 2016 GMC Sierra HD

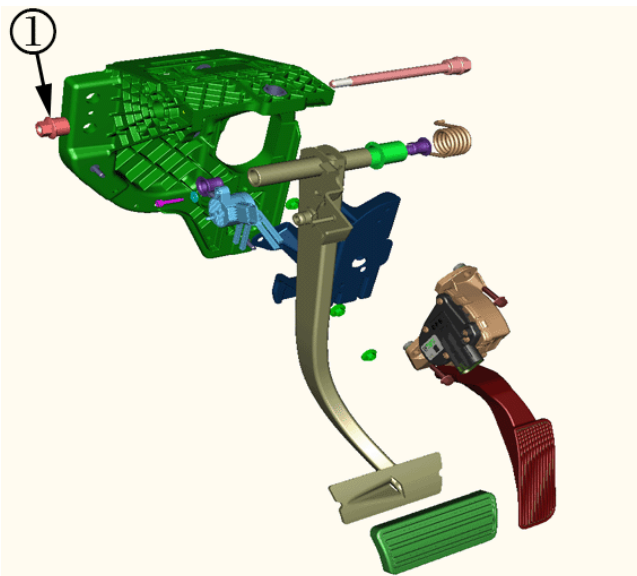
4404307

- Using an inspection mirror, determine if the brake pedal pivot nut is on the outboard side of the vehicle.

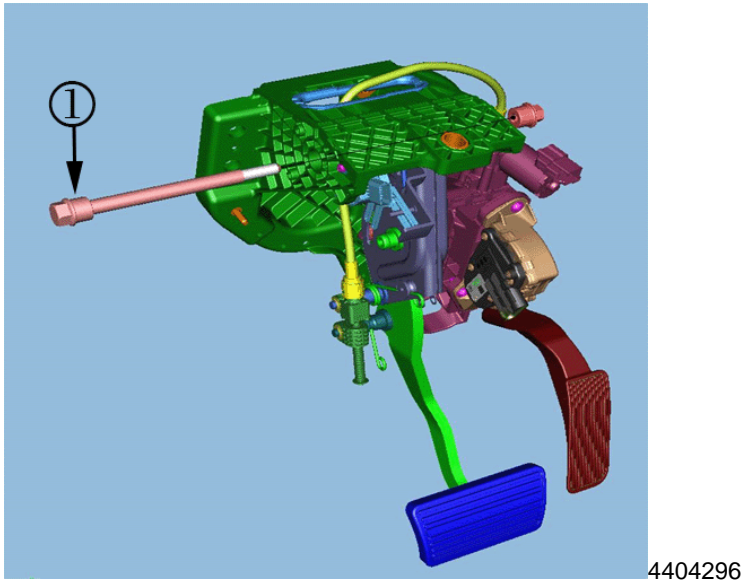
- If the brake pedal pivot nut (1) is on the outboard side of the vehicle, proceed to step 2.
