Recall Bulletin

PRODUCT SAFETY RECALL

SUBJECT: Brake Pedal Pivot Nut/Bolt Loose

MODELS: 2015 – 2016 Chevrolet Silverado HD
2015 – 2016 Chevrolet Tahoe PPV (RPO 9C1)
2015 – 2016 GMC Sierra HD

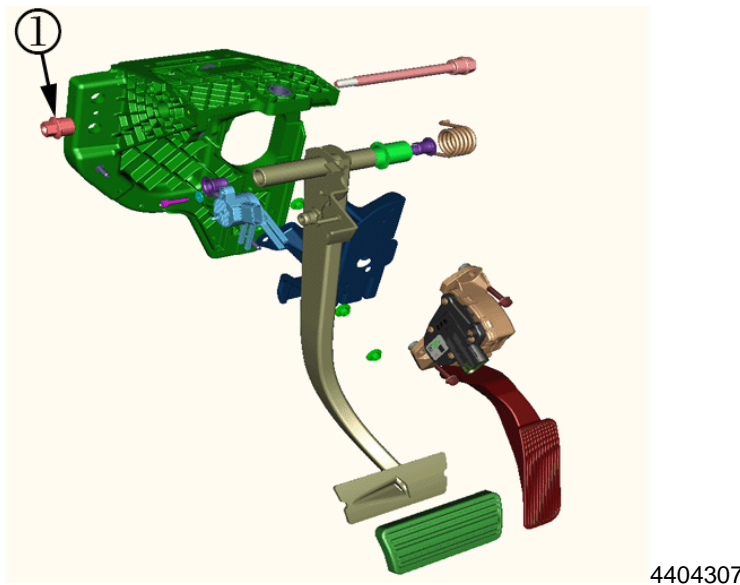
- If the brake pedal pivot nut (1) is on the outboard side of the vehicle, proceed to step 2.

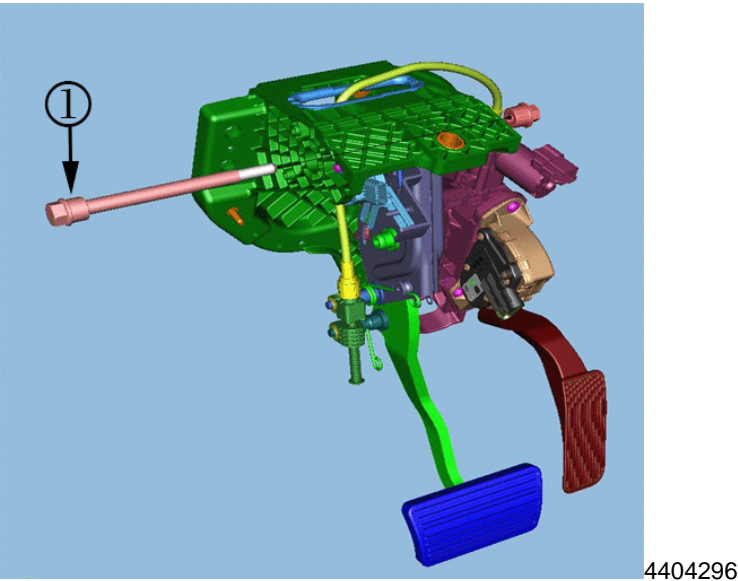
- If the brake pedal pivot bolt (1) is on the outboard side of the vehicle (nut on the inboard side), no further action is required.
2. Remove the Instrument Panel Knee Bolster. Refer to *Instrument Panel Knee Bolster Replacement* in SI.
 3. Remove the Floor Front Air Outlet Duct Replacement - Left Side. Refer to *Floor Front Air Outlet Duct Replacement - Left Side* in SI.
