Recall Bulletin

F/CMVSS NONCOMPLIANCE RECALL

SUBJECT: No Key in Reminder Chime and/or No Audio

MODELS: 2016 Chevrolet Camaro, Malibu, Silverado
2016 GMC Sierra
Equipped with Radio Infotainment System (RPO IOA/IOB)

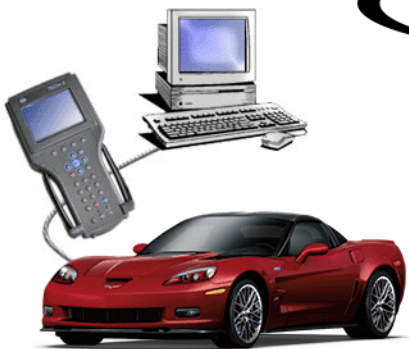
4919549

Note: If the Same Calibration/Software Warning is noted on the SPS Controller screen, continue with the programming event using SPS to ensure a Warranty Claim Code is displayed on screen. Technicians **MUST** record the Warranty Claim Code (1) on the Job Card. To avoid warranty transaction rejection, this information must be entered when submitting the transaction.
