Product Safety Recall

15816 Front Passenger Air Bag Inflator

Reference Number: N150816

Revision: 04

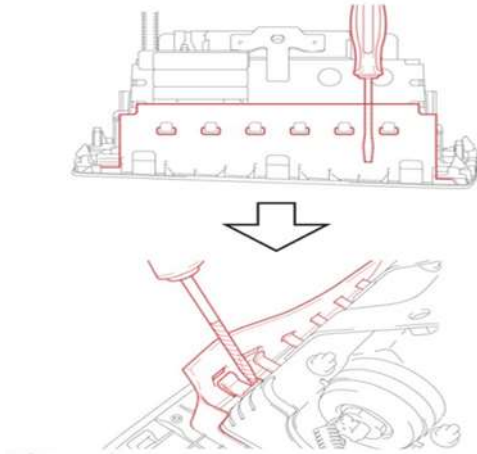
4486638

3. Remove the cover.
 - 3.1. Gently insert the screwdriver between the air bag door and module and disengage the claws holding the door to the module.
 - 3.2. After all the claws have been disengaged, separate the module from the door.
 - 3.3. Mark the old module so it is not reused.
 - 3.4. Inspect the door for damage to the mounting slots.

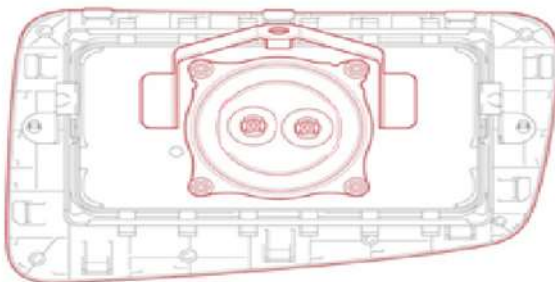
4486640

4. Install the new module.
 - 4.1. Carefully slide the new module into the air bag door. Note the mounting direction.

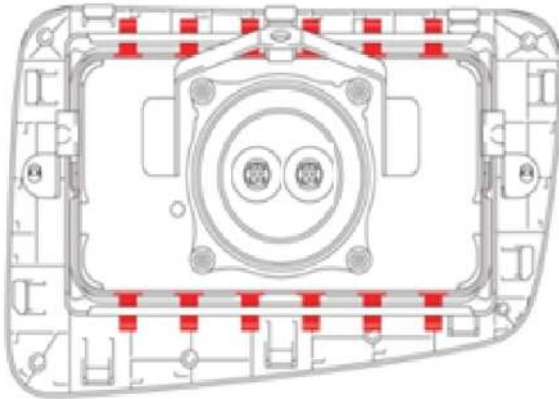
4486641

- 4.2. Reengage the tangs of the module into the door using the screwdriver with the shaft wrapped in tape.

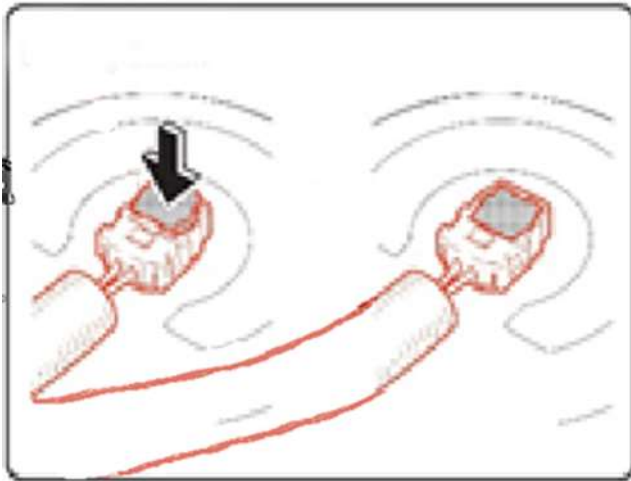
4486647

- 4.3. Connect the new harness to the new module.
- 4.4. Press the lock tab down.
5. Install the instrument panel passenger air bag assembly. Refer to *Air Bag Instrument Panel Module Replacement* in SI.
6. Install the instrument panel (I/P) compartment. Refer to *Instrument Panel Compartment Replacement* in SI.
7. Connect cable from negative battery terminal. Refer to *Battery Negative Cable Disconnection and Connection* in SI.
8. Connect the scan tool and determine if any diagnostic trouble codes (DTCs) have been set. Clear set DTCs, if required. Ensure no DTCs set after scan tool evaluation.
