## PART 3 of SR16-18 – AFTERTREATMENT HYDROCARBON DOSER HARD FUEL LINE REPLACEMENT

Prevost vehicles

This special bulletin constitutes **PART 3 of Safety Recall SR16-18**.

## 2585-03-02-12 Hard Fuel Line, Aftertreatment Hydrocarbon Doser, Replacement

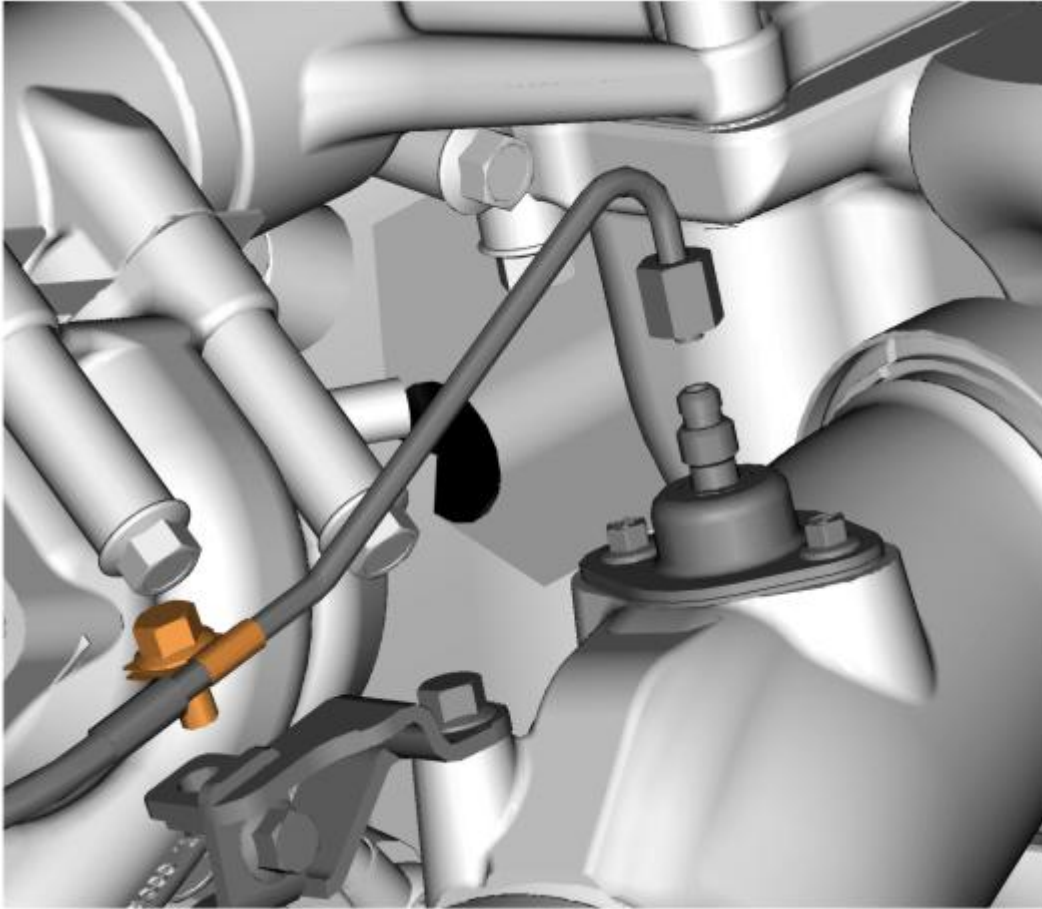
6

Disconnect the aftertreatment hydrocarbon doser hard line from the hard line connected to the aftertreatment hydrocarbon dosing module.

Disconnect the hard line from the aftertreatment hydrocarbon doser. Collect any residual fuel that might be in the line into a suitable container.

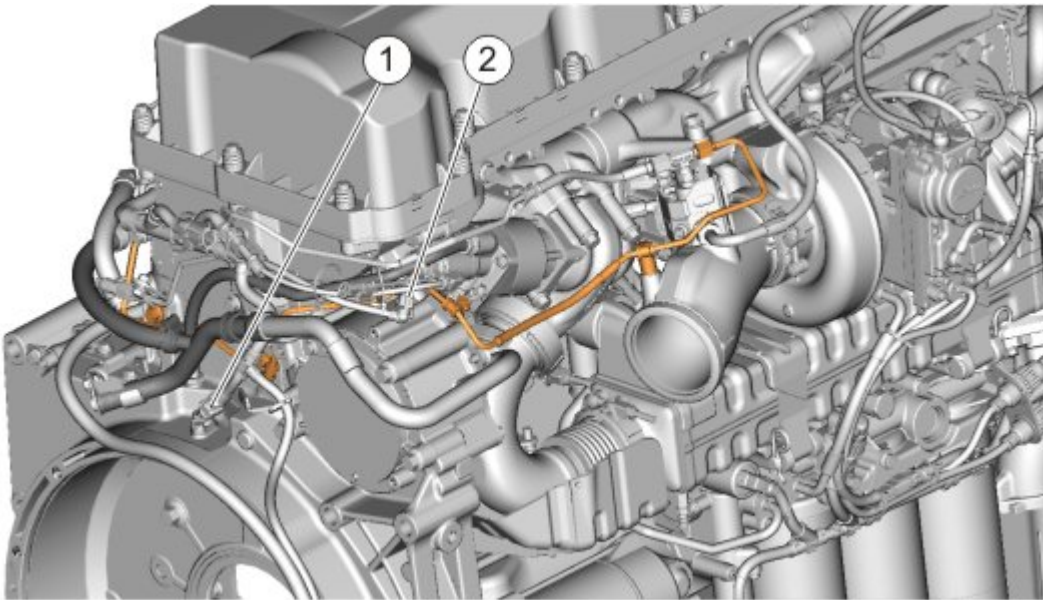
7

1. Crankshaft sensor
2. Camshaft sensor

Disconnect and remove the camshaft and crankshaft sensors.

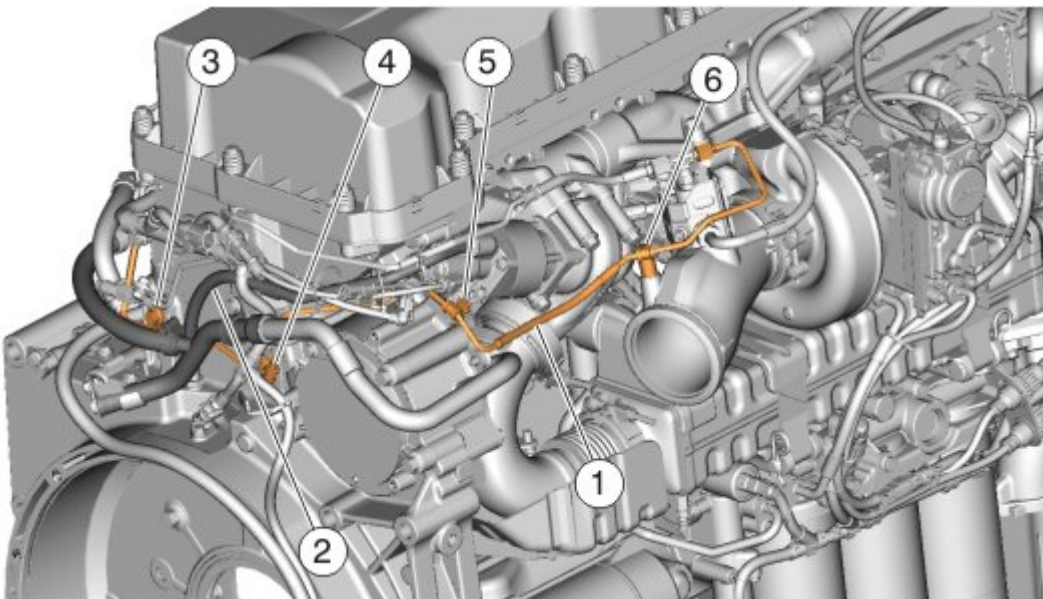
8

1. Aftertreatment Hydrocarbon Doser Line
2. EGR valve oil return line
3. M10 screw. Air line bracket and M10 clamp
4. Silicon clamp
5. Silicon clamp
6. Silicon clamp

Disconnect Exhaust Gas Recirculation (EGR) valve oil return line at flywheel housing. Remove the fasteners and P-clamps securing the line. Remove the line from the engine.

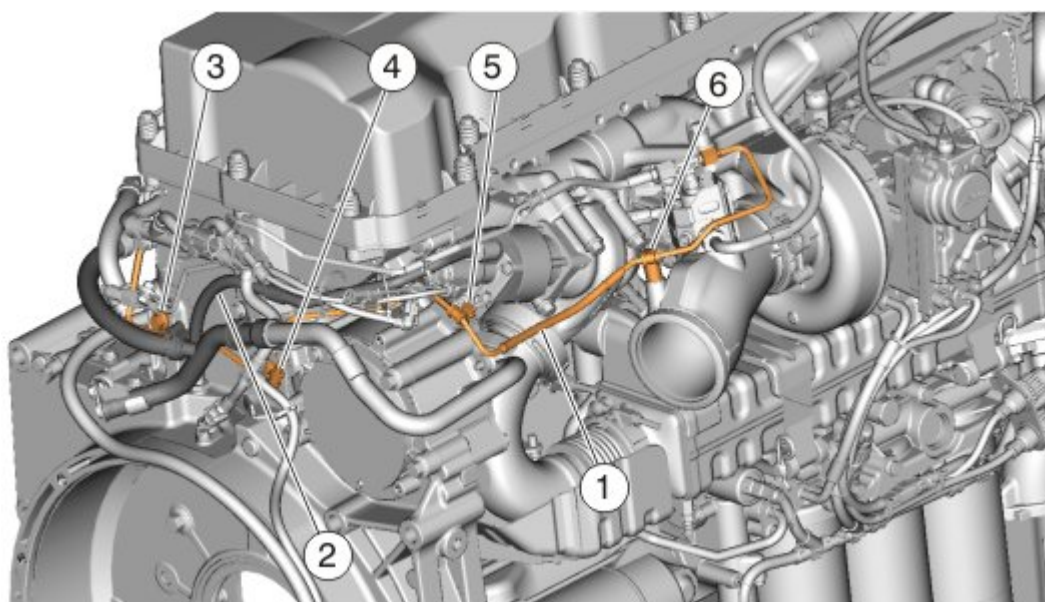
3

- 1. Aftertreatment Hydrocarbon Doser Line
- 2. EGR valve oil return line

3. Air line bracket and M10 clamp
4. Silicon clamp
5. Silicon clamp
6. Silicon clamp

Connect the aftertreatment hydrocarbon doser line to the line connected to the aftertreatment hydrocarbon dosing module. Install the fasteners and P-clamps to secure the line. Tighten the line fittings and fasteners to specification, refer to Function Group 20; "Specifications". Connect Exhaust Gas Recirculation (EGR) valve oil return line at flywheel housing.
