Bulletin No.: 31820C
Date: April 2016

Recall Bulletin

SUBJECT: Side Impact Airbag Weld Stud Fractures

MODELS: 2016 Chevrolet Malibu

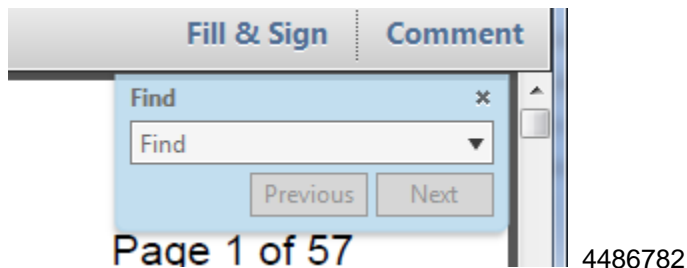
1. Open the VIN list identified above. To search for your dealership’s BAC, use the search function by pressing the “Control” key and the letter “F” key simultaneously on your keyboard. This will bring up the “Find” feature located at the top right of the PDF file as seen below. Once the vehicle is found on the list, follow the line across to determine the appropriate airbag replacement. Airbags that require replacement will be indicated with a YES in the column. **Ensure that you follow the correct line across and review all columns.**
