Bulletin No.: 15822C  
Date: January 2017

# Recall Bulletin

**SUBJECT:** Seatbelt Lap Anchor Tensioner Cable – Driver’s Side

**MODELS:** 2014-2015 Chevrolet Silverado 1500 Series  
2014-2015 GMC Sierra 1500 Series

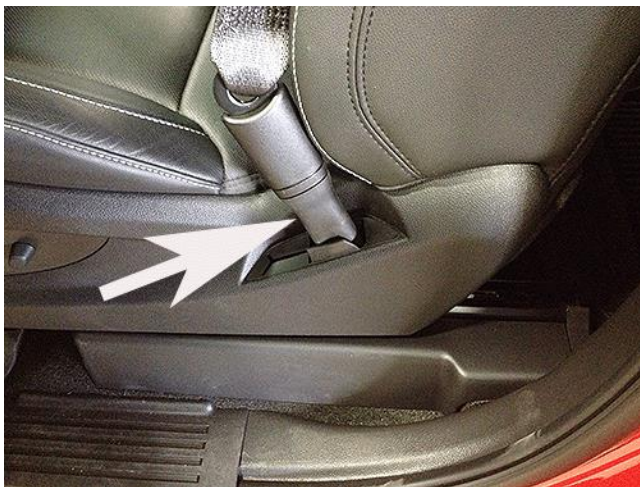
4522278

1. Move the driver seat to the full forward and full down position.

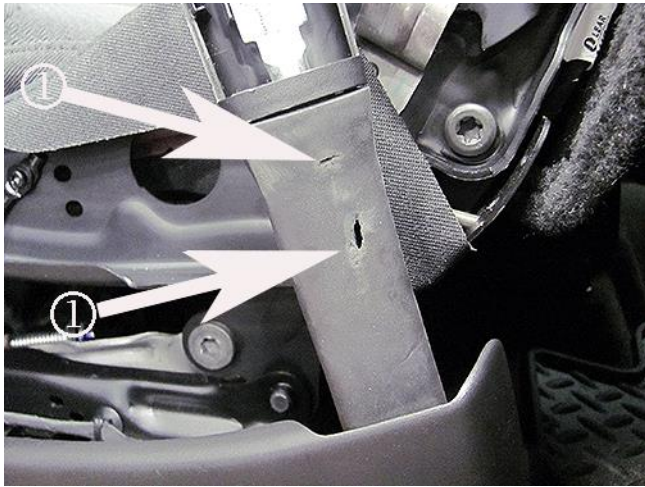
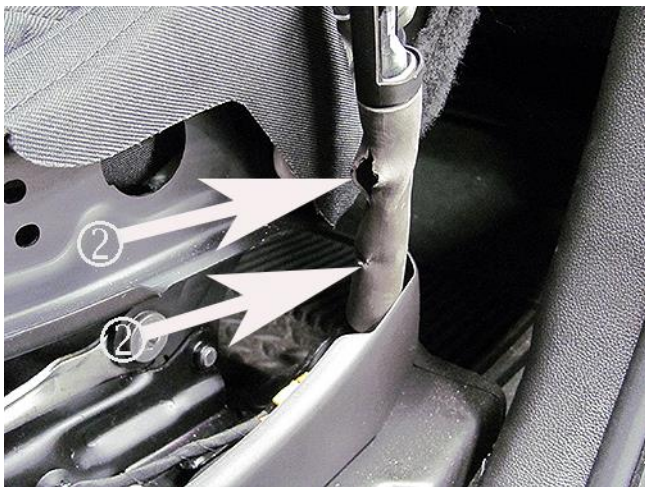
4522272

2. Inspect the tensioner cable cover for damage. Inspect the complete cable from the base of the cable to the buckle.

This damage will be in the form of holes (1) or splitting (2).

- If **any damage** is found, replace the tensioner while performing the bracket installation.
- If no damage is found, install the seat tensioner bracket using the existing tensioner.
