Bulletin No.: 15822B
Date: July 2016

Recall Bulletin

SUBJECT: Seatbelt Lap Anchor Tensioner Cable – Driver’s Side

MODELS: 2014-2015 Chevrolet Silverado 1500 Series
2014-2015 GMC Sierra 1500 Series

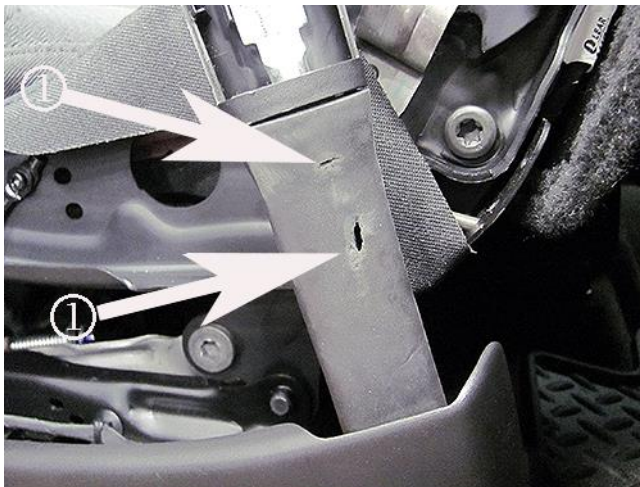
4522272

2. Inspect the tensioner cable cover for damage. Inspect the complete cable from the base of the cable to the buckle.

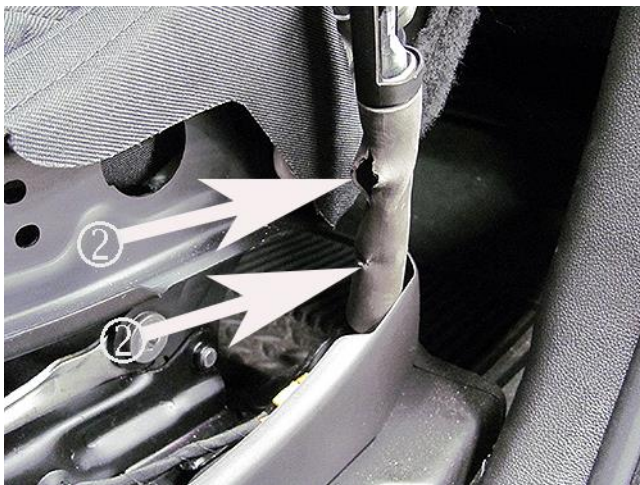
4522274

This damage will be in the form of holes (1) or splitting (2).

- If **any damage** is found, replace the tensioner while performing the bracket installation.
- If no damage is found, install the seat tensioner bracket using the existing tensioner.
