Recall Bulletin

F/CMVSS NONCOMPLIANCE RECALL

SUBJECT: Loss of Key Reminder Chime

MODELS: 2013-2016 Chevrolet Sonic
2013-2015 Chevrolet Spark
2013-2016 Chevrolet Trax
Equipped with Bring Your Own Media (RPO UF7)

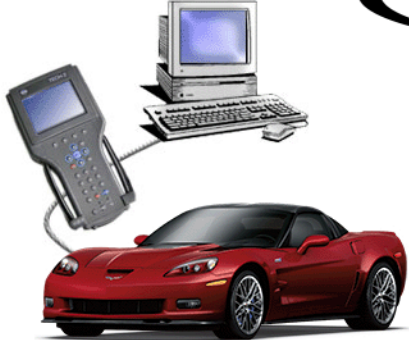
Action Complete
Radio - Programming (A11)
2017-12-06 09:14:03 EST

Warranty Claim Code: 8038A
Record this code on the warranty repair order (if applicable).

Important: Technicians MUST record the Warranty Claim Code (1) on the Job Card. To avoid warranty transaction rejection, this information must be entered when submitting the transaction.
