Product Safety Recall

15826 Front Passenger Air Bag Inflator

Reference Number: N150826000

Release Date: March 2017
Revision: 00

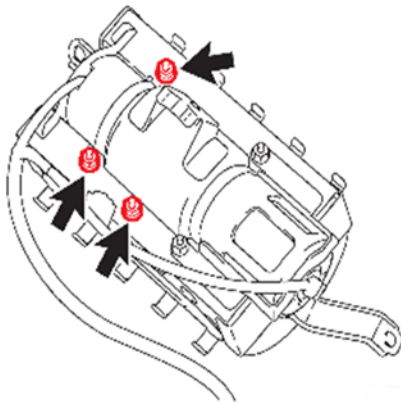
4751083

Important: If any gap exists, the aligned flats may move apart, resulting in failure in normal deployment of the airbag.

8. Remove the 3 remaining old self-locking nuts and install temporarily 3 NEW self-locking nuts by hand. Store the removed self-locking nuts in a replacement part box or the like.
9. Push the inflator and plate towards the position determining plate to eliminate any gap.

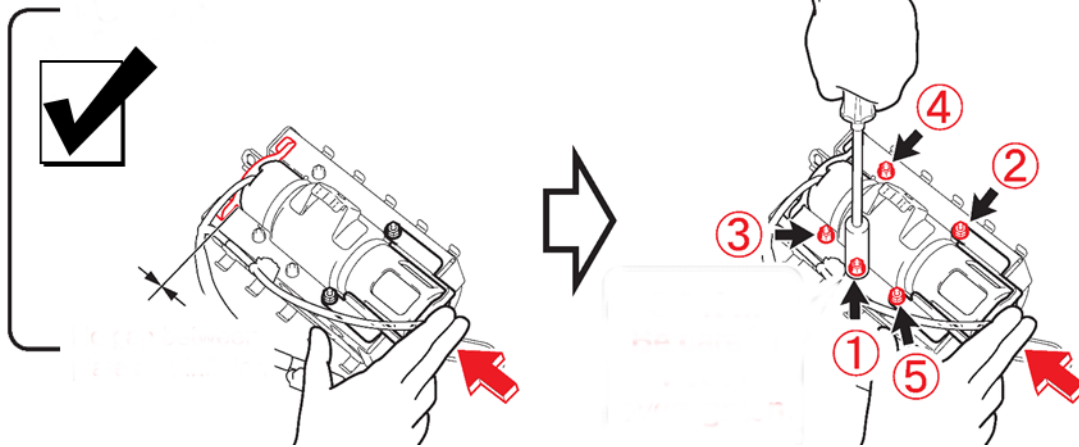
4751085

Important: The tightening torque is low (3.9 N·m). Use of an air ratchet wrench or tightening strongly with a T-handle wrench or a ratchet handle may cause deformation of the stud bolt.

10. Tighten 5 nuts evenly in several increments in the order shown above using a socket driver while pushing the inflator and plate. (You will encounter some resistance during tightening because these nuts are self-locking nuts.). Torque: 3.9 N*m (40 kgf*cm, 35 in.*lbf).
11. Install the harness clip to the center stud after all 5 nuts have been torqued.
