Product Safety Recall

15826 Front Passenger Air Bag Inflator

Reference Number: N150826000

Revision: 03

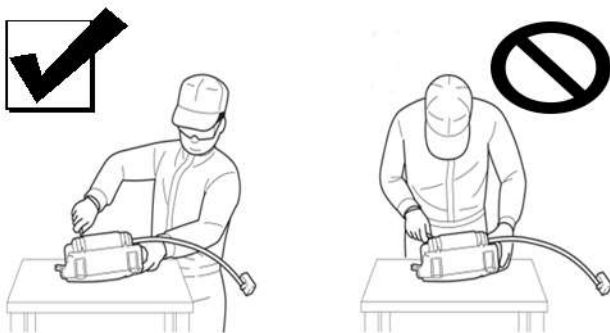
4751076

Warning: Confirm the stopper plate to inflator fitment is correct. **DO NOT** pinch the harness between the inflator and the stopper plate.

Warning: When working with the airbag module, avoid standing directly in front of the parts.

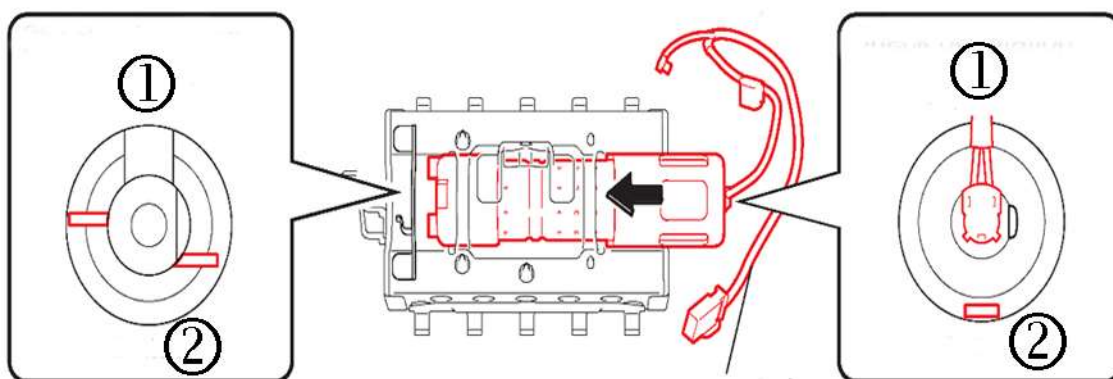
4751078

Important: DO NOT insert the inflator fully.

4. Insert a NEW inflator to the center of the airbag case with the correct orientation as shown (1) Upper side (2) Bottom.

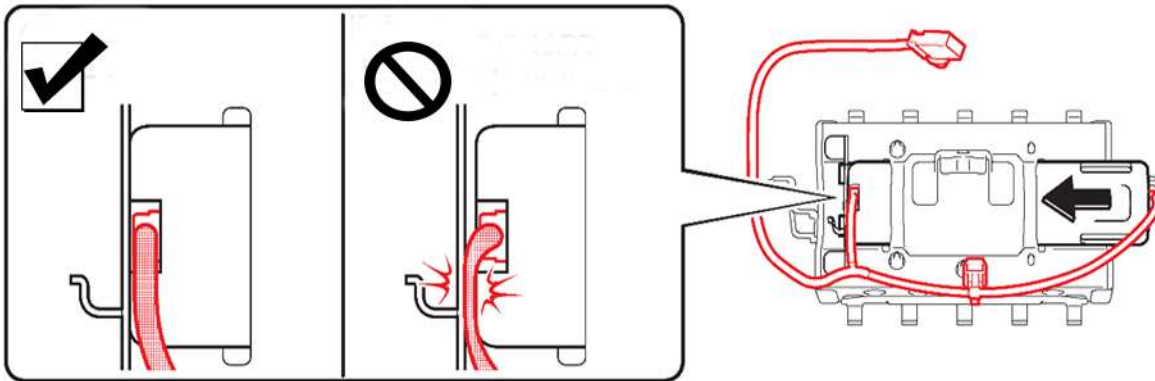
4751080

Important: Make sure that the inflator is oriented correctly as shown in the illustration, not upside down. If the passenger airbag inflator is upside down, it will not be able to be fully inserted.

6. Insert the inflator fully with the correct orientation as shown. DO NOT pinch the wire.

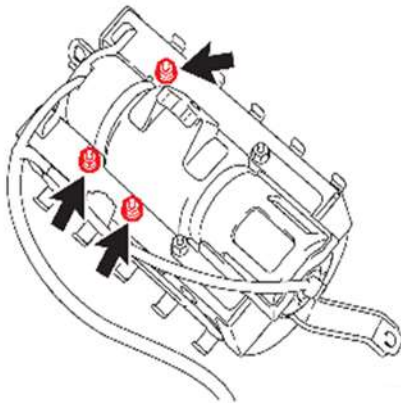
4751083

Important: If any gap exists, the aligned flats may move apart, resulting in failure in normal deployment of the airbag.

8. Remove the 3 remaining old self-locking nuts and install temporarily 3 NEW self-locking nuts by hand. Store the removed self-locking nuts in a replacement part box or the like.
9. Push the inflator and plate towards the position determining plate to eliminate any gap.

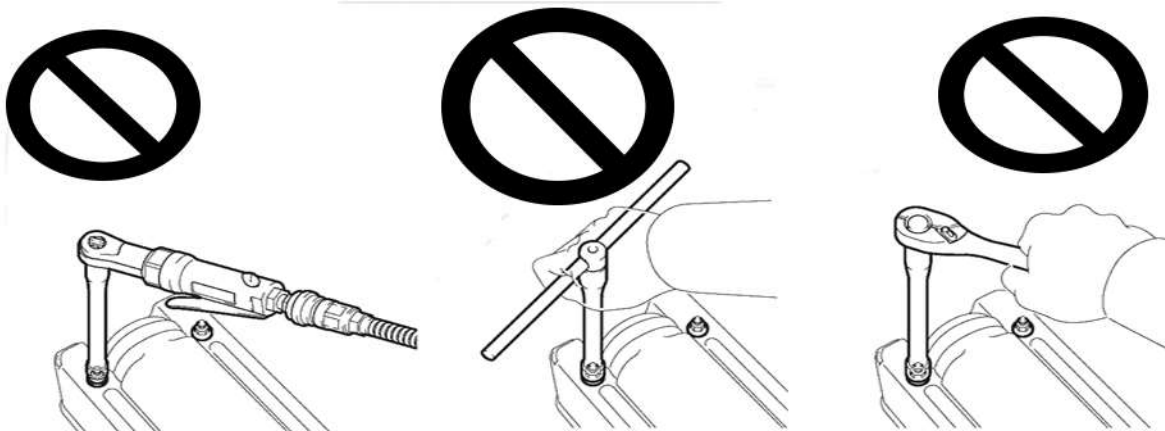
4751084

Important: The tightening torque is low (3.9 N·m). Use of an air ratchet wrench or tightening strongly with a T-handle wrench or a ratchet handle may cause deformation of the stud bolt.
