# Product Safety Recall

## 15826 Front Passenger Air Bag Inflator

**Reference Number:** N150826000

**Release Date:** October 2017

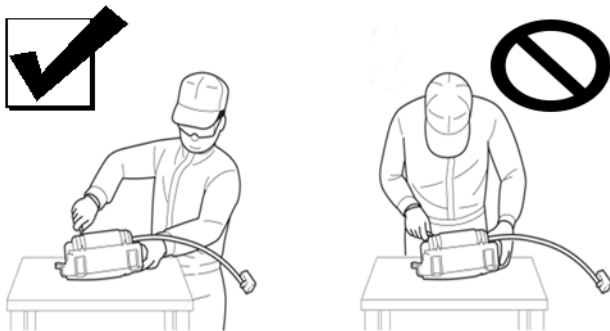
4751076

**Warning:** Confirm the stopper plate to inflator fitment is correct. **DO NOT** pinch the harness between the inflator and the stopper plate.

**Warning:** When working with the airbag module, avoid standing directly in front of the parts.

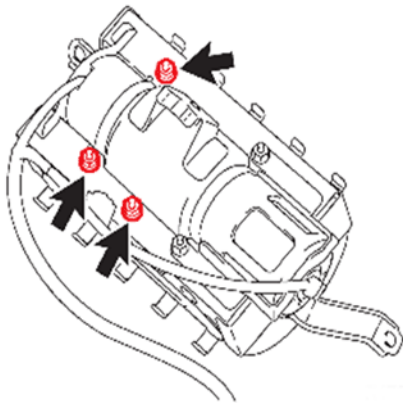
4751083

**Important:** If any gap exists, the aligned flats may move apart, resulting in failure in normal deployment of the airbag.

8. Remove the 3 remaining old self-locking nuts and install temporarily 3 NEW self-locking nuts by hand. Store the removed self-locking nuts in a replacement part box or the like.
9. Push the inflator and plate towards the position determining plate to eliminate any gap.
