Product Safety Recall

15826-01 Front Passenger Air Bag Inflator

Reference Number: N150826000

Release Date: May 2017
Revision: 01

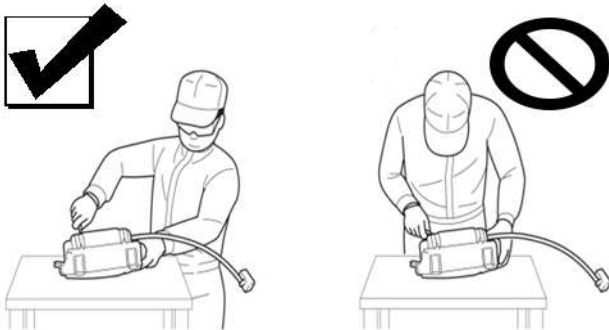
4751076

Warning: Confirm the stopper plate to inflator fitment is correct. *DO NOT* pinch the harness between the inflator and the stopper plate.

Warning: When working with the airbag module, avoid standing directly in front of the parts.

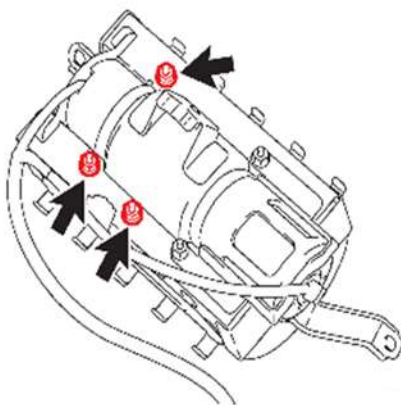
4751083

Important: If any gap exists, the aligned flats may move apart, resulting in failure in normal deployment of the airbag.

8. Remove the 3 remaining old self-locking nuts and install temporarily 3 **NEW** self-locking nuts by hand. Store the removed self-locking nuts in a replacement part box or the like.
9. Push the inflator and plate to towards the position determining plate to eliminate any gap.

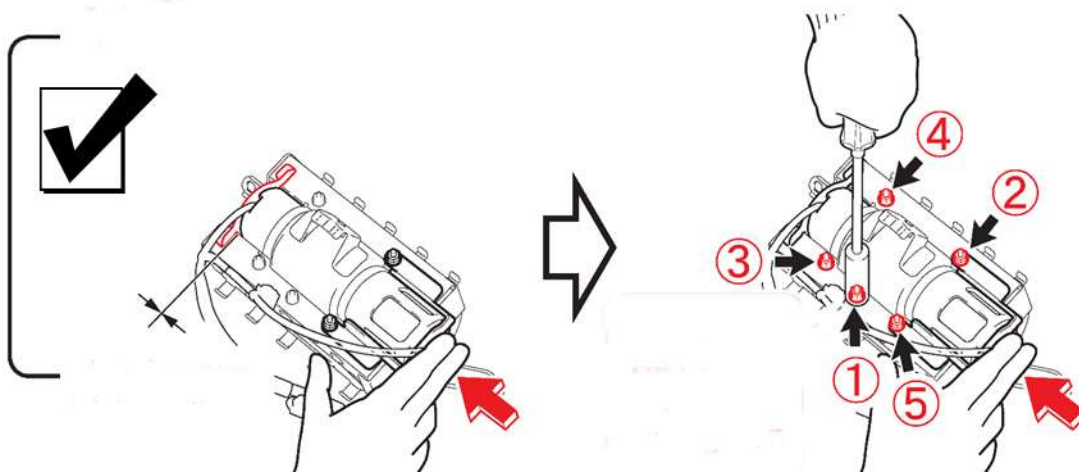
4751085

Important: The tightening torque is low (3.9 N·m). Use of an air ratchet wrench or tightening strongly with a T-handle wrench or a ratchet handle may cause deformation of the stud bolt.

10. Tighten 5 nuts evenly in several increments in the order shown above using a socket driver while pushing the inflator and plate. (You will encounter some resistance during tightening because these nuts are self-locking nuts.). Torque: 3.9 N·m (40 kgf·cm, 35 in.·lbf).

11. Install the harness clip to the center stud after all 5 nuts have been torqued.
