F/CMVSS Noncompliance Recall

45340 BYOM1 Lockup with Loss of Key Chime

Reference Number: A162045340

Release Date: December 2017

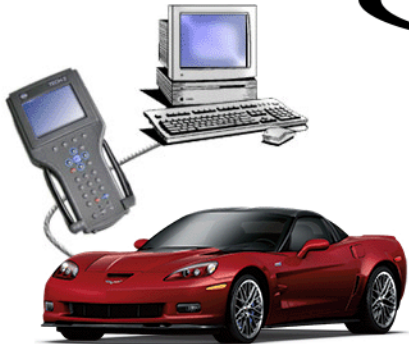
4919549

Action Complete
Radio - Programming (A11)
2017-12-06 09:14:03 EST

Warranty Claim Code: 8038A
Record this code on the warranty repair order (if applicable).

Important: Technicians **MUST** record the Warranty Claim Code (1) on the Job Card. To avoid warranty transaction rejection, this information must be entered when submitting the transaction.
