Product Safety Recall

36110 Passenger Presence Sensor and Instrument Cluster Malfunction

Reference Number: N16203611
GWM Number: 2036110

Release Date: June 2016
Revision: 00

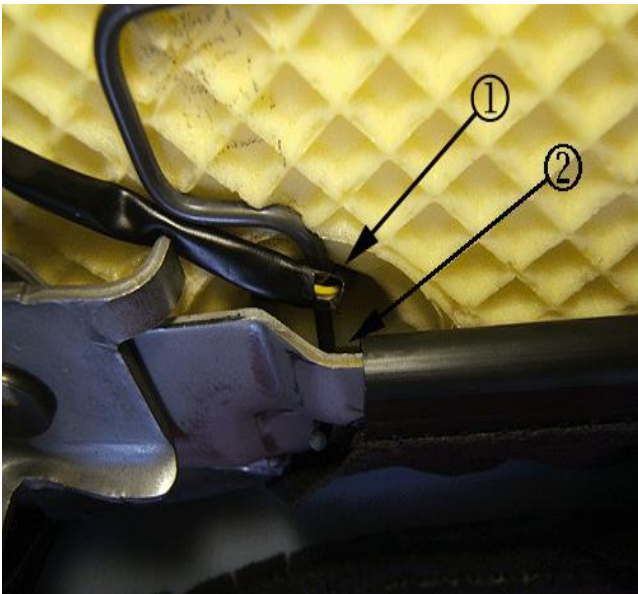
2462639

3. The picture above illustrates an example of the chafing (1) that may be identified on the PPS harness where it contacts the metal seat pan (2).

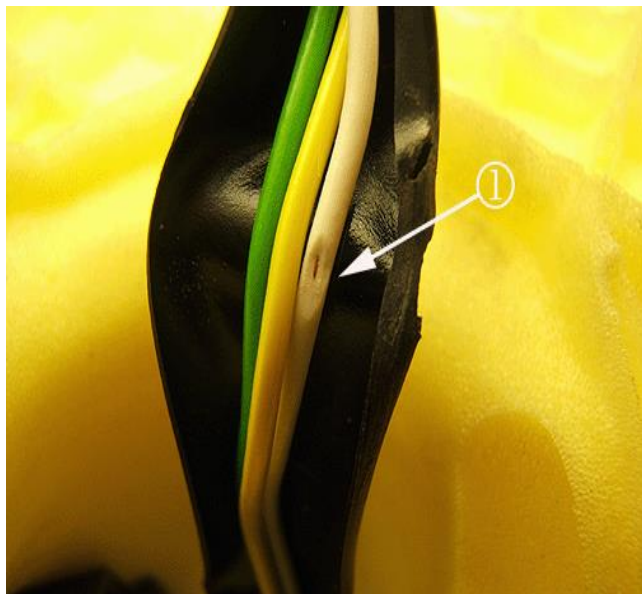
2462646

4. If the PPS harness shows signs of chafing, examine the wires in the harness carefully. If any wire is broken, shows signs of fraying or damage from an electrical short, repair using SI procedures. Refer to *Splicing Copper Wire Using Splice Sleeves* in SI. If the yellow wire is one of the damaged wires, please verify proper size airbag fuse is installed within the fuse box. If airbag fuse is open, please replace the airbag fuse. After performing any wiring repairs, proceed to Step 5. If the wire is not broken, frayed or showing damage from an electrical short, but the wire is exposed from the insulation (1) as shown above, proceed to Step 5.
