Product Safety Recall

30710 Inoperative Power Seats and Seat Fires

Reference Number: N162030710

Release Date: February 2017
Revision: 00

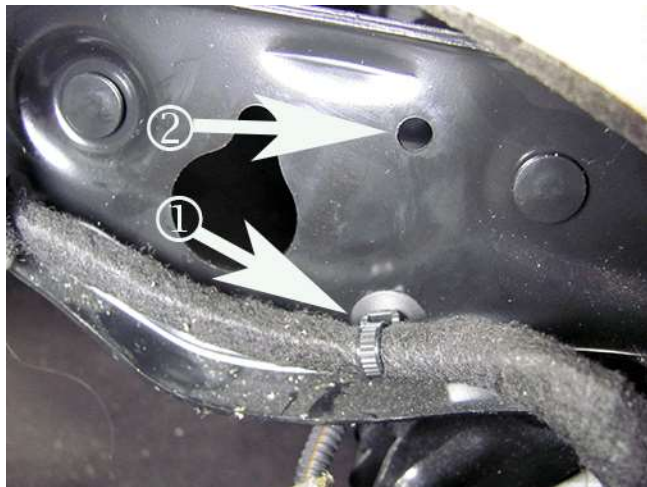
4708310

5. Ensure the harness retainer is located in the lower hole in the seat frame (1) not the upper hole (2).

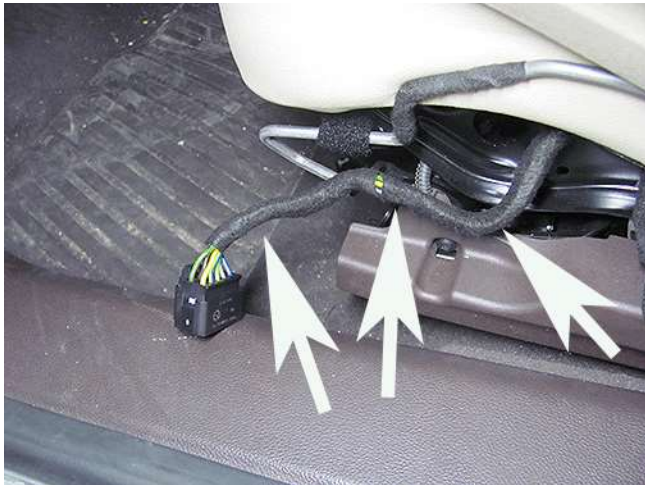
4708315

Correct Routing

6. Route the harness on the outside (front) of the seat side shield mounting rod. It may be necessary to remove the seat shield mounting rod screw.
7. Inspect the wrapping of the wiring harness for damage. Repair wire harness, if necessary. Refer to appropriate wire repair procedures in SI.

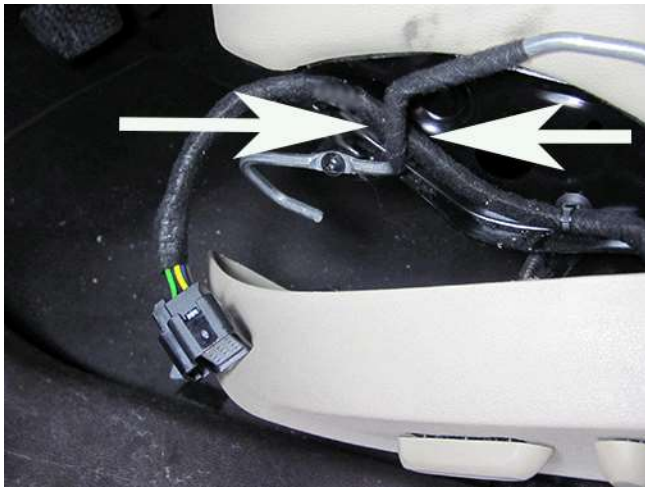
4708324

Incorrect Routing
