Product Safety Recall

31340 Seatbelt Lap Anchor Tensioner Cable

Reference Number: N16203134

Release Date: October 2016
Revision: 00

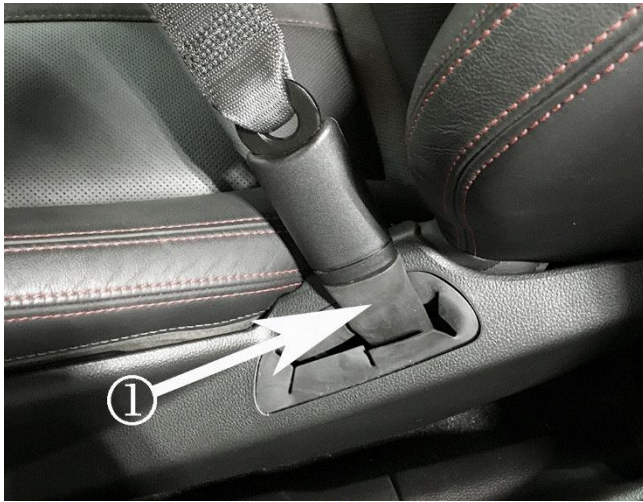
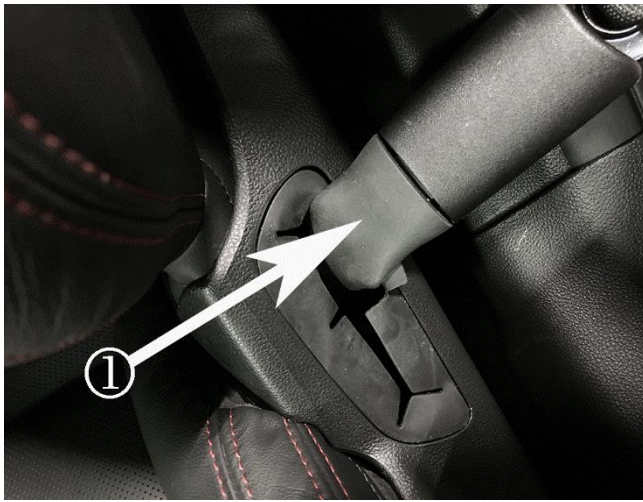
1. Using the seat adjustment switch, move the driver seat as far rearward and downward as possible. The front safety belt cable sleeve (hereinafter, “sleeve”) covers the flexible steel cable that connects the safety belt to the vehicle at the front outside seating position. The sleeve is covered by the seat trim and comes out of the slot on the side of the front seat.

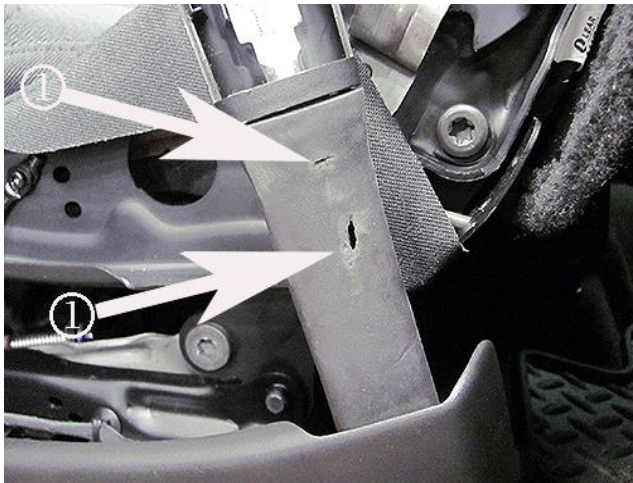
4522272

2. Inspect the sleeve for any cuts or cracks. Bend the cable toward the inside and outside of the vehicle and inspect the area near arrows (1) above.

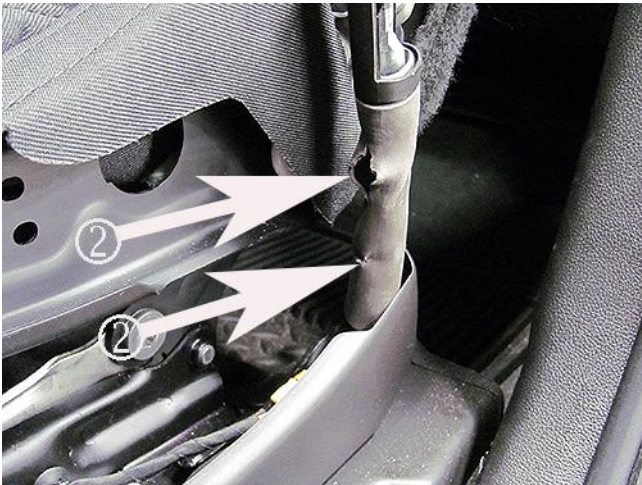
4522274

This damage will be in the form of holes (1) or splitting (2).

- If **any damage** is found, replace the tensioner with the revised tensioner and seat trim listed above. The tensioner bracket is not required. Refer to *Front Seat Belt Anchor Plate Tensioner Replacement* in SI.
- If no damage is found, install the seat tensioner bracket using the existing tensioner. Follow the steps in the Bracket Installation section below.
