Product Safety Recall

51230 Manual Service Disconnect Not Seated

Reference Number: N162051230
GWM Number: 2051230

Release Date: July 2016
Revision: 00

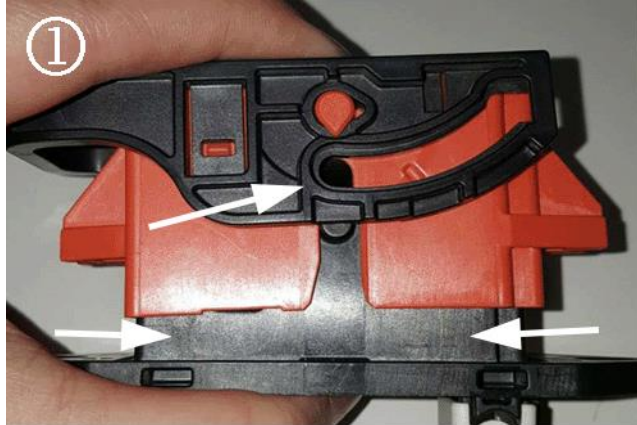
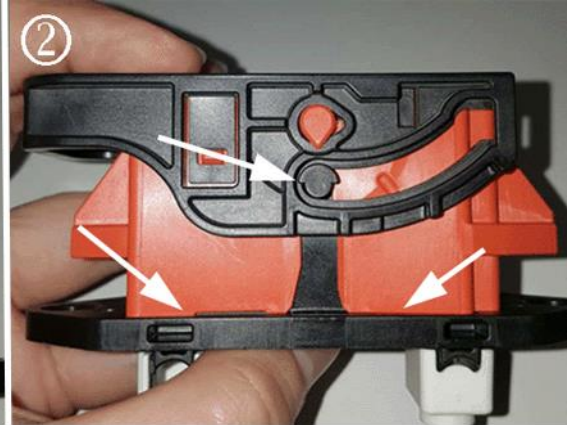
4551491

2. Inspect the drive motor battery high voltage manual disconnect lever (MSD) and make sure the connection is properly seated and retained. When properly installed the drive motor battery high voltage manual disconnect lever (MSD) should be flush with the base. Also visually inspect that the “lugs” are inside the retaining lever “ramps” as illustrated in figure 2
 - If the drive motor battery high voltage manual disconnect lever (MSD) IS NOT properly seated as shown (1), continue to step 3.
 - If the drive motor battery high voltage manual disconnect lever (MSD) is properly seated (2), skip to step 6.
3. Disconnect the 12 V battery.
 - 3.1. Remove the drive motor battery high voltage manual disconnect lever (MSD). Refer to *Drive Motor Battery High Voltage Manual Disconnect Lever Replacement* in SI.

Note: It is imperative that the drive motor battery high voltage manual disconnect lever (MSD) is fully inserted in the base and locking pins are engaged before rotating cam lever down. When properly installed the drive motor battery high voltage manual disconnect lever should be flush with the base.
