Product Safety Recall

51230 Manual Service Disconnect Not Seated

Reference Number: N162051230
GWM Number: 2051230
Revision Description: The Service Procedure and the Warranty Information sections have been revised. Please discard all copies of bulletin 51230-01.

Release Date: November 2017
Revision: 02

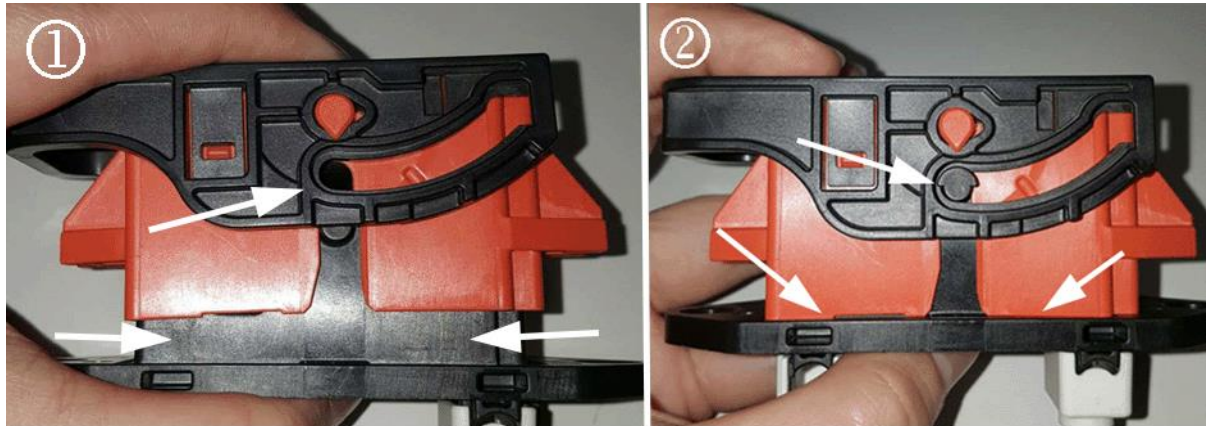
4551491

2. Inspect the drive motor battery high voltage manual disconnect lever (MSD) and make sure the connection is properly seated and retained. When properly installed the drive motor battery high voltage manual disconnect lever (MSD) should be flush with the base. Also visually inspect that the “lugs” are inside the retaining lever “ramps” as illustrated in figure 2.
 - If the drive motor battery high voltage manual disconnect lever (MSD) IS NOT properly seated as shown (1), continue to step 3.
 - If the drive motor battery high voltage manual disconnect lever (MSD) is properly seated (2), skip to step 6.

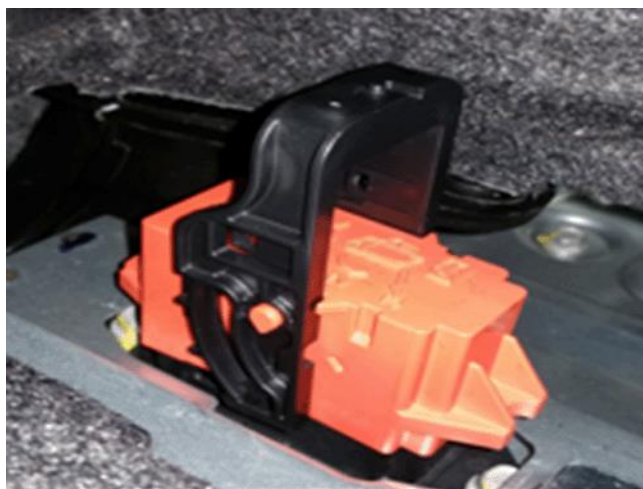
4551492

Note: It is imperative that the drive motor battery high voltage manual disconnect lever (MSD) is fully inserted in the base and locking pins are engaged before rotating cam lever down. When properly installed the drive motor battery high voltage manual disconnect lever should be flush with the base.

4. With the cam on the drive motor battery high voltage manual disconnect lever (MSD) in the fully upright position, install the drive motor battery high voltage manual disconnect lever onto the battery.
