# Product Safety Recall

## 51230 Manual Service Disconnect Not Seated

**Reference Number:** N162051230  
**GWM Number:** 2051230  
**Revision Description:** This bulletin has been revised to include a copy of the customer notification letter. Please discard all copies of bulletin 51230.

<b>Condition</b>	General Motors has decided that a defect, which relates to motor vehicle safety, exists in certain 2016 model year Chevrolet Malibu Hybrid vehicles equipped with a manual service disconnect (MSD). The MSD is a shut-off switch to the high voltage battery designed to shut off high voltage power before servicing the vehicle. In some of these vehicles, the MSD was not installed properly and may not be locked in position. Improperly installed MSDs could become loose and disconnect while driving, which would cut off all high-voltage power to the vehicle. The loss of high-voltage power to these vehicles would cut propulsion energy and effectively stall the vehicle, which could affect the driver's ability to control the vehicle and could increase the risk of a crash.
<b>Correction</b>	Dealer will inspect the MSD and, if necessary, seat the connector properly. The dealer will also reflash

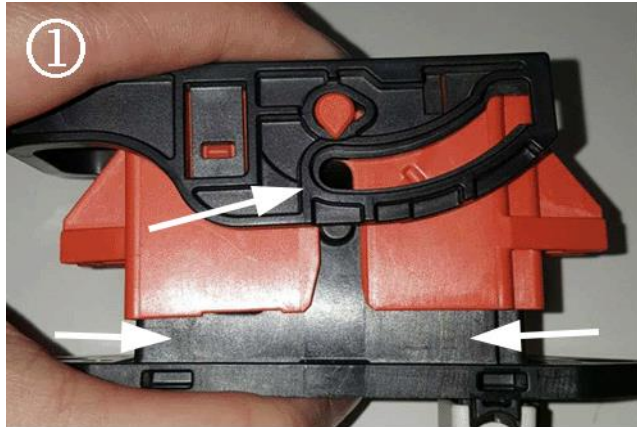
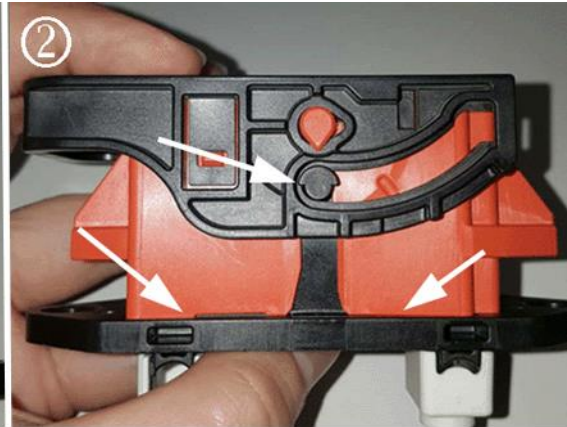
4551491

2. Inspect the drive motor battery high voltage manual disconnect lever (MSD) and make sure the connection is properly seated and retained. When properly installed the drive motor battery high voltage manual disconnect lever (MSD) should be flush with the base. Also visually inspect that the “lugs” are inside the retaining lever “ramps” as illustrated in figure 2.
  - If the drive motor battery high voltage manual disconnect lever (MSD) IS NOT properly seated as shown (1), continue to step 3.
  - If the drive motor battery high voltage manual disconnect lever (MSD) is properly seated (2), skip to step 6.
3. Disconnect the 12 V battery.

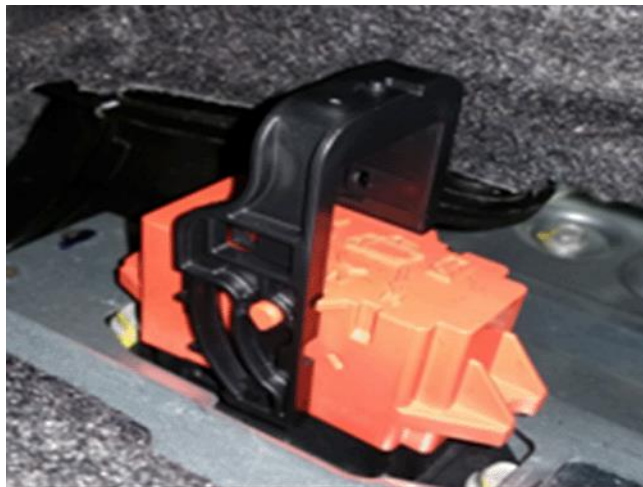
4551492

**Note:** It is imperative that the drive motor battery high voltage manual disconnect lever (MSD) is fully inserted in the base and locking pins are engaged before rotating cam lever down. When properly installed the drive motor battery high voltage manual disconnect lever should be flush with the base.

4. With the cam on the drive motor battery high voltage manual disconnect lever (MSD) in the fully upright position, install the drive motor battery high voltage manual disconnect lever onto the battery.
