# Product Safety Recall

## 16035 Front Passenger Seat Belt Missing Bolt

Reference Number: N16206657

Release Date: September 2016  
Revision: 00

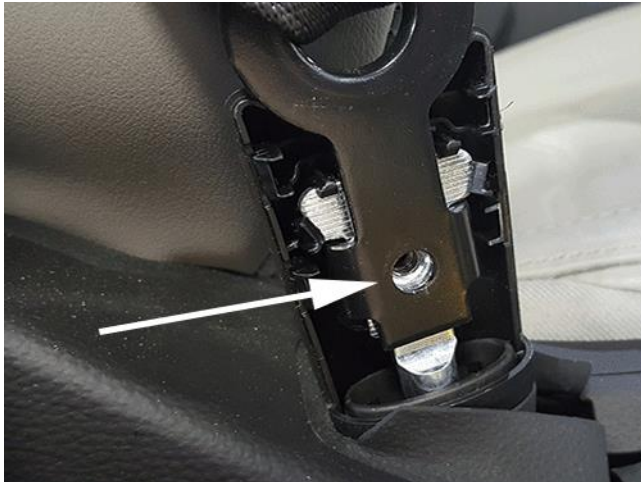
2. Open the passenger side door and adjust the front passenger seat to the full forward and full down position.

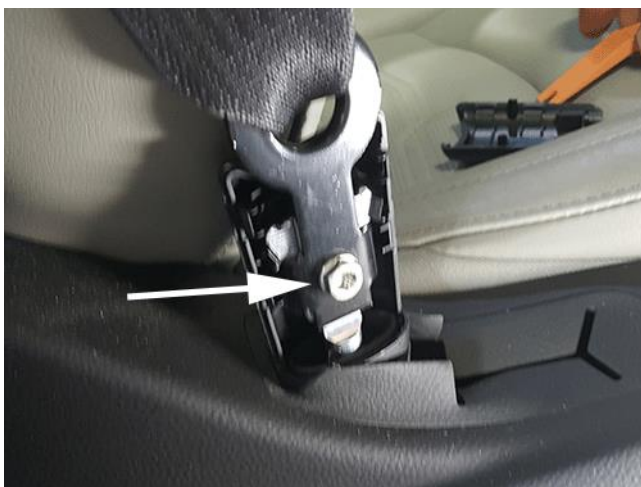
3. Locate the front seat belt anchor plate tensioner. The front seat belt anchor plate tensioner cover and bolt will most likely be missing.

- If the front seat belt anchor plate tensioner cover and bolt are present, remove and discard. Proceed to step 4.
- If the front seat belt anchor plate tensioner cover and bolt are missing, proceed to step 4.

4. Install the new seat belt anchor plate tension bolt. Torque to 6 Nm (33 lb ft).
