Tightening Torque Value Update for Final Drive Pulley Retaining Nut and Side-stand Fastener
Models: 2016-2017 Model Year XDiavel and XDiavel S (all country versions)
Recall Bulletin SRV-RCL-16-003 (A & B)

Date: October 3, 2016
To: Dealer Principal, General Manager, Service Manager, North American Dealer Network
From: Richard Kenton, Technical Director; Jonathan LaForte, Technical Manager

NHTSA Campaign I.D. Number (A): 16V679
NHTSA Campaign I.D. Number (B): **XXX**
Transport Canada Safety Recall I.D. Number 2016472

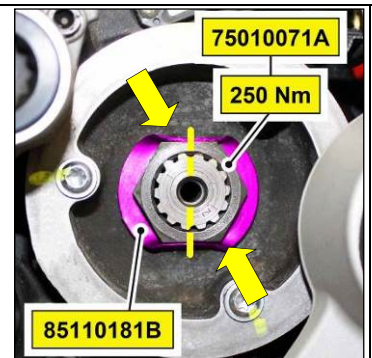
The first issue (SRV-RCL-16-003A) is regarding the possible loosening of the **final drive pulley retaining nut**. Should this be the case, a loss of vehicle traction may occur, after heavy use, due to the possible wear of the pulley teeth which would make the gearbox secondary shaft slip with respect to the same pulley.

- 1) increase the nut tightening torque to 250 Nm (previously 186 Nm);
- 2) replace the lockwasher with one made with a new material (part no. 85110181B);
- 3) replace the retaining nut.

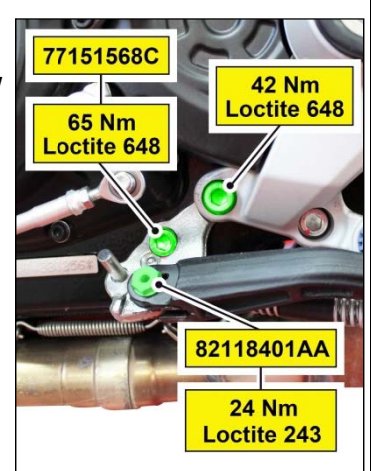
a) The second issue (SRV-RCL-16-003B) is regarding the possible loosening of the lower side-stand plate fastening screw; and Ducati has decided to upgrade the **side stand plate fastener** by means of the three operations indicated below:

- 1) replace the lower fastening screw with a longer one having a higher strength class (M10x30 10.9 part no. 77151568C) to increase the tightening torque to 65 Nm; and add application of Loctite 648.
- 2) apply Loctite 648 on the upper fastening screw and tighten to a torque of 42 Nm;
- 3) replace the side-stand pivot with one made of a new material part no. 82118401AA, and tighten to a torque of 24 Nm.
