# Product Safety Recall

## 16079 Side Impact Air Bag LAT Failure

Reference Number: N16205494

Release Date: October 2016  
Revision: 00

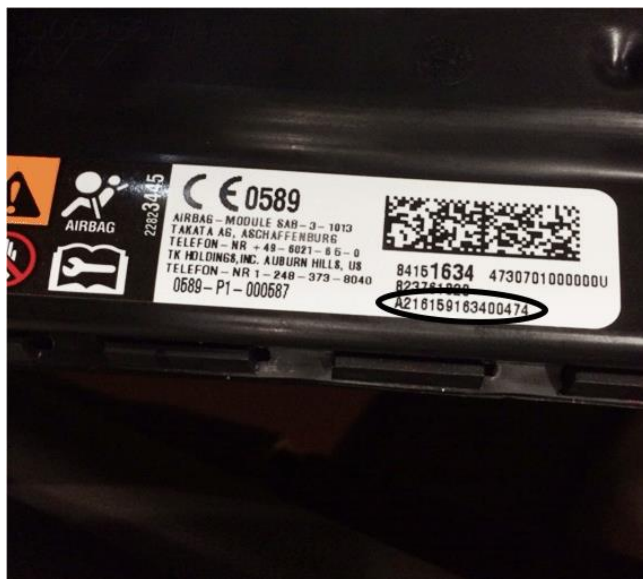
- Inspect the serial number on the back of the SIAB.
  - If the serial number on the back of the SIAB matches the serial number listed in the table above, proceed to step 4.

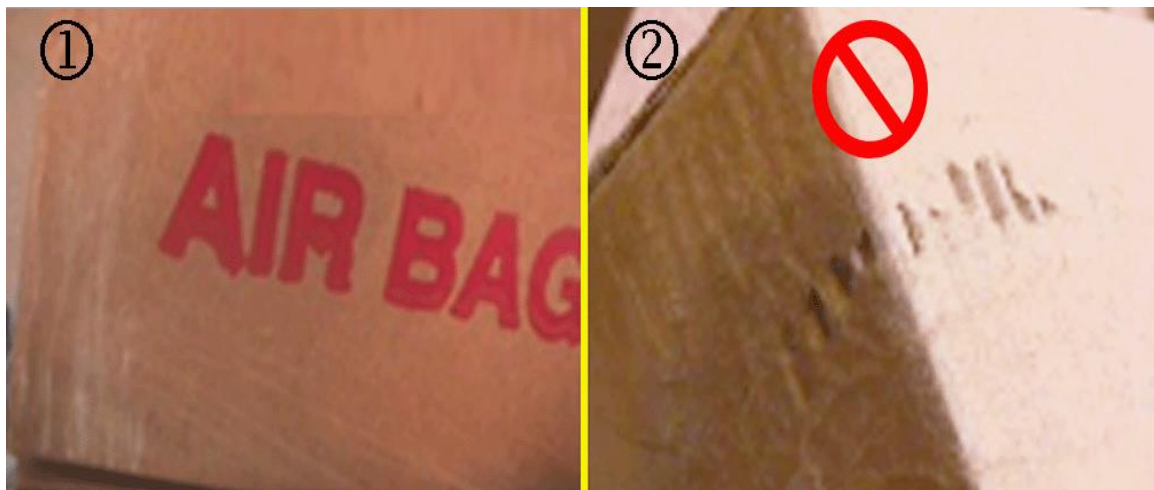
3961561

- **Abrasions:** Abrasions result from sliding the package against a rough surface (e.g. concrete floors). Major abrasions (2) are NOT acceptable. Note the flutes are visible.

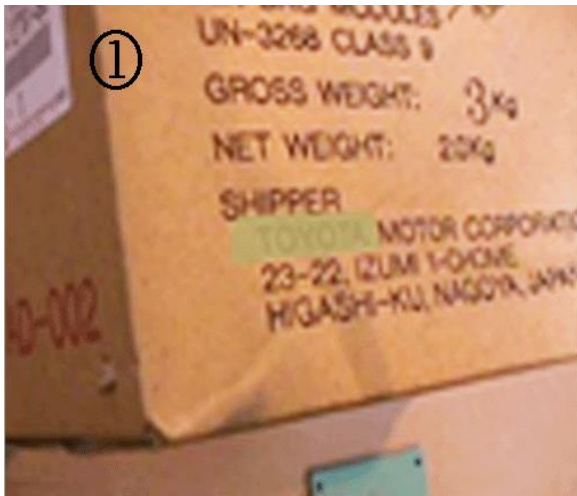
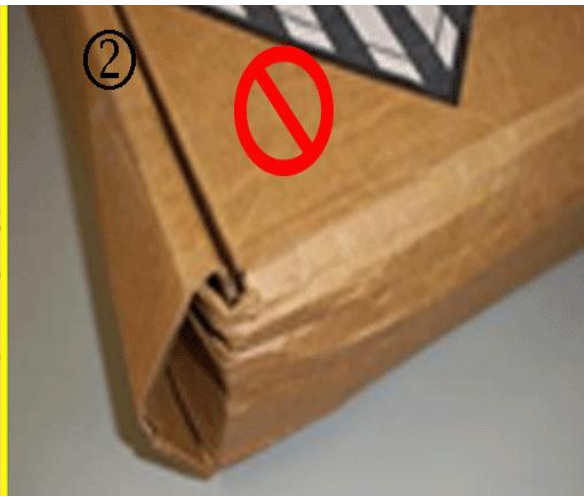
3691563

- **Compressions:** Compressions result from superimposed weights (e.g. stacked too high) or from dropping the packages. Small dimples (1) are acceptable.

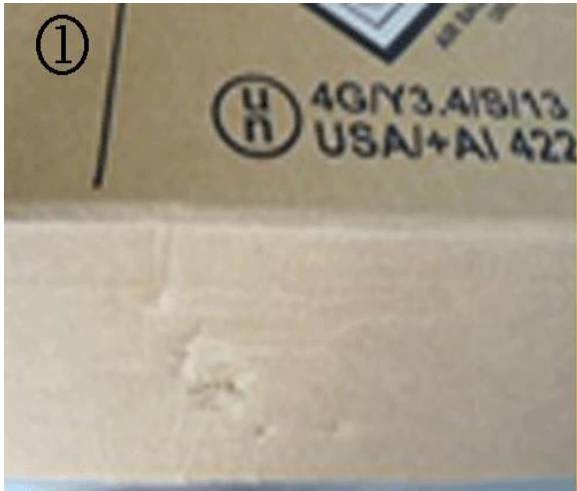
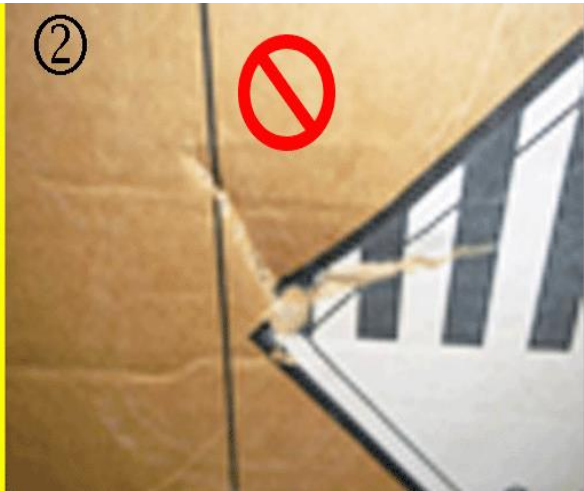
3961564

- **Dents:** Minor dents (1) occur through normal handling and picking (e.g. pulling from bin locations) and are acceptable. Major dents (2) result from impacts with others objects (e.g. pallet impacts).

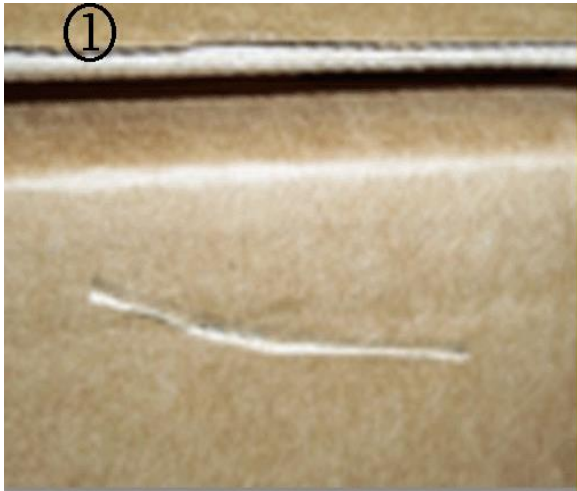
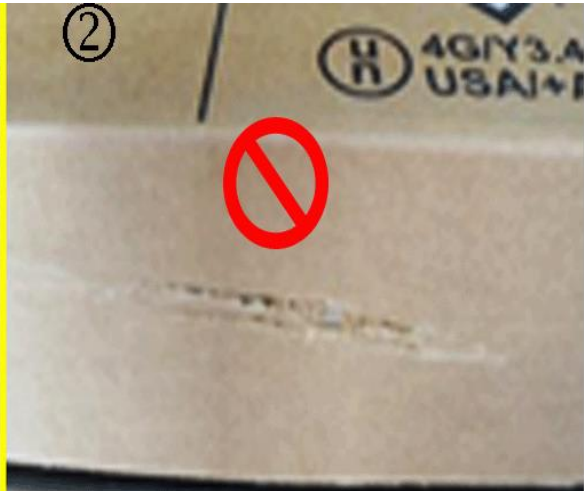
3961565

- **Incisions:** Minor incisions (1) are acceptable. Major incisions (2) (e.g. pallet box cut open with utility knife) are NOT acceptable.

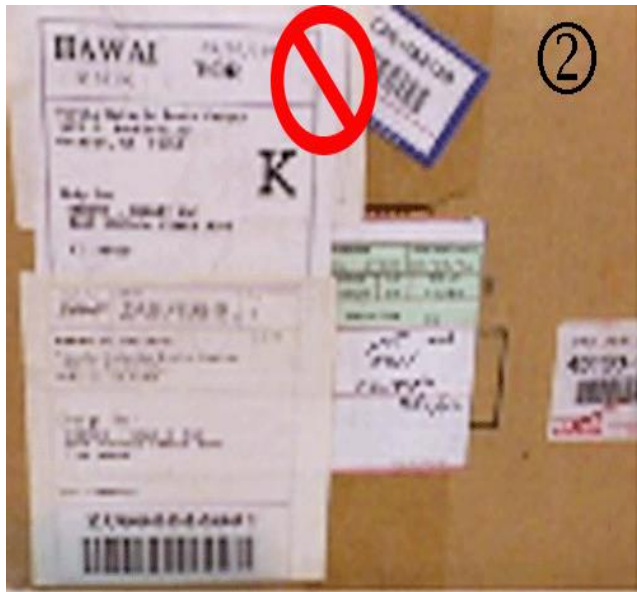
3961566

- **Labeling:** Packages with excessive labeling are NOT acceptable, particularly if the labels obscure other required marks and labels.

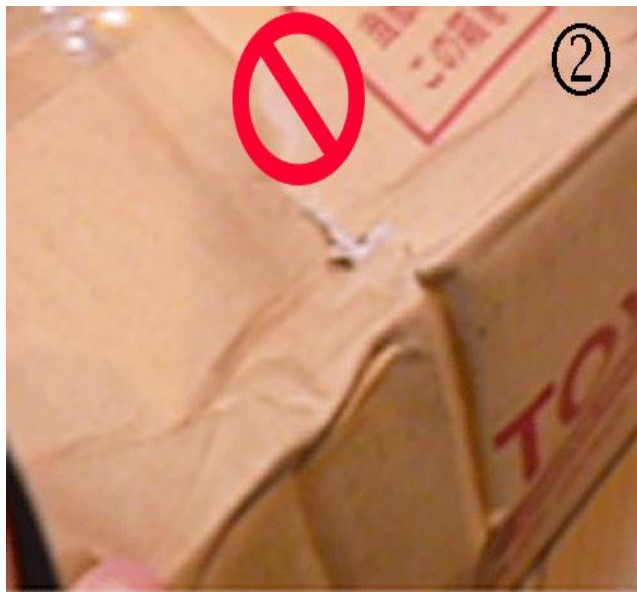
3961567

- **Other Damages:** Multiple damages, such as those shown above, may affect the integrity of the packages, and are NOT acceptable. Others that are not as severe may be acceptable. If questionable, repackage the material.

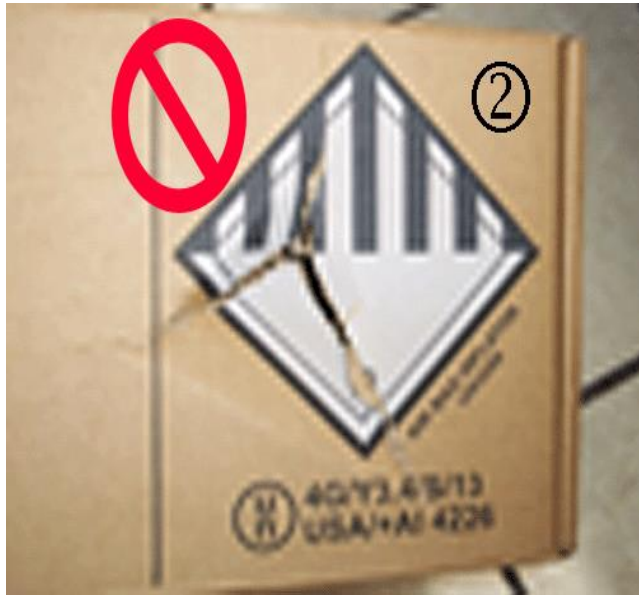
- **Punctures:** Any punctures, even minor ones, are NOT acceptable.

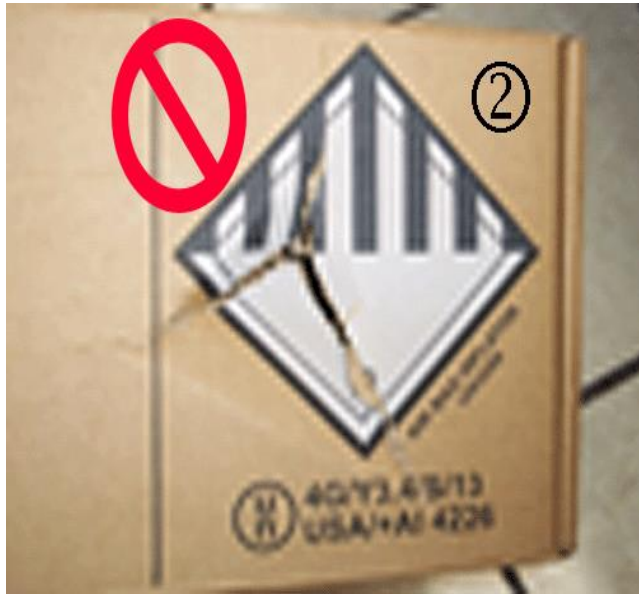
- **Tears:** Minor tears will not generally affect the structural integrity of the packaging and are considered to be normal "wear and tear", however, large tears or rips are NOT acceptable.

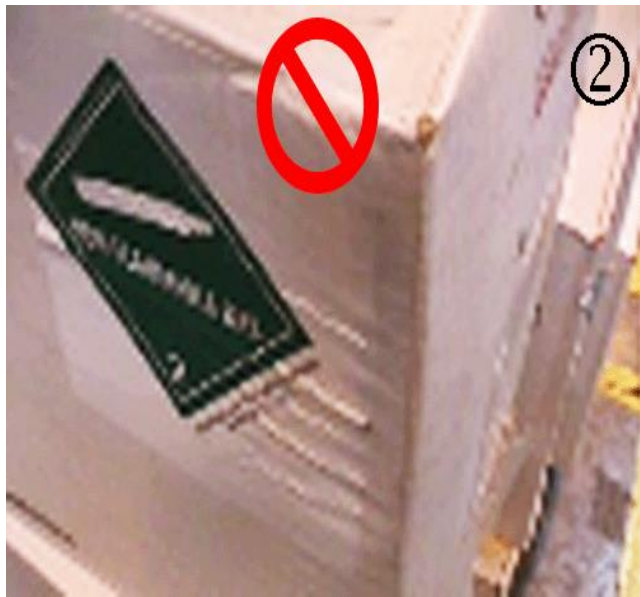
3961569

- **Water Damages:** Water Damages, such as the example shown above, are NOT acceptable. Water damages will affect the structural integrity of the packaging. These packages should be repacked in appropriate specification packages.
