Product Safety Recall

16145 Engine Cooling Fan Fires

Reference Number: N151702620

Release Date: August 2017
Revision: 00

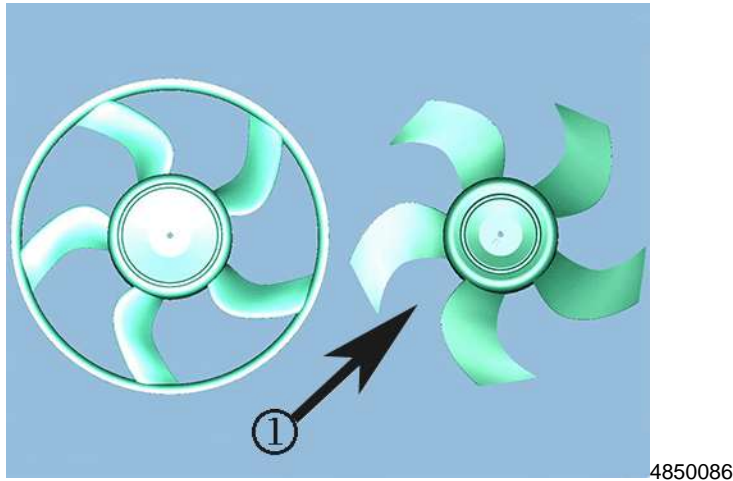
Note: There is the possibility of a different variant of the cooling fan being in the vehicle due to prior vehicle service. Prior to disassembly check that the driver and passenger side fan blades are both rimless 5 blades (1). Vehicle may have none or some of these conditions;

If driver side does not have rimless 5 blade design then, order and install new driver side 5 blade rimless design (Left Hand) and LH fan motor.

If passenger side does not have rimless 5 blade design then, order and install new passenger side 5 blade rimless design (Right Hand) and RH fan motor.

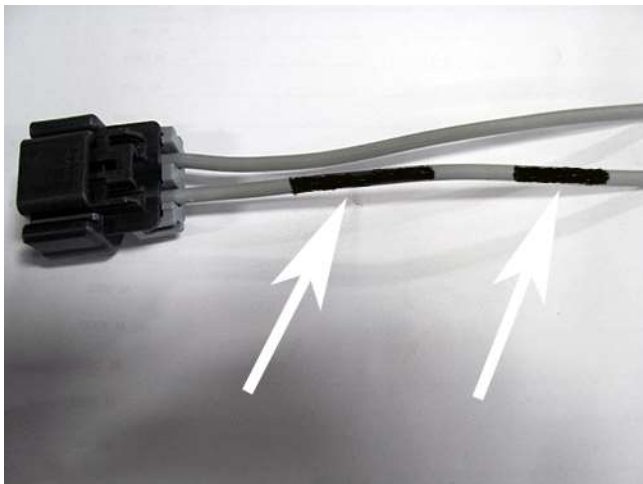
4850090

Note: The service connector has two grey colored wires. It is important to identify the black wire on the vehicle and mark the service wires to match the polarity of the vehicle. If the wires are crossed, the fan will run backwards.

9. Hold the service wiring connector up to the vehicle connector. Identify the black wire in relation to the vehicle and service connector. Using a black Sharpie, mark the correct lead with a black tracer.
