Product Safety Recall

16146 Right Rear Side Air Bag

Reference Number: N162076520

Release Date: January 2017

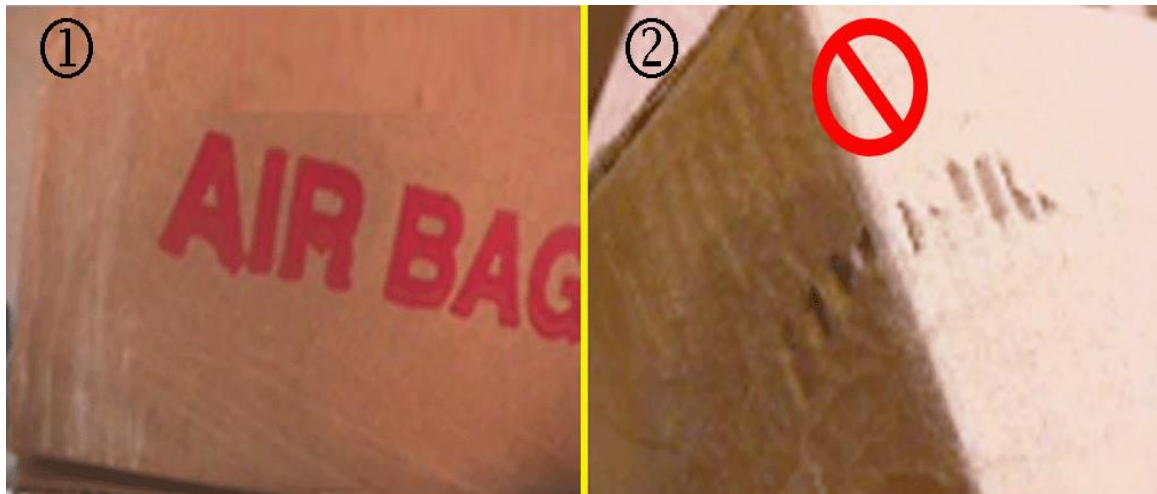
- **Abrasions:** Abrasions result from sliding the package against a rough surface (e.g. concrete floors). Major abrasions (2) are NOT acceptable. Note the flutes are visible.

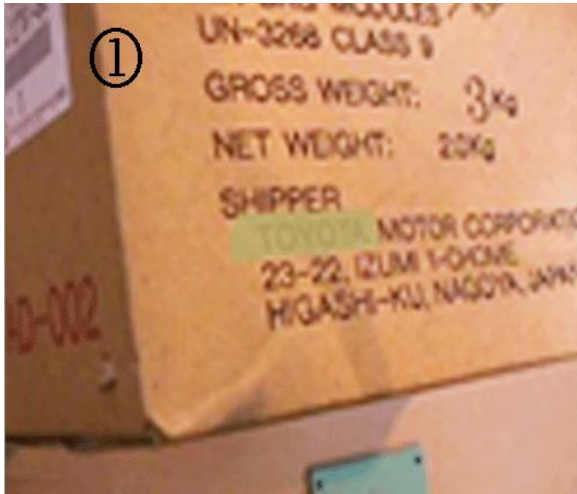
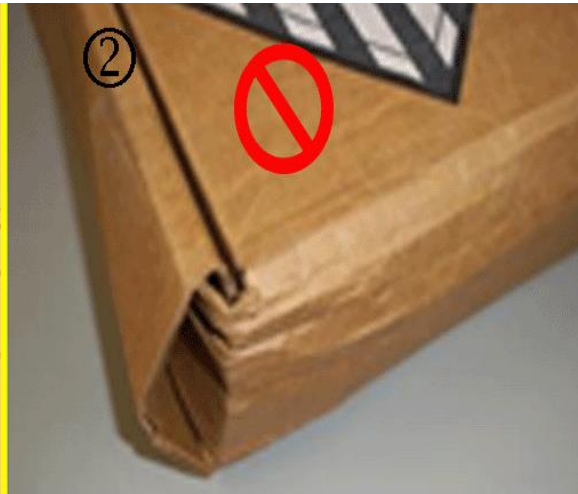
3691563

- **Compressions:** Compressions result from superimposed weights (e.g. stacked too high) or from dropping the packages. Small dimples (1) are acceptable.

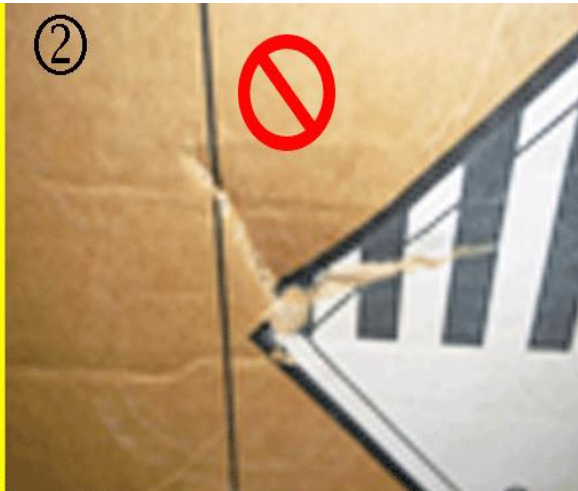
3961564

- **Dents:** Minor dents (1) occur through normal handling and picking (e.g. pulling from bin locations) and are acceptable. Major dents (2) result from impacts with others objects (e.g. pallet impacts).

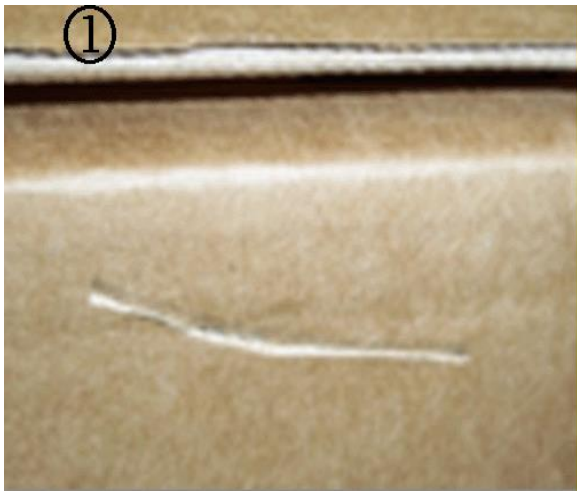
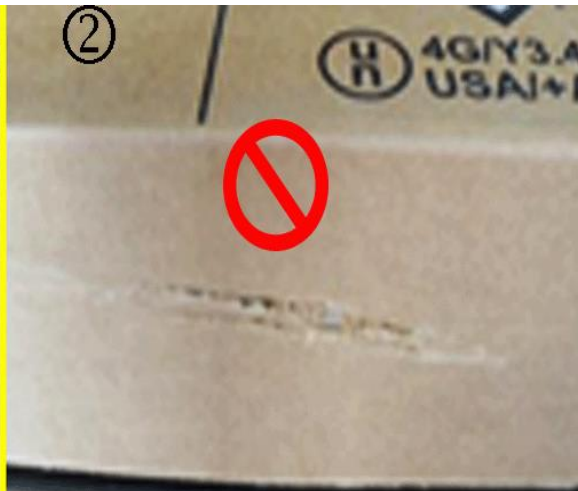
3961565

- **Incisions:** Minor incisions (1) are acceptable. Major incisions (2) (e.g. pallet box cut open with utility knife) are NOT acceptable.

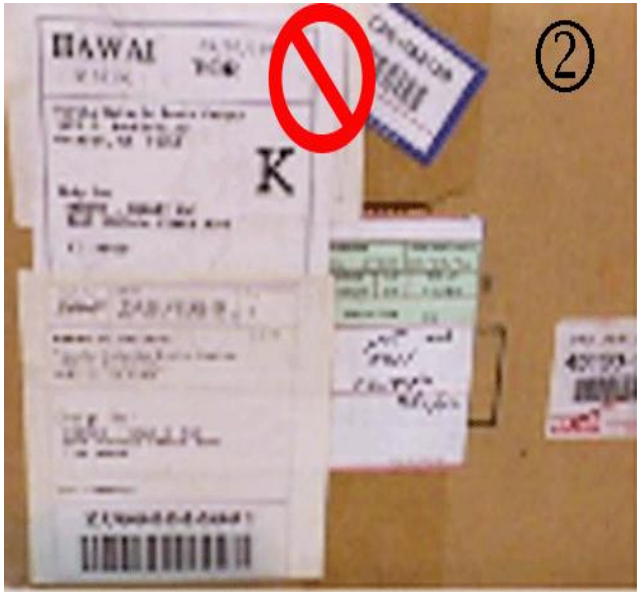
3961566

- **Labeling:** Packages with excessive labeling are NOT acceptable, particularly if the labels obscure other required marks and labels.

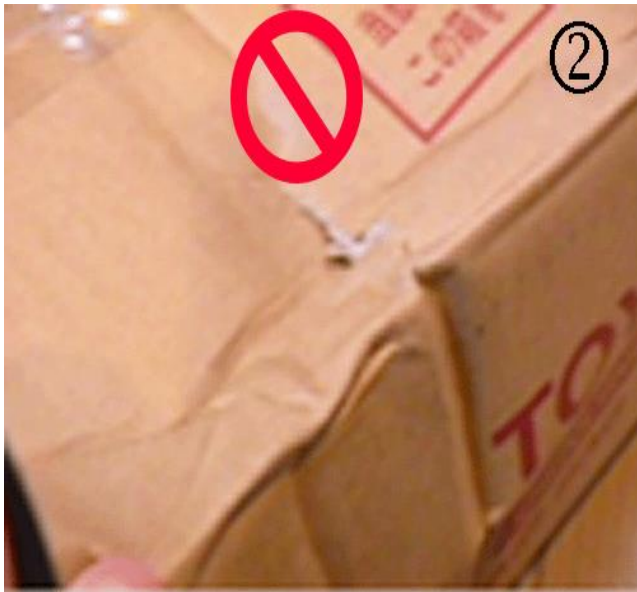
3961567

- **Other Damages:** Multiple damages, such as those shown above, may affect the integrity of the packages, and are NOT acceptable. Others that are not as severe may be acceptable. If questionable, repackage the material.

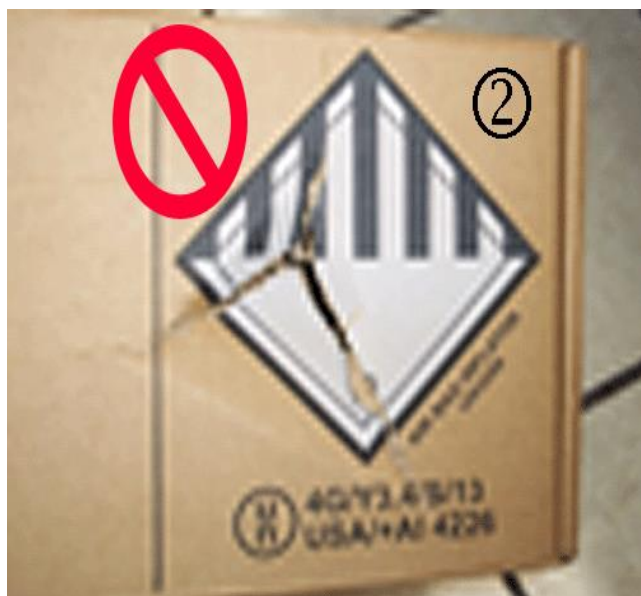
3961568

- **Punctures:** Any punctures, even minor ones, are NOT acceptable.

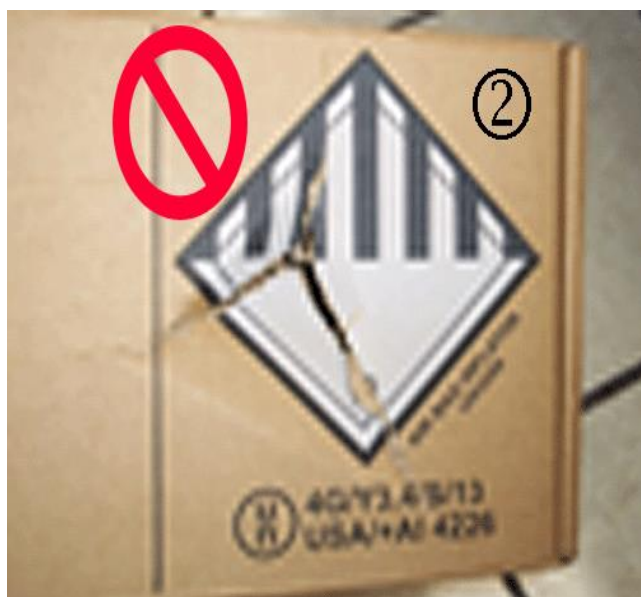
3961568

- **Tears:** Minor tears will not generally affect the structural integrity of the packaging and are considered to be normal "wear and tear", however, large tears or rips are NOT acceptable.

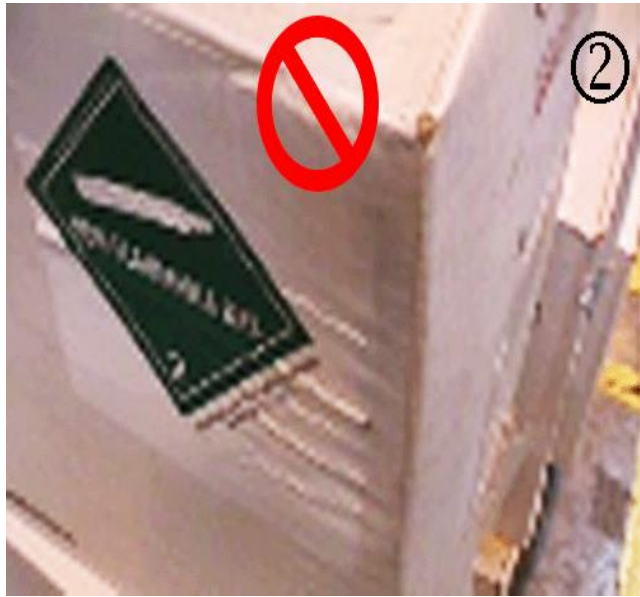
3961569

- **Water Damages:** Water Damages, such as the example shown above, are NOT acceptable. Water damages will affect the structural integrity of the packaging. These packages should be repacked in appropriate specification packages.
