SERVICE BULLETIN

UTILITY TRAILER MANUFACTURING CO.

SB-08-200

Subject: BENDIX SR-5 VALVE Recall – INTERIM NOTIFICATION

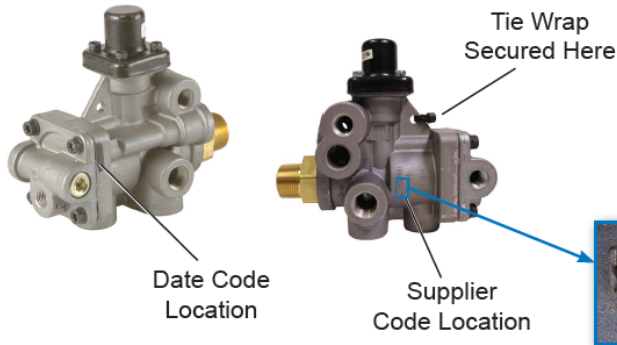
Bendix® SR-5™ Valve

To verify that the Bendix® SR-5™ valve has been repaired per the recall campaign, look for the presence of a black or green tie wrap secured to the valve body. **No further action is required.**

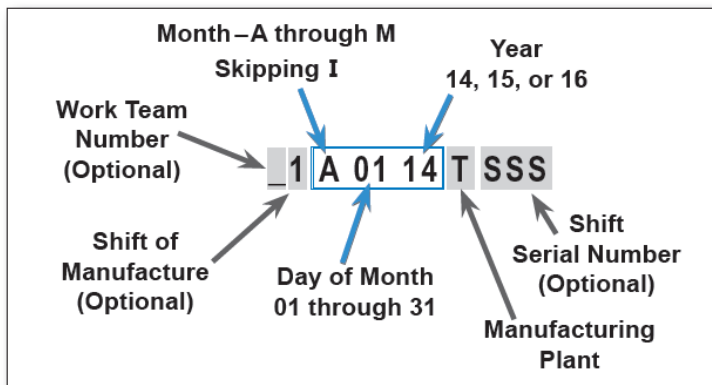
Interpreting the Date Code

A date code is stamped (not cast) on the SR-5 valve body housing. *Locate the date code – removing the paint coating, if necessary – to read the code.* Disregard the Work Team Number, Shift of Manufacture, Manufacturing Plant and Shift Serial Number codes shown in gray below. The portion of the date code that determines the date of manufacture is highlighted and can be interpreted as follows:

- The first field is the month (A=January, B=February, etc. – excluding the letter I – so that J=September, and so on),
- The next two fields are the day of the month (e.g. 01 = 1st); and
- The next two fields are the year (e.g. 14=2014)

January 1, 2014 through March 4, 2016
That is, A0114T through C0416T

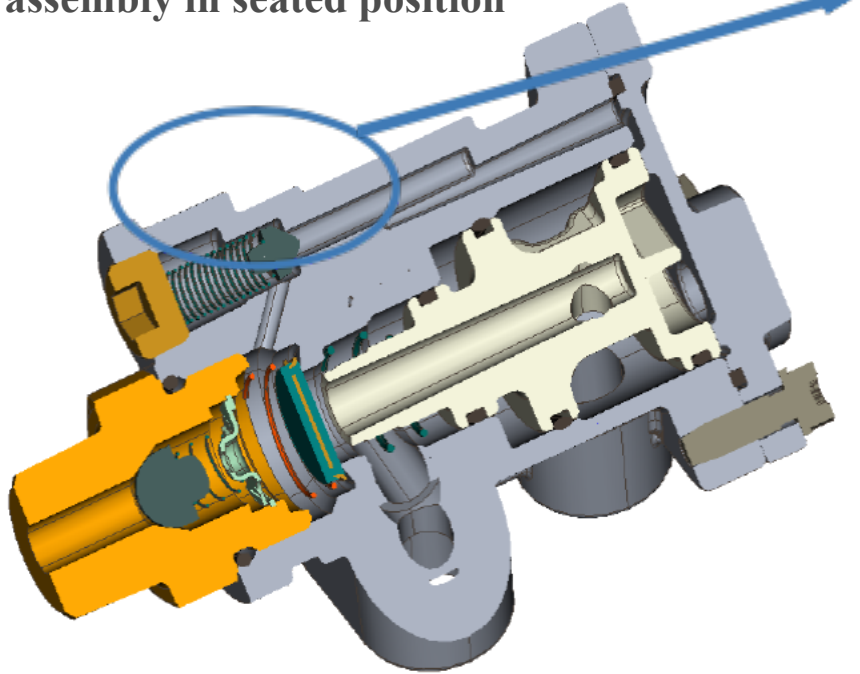
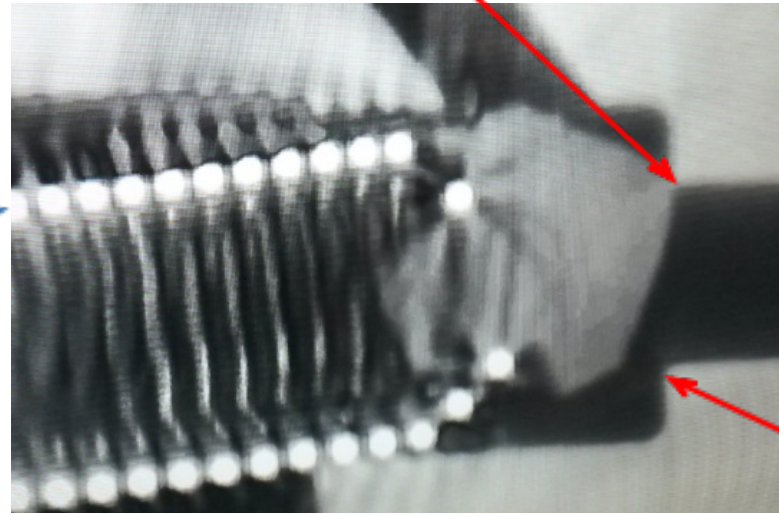
Sectional view of check valve assembly in seated position

Missing Radius on Aluminum valve Body

When combined with certain field conditions – causes misalignment of internal Check Valve

Caught on Sharp Edge

Missing Radius on Valve Body

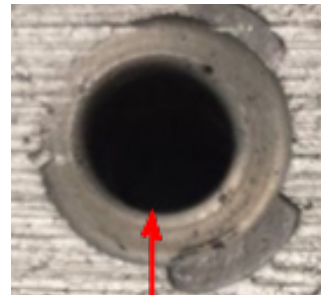
Check Valve seat
(Radius Present / Radius Not Present)

If Valve becomes Misaligned, Leakage can be Large enough to cause 'Slow to Park'

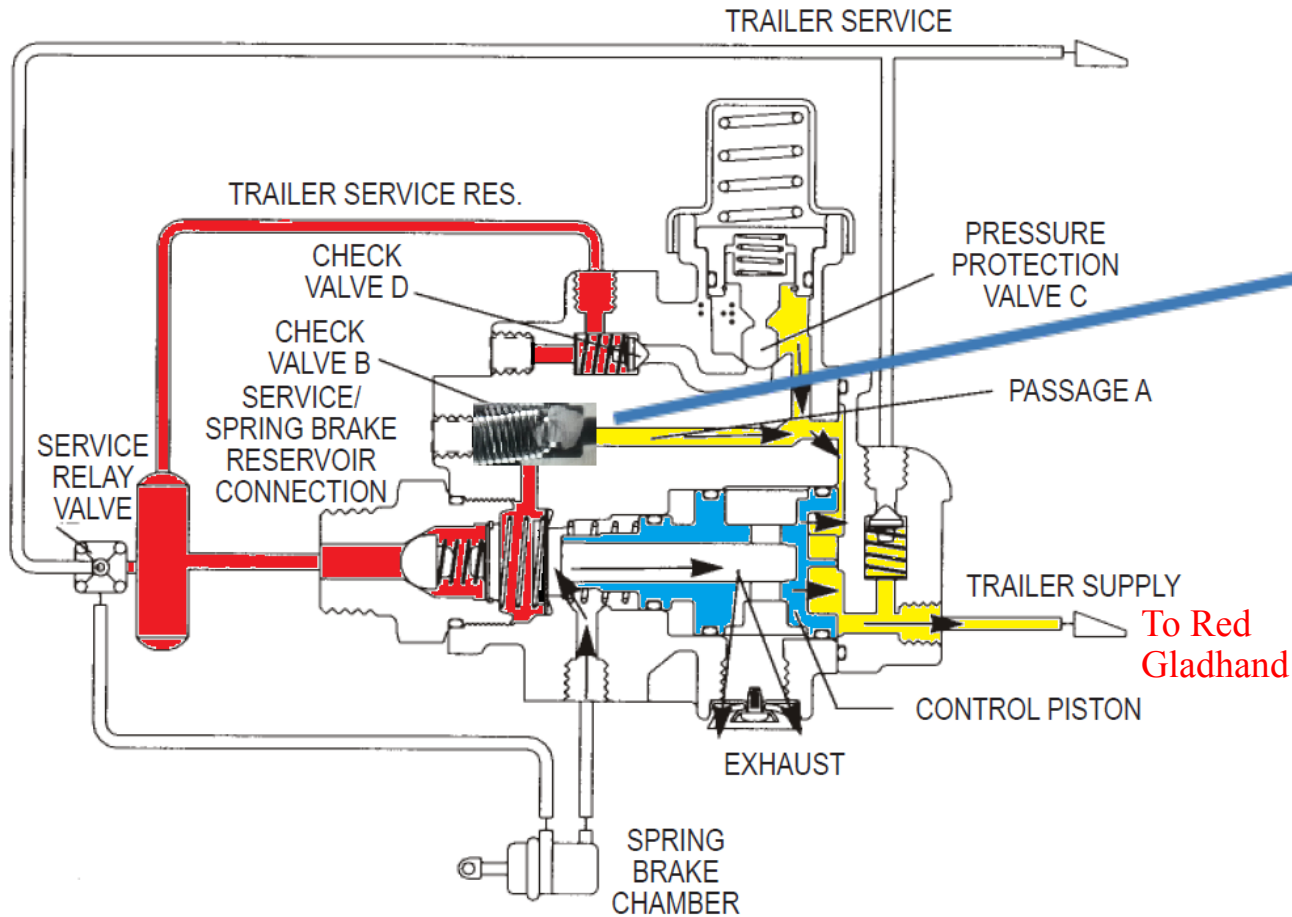
Missing Radius on Aluminum valve Body

When combined with certain field conditions – causes misalignment of internal Check Valve

If Leakage is present (& large enough), the leaking air provides enough back pressure on the main control piston (**BLUE**) to prevent normal movement.

If the main piston does not move, immediate exhaust (<3 seconds) cannot happen.

This is how the leakage from the check valve is causing the ‘slow to park’ condition.

Once leakage fully exhausts tank pressure, the backpressure drops, the main piston moves & the trailer parks.

Missing Radius (combined with other conditions) can cause leakage – preventing immediate parking
