### IMPORTANT SAFETY RECALL

General Motors has decided that a defect which relates to motor vehicle safety exists in all 2013-2016 model year Chevrolet Caprice Police Pursuit Vehicles and Chevrolet SS vehicles as a result, GM is conducting a safety recall. We apologize for this inconvenience. However, we are concerned about your safety and continued satisfaction with our products.

GM Recall #31340

#### SAFETY BELT CABLE SLEEVE INSPECTION PROCEDURE FOR RECALL 31340

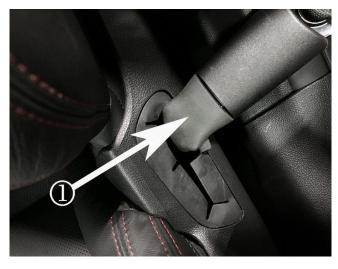
This inspection is to be performed on the driver side safety belt cable sleeve (1). If the front driver seat sleeve is cut, cracked or worn through on the inboard or outboard side (see arrows 1 above) the safety belt assembly should be replaced. If the sleeve shows only scuffs or wear marks but no cuts or cracks, replacement is not necessary.

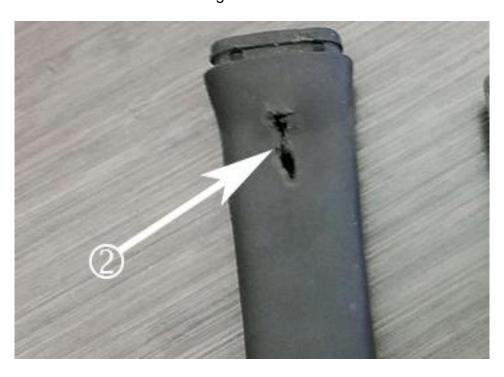
- 1. Using the seat adjustment switch, move the driver seat as far rearward and downward as possible. The front safety belt cable sleeve (hereinafter, "sleeve") covers the flexible steel cable that connects the safety belt to the vehicle at the front outside seating position. The sleeve is covered by the seat trim and comes out of the slot on the side of the front seat.
- 2. Inspect the sleeve for any cuts or cracks. Bend the cable toward the inside and outside of the vehicle and inspect the area near arrows (1) above. The sleeve shown below (2) requires replacement as a hole has worn through the sleeve.

- If the driver sleeve shows any cuts, cracks or wear through, please stop driving your vehicle
  and immediately contact your GM dealer. Your dealer will arrange for your vehicle to be
  towed to the dealership at no charge and provide you with a free loaner vehicle while the
  damaged safety belt assembly is replaced. Note that this replacement is a temporary
  repair and your vehicle will still need to be serviced when parts are available.
- If the driver sleeve shows no visible cuts or cracks, no further action is required until you
  receive a second letter from GM asking you to take your vehicle to your dealer for the
  permanent repair.
